DAMAGE ASSESSMENT OF IMPACT DAMAGES ON CFRP WITH LASER SHEAROGRAPHY

Raphael Schoen, Steinbichler Optotechnik GmbH, Neubeuern, 83115 Germany

Simon G. Pickering, University of Bath, Bath, BA2 7AY, UK

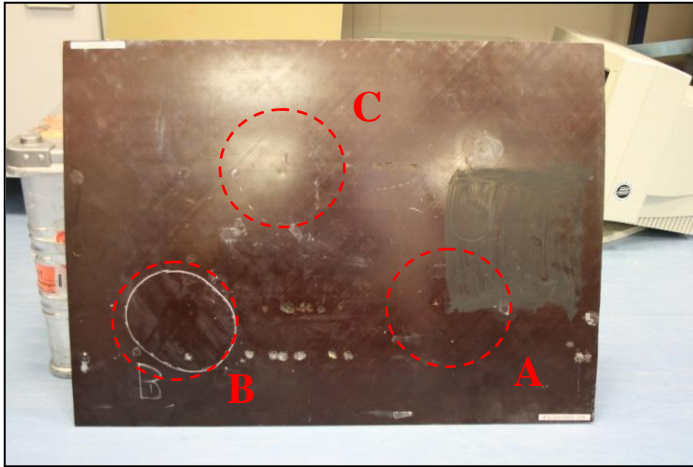
Figure 5. Stringer panel (front side view) with 3 impacted areas indicated with red circles

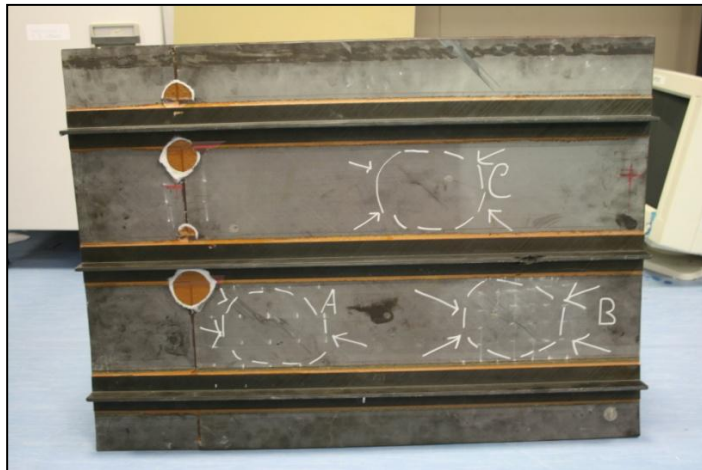
Figure 6. Stringer panel (back side view) with 3 impacted areas

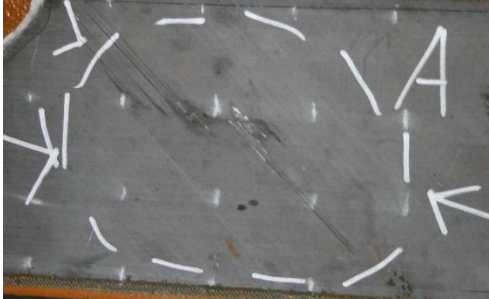
Impact damage	Front side view	Back side view
A

Figure 7. Close up view table of the impacts on the front and back side

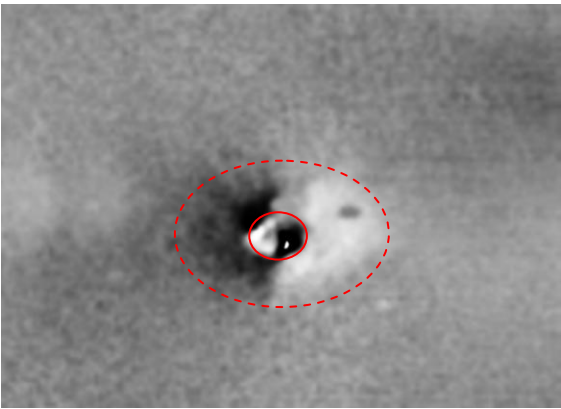
Impact damage	Visible damage	Shearographic Image
A

Figure 9. View of the impact (left image) and the Shearographic result image (right image) with the defects extension into the material. (Visible area = red inner circle, non-visible area, but damaged area = outer red circle)

The Shearographic image shows that below the visible indication of the first impact the damaged area spread out deeper into the material.

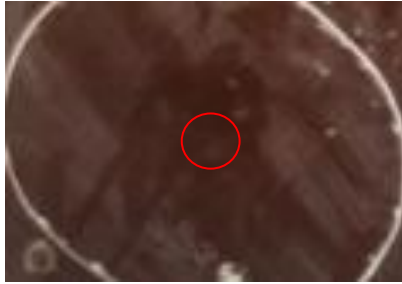
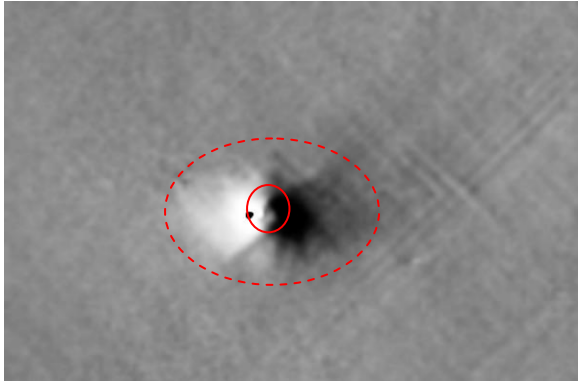
Impact damage	Visible damage	Shearographic Image
B

Figure 10. View of the impact (left image) and the Shearographic result image (right image) with the defects extension into the material. (Visible area = red inner circle, non-visible area, but damaged area = outer red circle)

By eye barely any damage is seen, but Shearography reveals that there is a significant damaged area. Further investigation to size and evaluate the defect is enabled.

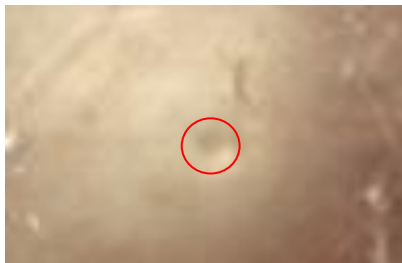
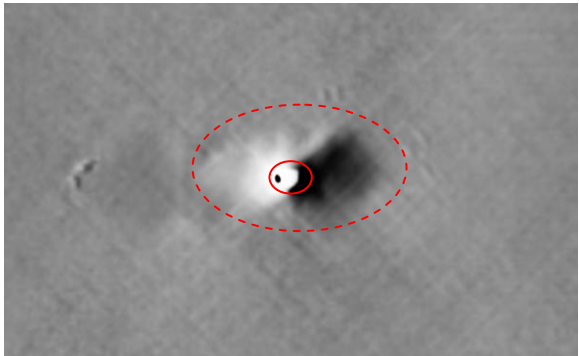
Impact damage	Visible damage	Shearographic Image
C

Figure 11. View of the impact (left image) and the Shearographic result image (right image) with the defects extension into the material. (Visible area = red inner circle, non-visible area, but damaged area = outer red circle)

Some slight visible indication of damage is seen. Further investigation with Shearography shows that the damaged area extends beyond the area that could be discovered by visible inspection.
