DIGITAL IMAGE CORRELATION ANALYSIS APPLIED TO MONITOR DAMAGE EVOLUTION OF COMPOSITE PLATES WITH STRESS CONCENTRATIONS AND BONDED PATCH REPAIRS

M.A. Caminero^{1*}, S. Pavlopoulou², M. López-Pedrosa², B.G. Nicolaisson³, C. Pinna²,
C. Soutis²

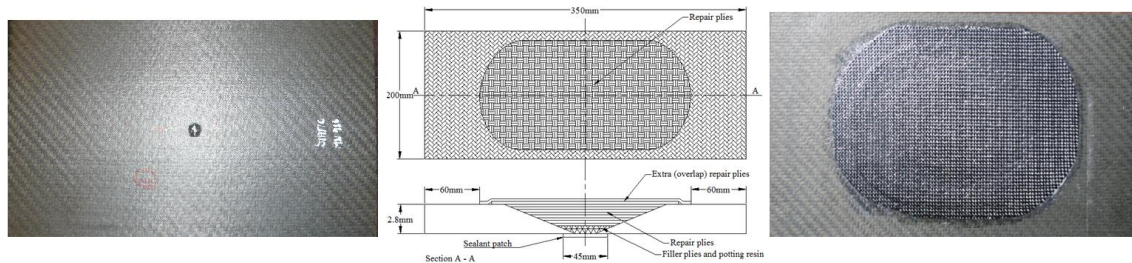
Figure 1. Left: CFRP panel after impact. Center: Scarf repair geometry details. Right: Cured scarf repair specimen

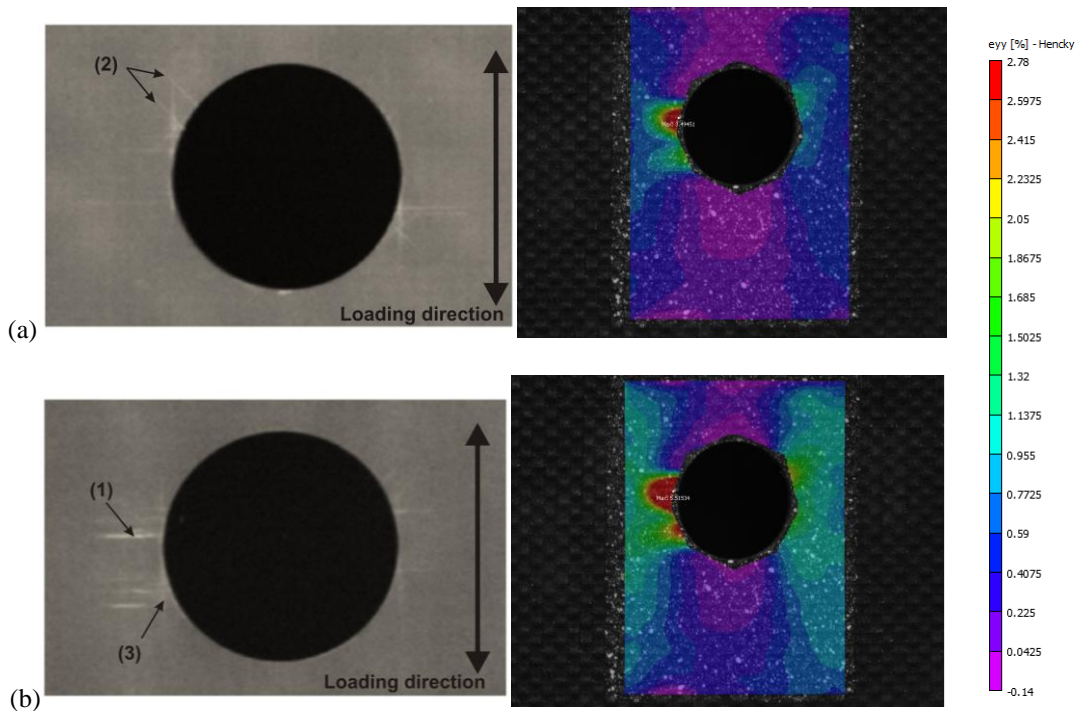
Figure 2: (Left) X-ray radiographs showing different stages of notched HTA/M21 specimen loaded in tension. (a): 80% (42.4 kN) of UTS (≈ 53 kN) and (b) 90% (47.7 kN) of the UTS. (1) and (2) indicate 90° and 45° off axis matrix cracks and (3) 0° splits. (Right) DIC Hencky strain results at the same loading stages. (a) 80% of the UTS ($\epsilon_{\max} = 0.0349$) and (b) 90% of the UTS ($\epsilon_{\max} = 0.0551$)

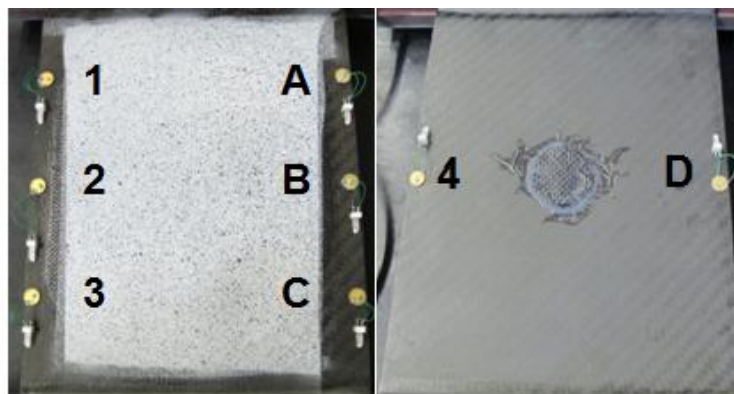
Figure 3: Scarf repaired with speckle pattern and PZT transducers. Propagation paths: Actuators: 1,2,3,4 and Receivers: A,B,C,D

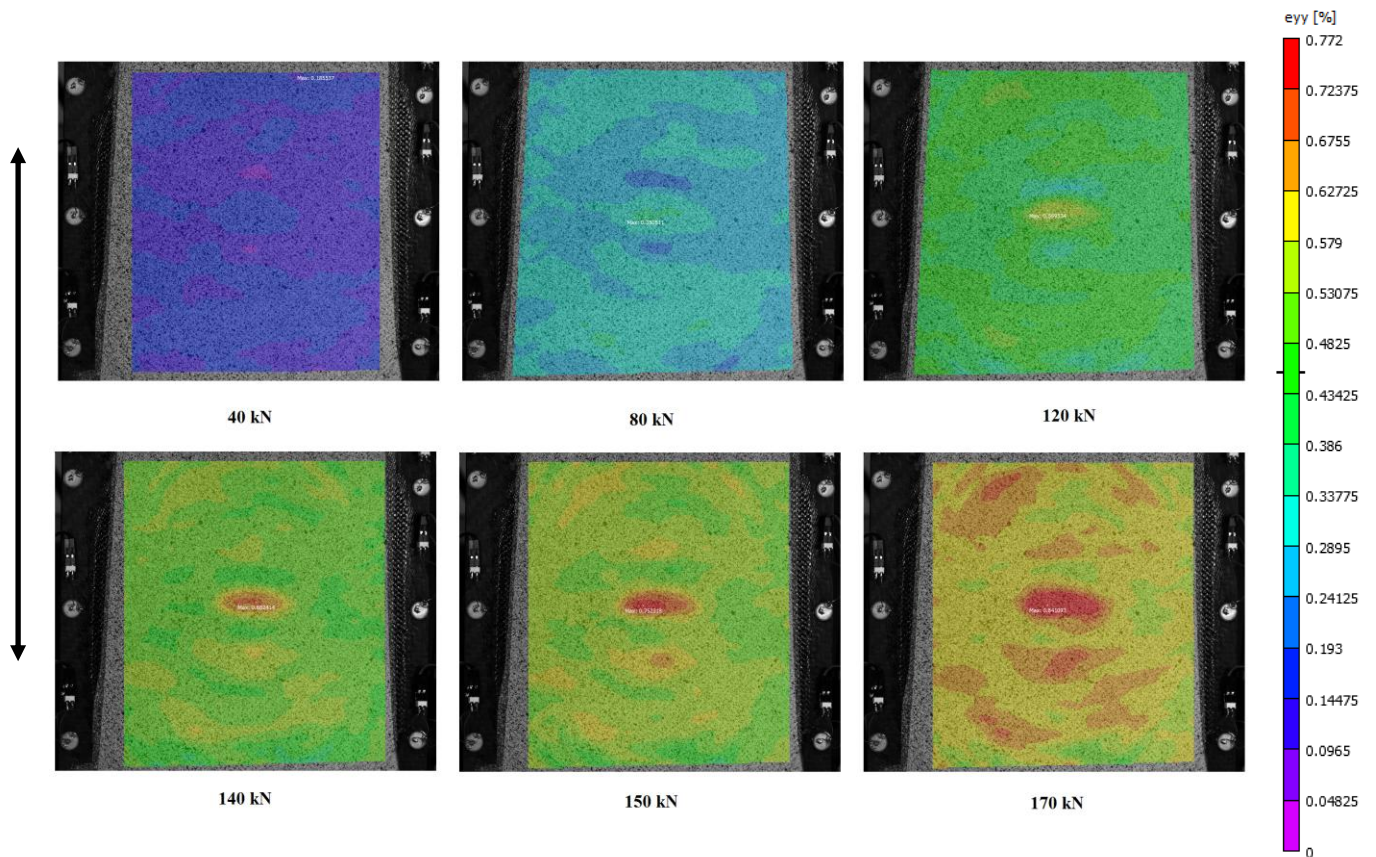
Figure 4: Full-field DIC results: Strain distribution at the surface of the repaired area in the loading direction (ϵ_{yy}) at different loading stages: 40, 80, 120, 140, 150 and 170 (failure) kN

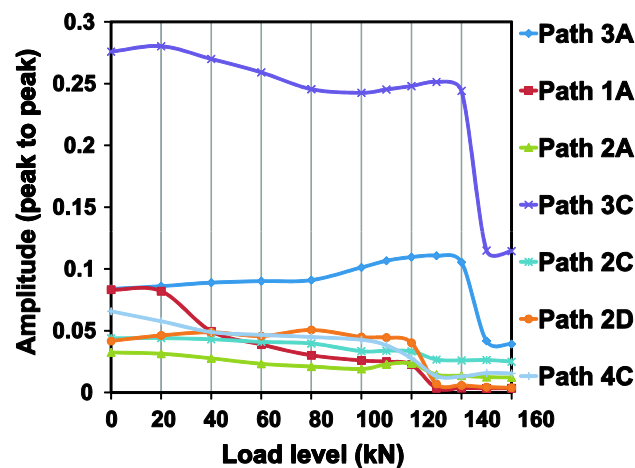
Figure 5: Damage index (peak to peak) with respect to the load level
