DAMAGE TOLERANCE OF COMPRESSED GASEOUS HYDROGEN COMPOSITES VESSELS

The present study is part of a project funded by the French National Research Agency, called Toledo. It is dedicated to the study of the effect of mechanical impacts on wound carbon fiber composite pressure vessels performance. A composite pressure vessel with a polymer liner has been designed and subjected to mechanical impacts. The damage in the composite due to the impact has been characterized by X Ray tomography. The residual performance (burst pressure) is assessed after the impact and after subjecting the composite pressure vessel to static or cyclic pressure load prior to burst test. The purpose is to clarify the effect of additional mechanical loads encountered in service by composite pressure vessels on the tolerance to the damage associated with mechanical impacts and thus on residual lifetime.

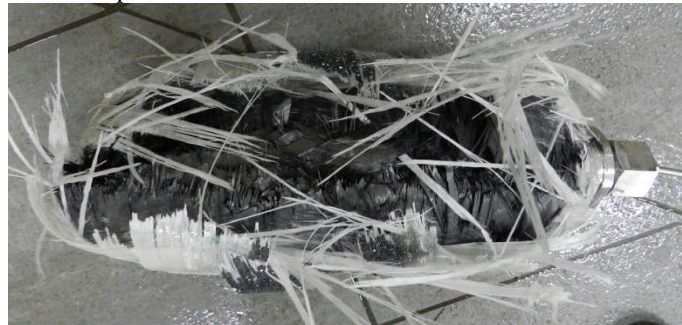
One impact is carried out per COPV. After performing X-Ray Tomography, the COPV was then subjected to a hydraulic burst test. Impact test matrix and residual burst pressure are listed in Table 1. Note that the lower impact energy is in the same range as a fall from 1.2 m (representative of a fall from a truck). For impact energies ranging from 52 J (4.6 kg, 1.07m) to 348 J (12.8 kg, 2.8 m), the burst pressure of the COPV remains in the range of the one of a virgin COPV. Results suggest that the dispersion is higher than the one established on the 3 reference specimens, namely ± 25 bar. Only the impact at 491 J (21 kg, 2.22 m) leads to a significant decrease of burst pressure. It is however worth mentioning that the burst is initiated on and grows from the damaged area for all COPV impacted with energy of 68 J (12.8 kg, 1.65 m) and more. Figure 3 gives an example of the COPV burst after an impact with a 120° angular impactor.

Figure 3. Picture of a 2.4L COPV after impact after the burst test

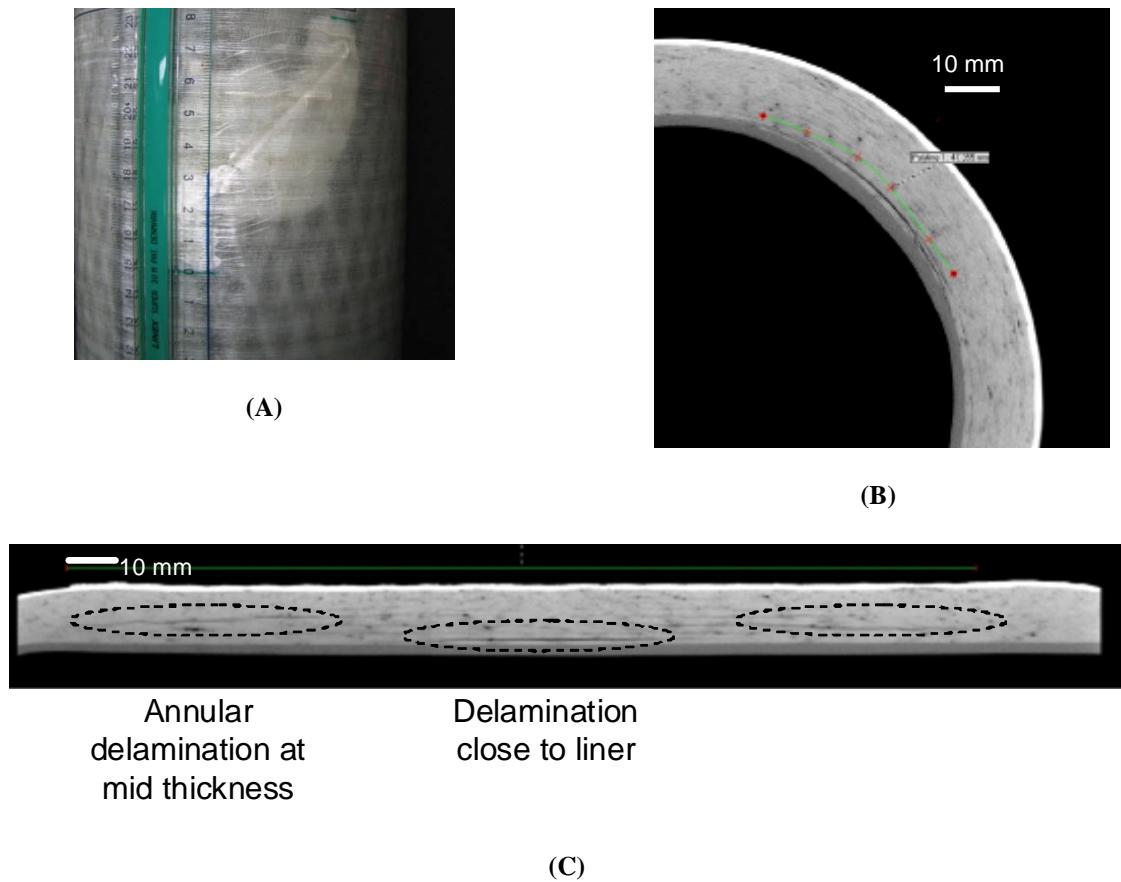
Impact creates several interlaminar damages and matrix cracking in the composite. The first delamination occurs in the glass fiber layer (more precisely between the glass fiber composite and the outer carbon fiber composite layer). It gives a whitening of the cylinder in the impact area matching with an ellipsoidal shape as illustrated in figure 4A for impact test n° 4. Delaminations in the carbon fiber composite wrapping were observed by X-Ray tomography. For the two lowest impact energies, one main delamination is observed at mid thickness of the carbon fiber composite. It presents an annular “donut” shape (see Figure 4C). For the 106J impact energy and more, an additional large delamination is observed close to the liner (not in a donut shape, plain delamination) (see Figures 4B and 4C). Smaller delaminations are also observed between the delaminations zone at mid thickness and close to liner in those cases. Delaminations have ellipsoidal shapes with long radius in the axis of the COPV and much

broader size than the superficial delamination in the glass fiber composite. The size of the delaminations increases with the energy of the impact.

Figure 4. (A) picture of COPV after impact n°4 (491 J), (B) & (C) X Ray Tomography

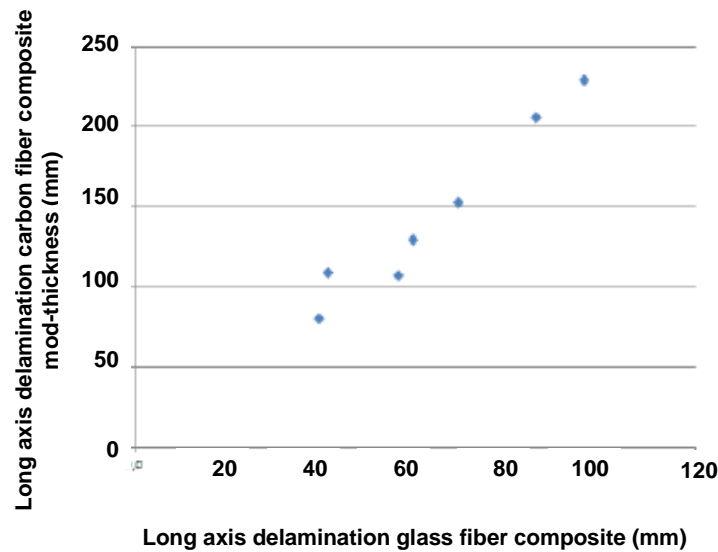
The Figure 5 shows the long radius of the ellipsoidal delamination in the glass fiber composite over the one of the carbon fiber composite at mid-thickness for the different impacts. It seems to be a linear correlation between the two parameters. The same trend was observed for the delamination area. This analysis could be a basis to define criteria for visual inspection of such COPV before filling and during periodic inspection.

Figure 5. Correlation between the delamination in the glass fiber composite layers and in the carbon fiber composite at mid thickness (long axis of the ellipse)
