# SCANNING ELECTRON MICROSCOPY ANALYSIS OF ELASTOMERIC O-RINGS AND SPRING SEALS FRACTURED DURING RAPID GAS DECOMPRESSION.

T. Mbwadzawo\* and A. Hodzic

*Composite Systems Innovation Centre, Department of Mechanical Engineering, The University of Sheffield, Sheffield, S1 3JD, United Kingdom*

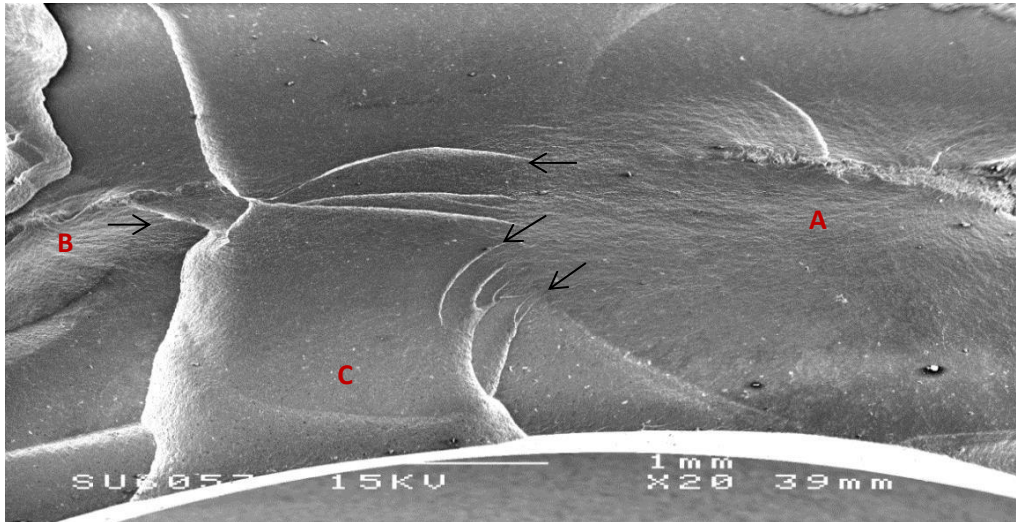
After conducting R.G.D. tests, the fractured surfaces were analysed using SEM analysis to identify the initiation points and the mode of crack propagation. Fig. 1 displays two distinct regions of fracture which are the initiation regions A and B and the rapid crack propagation region C. Cracks initiate in region A and B then propagate in slow increments during each

loading cycle. When the crack reaches a critical size, the crack becomes unstable and grows at a faster rate leading to a catastrophic macroscopic featureless fracture displayed in the region C. The initiation region is characterised by many small tearing lines obstructing one another and the fracture surface is microscopically rough. The crack propagation direction can be identified from the direction in which riverlines converge and the crack propagation direction in Fig. 1 is shown by the arrows.

**Fig.1** SEM showing fractured surface of O-ring tested in 90% CO<sub>2</sub> in methane, crack direction propagation was derived from the convergence direction of the riverlines.

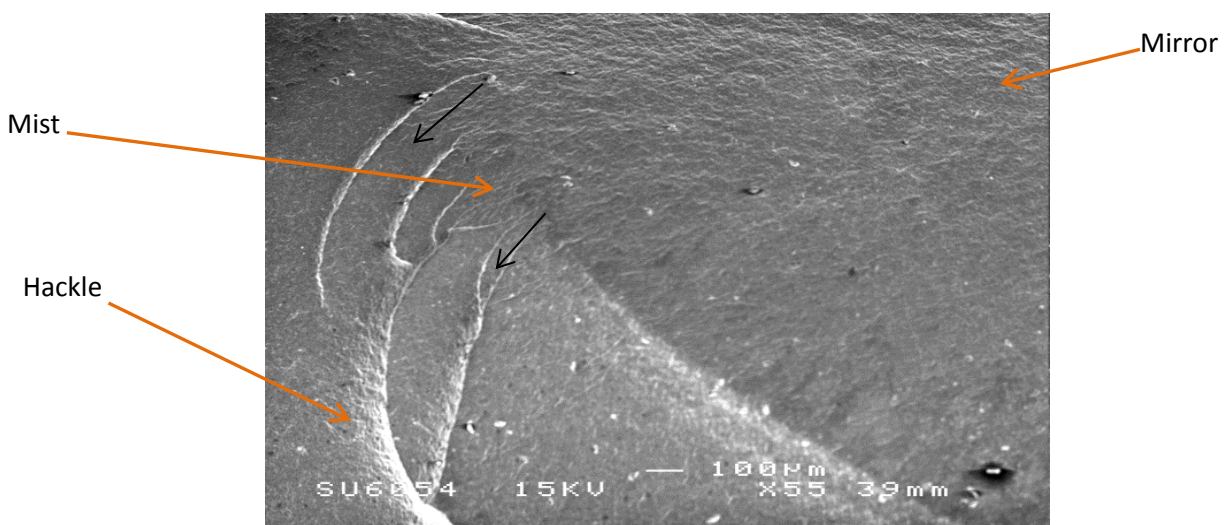
Fig. 2 displays the mirror, mist and hackle areas in the region A, and the crack direction is indicated by the direction in which the riverlines converge to form hackles. The mirror region is associated with slow crack propagation, and the boundary of the mirror region marks the transition of crack speed from a slow and stable speed to rapid acceleration. Hackle lines are formed as a result of smaller cracks branching into one crack. Hackle regions tend to appear in regions where the stress field is changing rapidly either in direction or magnitude [6].

**Fig.2** Mirror, mist and hackle morphology of the fractured surface of O-ring tested in 90% CO<sub>2</sub> in methane, the crack direction is indicated by the arrows.

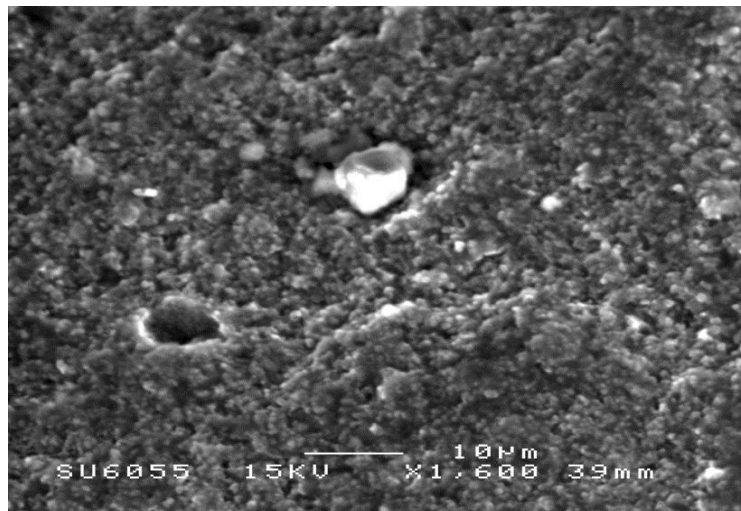
Fig. 3 is a magnification of the mirror region in Fig. 2. The fracture surface displays a dimpled fracture surface containing pits. N. M. Mathew and S. K. De [7] conducted tearing tests on natural rubber reinforced with clay particles and they observed a rough fracture surface containing pits/cavities similar to the fracture surface displayed in Fig. 3. They postulated that the formation of these pits on the surface was a result of reinforcing agglomerates, coming out of the matrix and these loose agglomerates in the matrix act as stress raisers and offer an easy path for the tear to follow, thereby reducing the overall strength of the material.

**Fig.3** SEM image showing mirror region of the fractured surface of O-ring tested in 90% CO<sub>2</sub> in methane, showing formation of pits on the fracture surface.

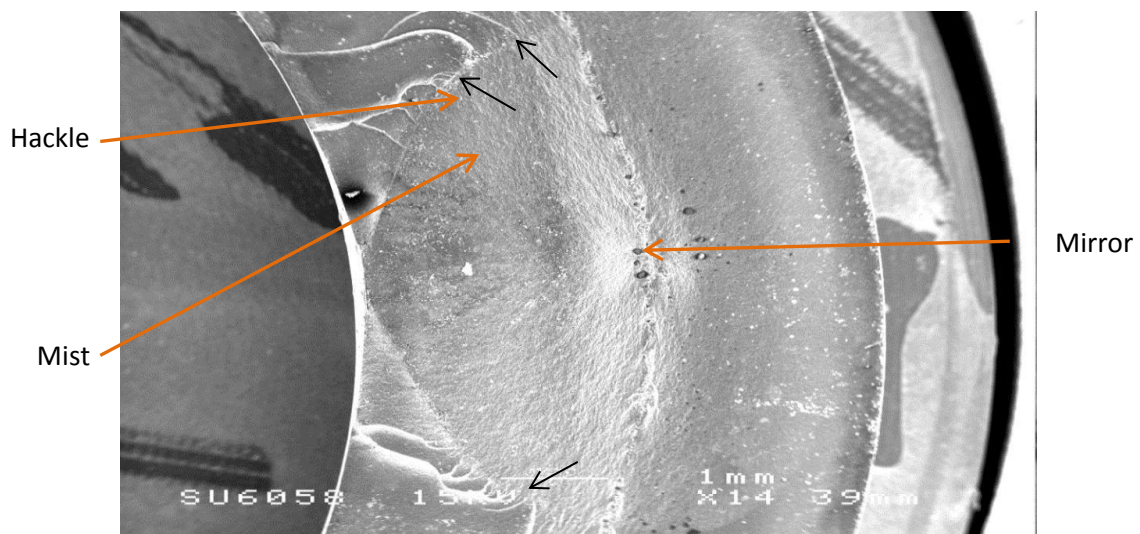
The fracture surface of the second O-ring tested under 90% CO<sub>2</sub> in methane also contains two distinct regions similar to the previous O-ring. In Fig. 4 stable crack growth is more pronounced on the inner circumference of the O-ring whilst the outer region displays a rapid crack propagation fracture surface. The direction of the converging hackles indicate that cracks initiated in the centre region and propagated towards the inner circumference of the O-ring and once the cracks reached a critical size, the crack accelerated resulting in rapid crack propagation fracture.

**Fig.4** Mirror, mist and hackle morphology of the fractured surface of O-ring tested under 90% CO<sub>2</sub> in methane, the crack direction is indicated by the arrows.

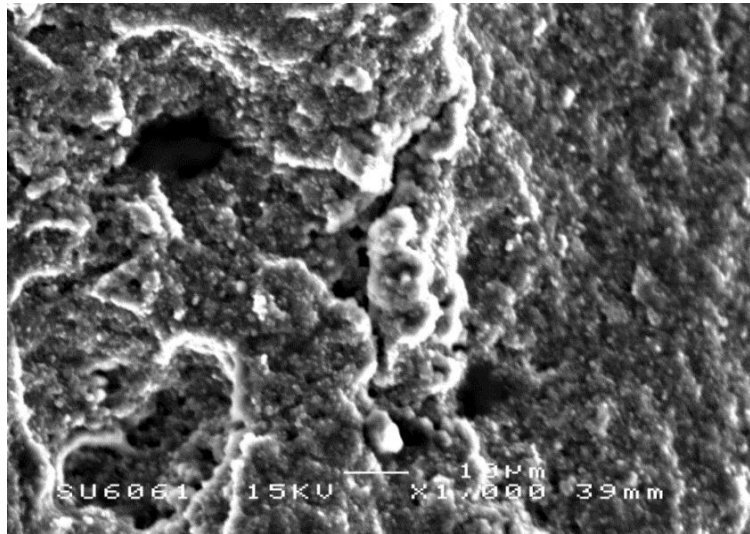
Fig. 5 shows the centre region of the fractured surface shown in Fig.4. Cracking was more pronounced in this region and this is an indication that either higher stress levels were experienced in this region of the O-ring during R.G.D. or this region is a point of weakness in the O-ring structure. The fracture surface in Fig. 5 shows cracks propagating from cavities and these open cavities were a result of inherent voids present in the material rupturing during rapid gas decompression. These cavities act as crack initiation sites in the O-ring thereby reducing the materials strength.

**Fig.5** SEM image of the centre region in O-ring tested under 90% CO<sub>2</sub> in methane, displaying cracks propagating from cavities.

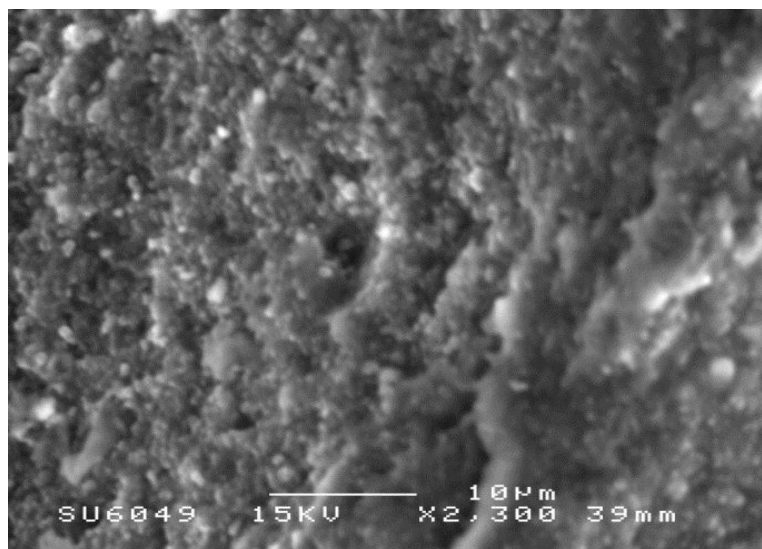
Fig. 6 displays a dimpled fracture morphology containing multiple tearing lines, which has been observed on the fracture surfaces of previous specimens. A dimpled fracture surface in rubber is reported to be a result of fracture under a combination of tension and compression loadings, Anil K. Bhowmick [8]. Dimples indicate debonding at the particle/matrix interface and result from a crack passing through debonded particles, A. K. Bhowmick et al [9].

**Fig.6** Crack initiation region in O-ring tested in 70% CO<sub>2</sub> in methane, displaying a dimpled fracture surface

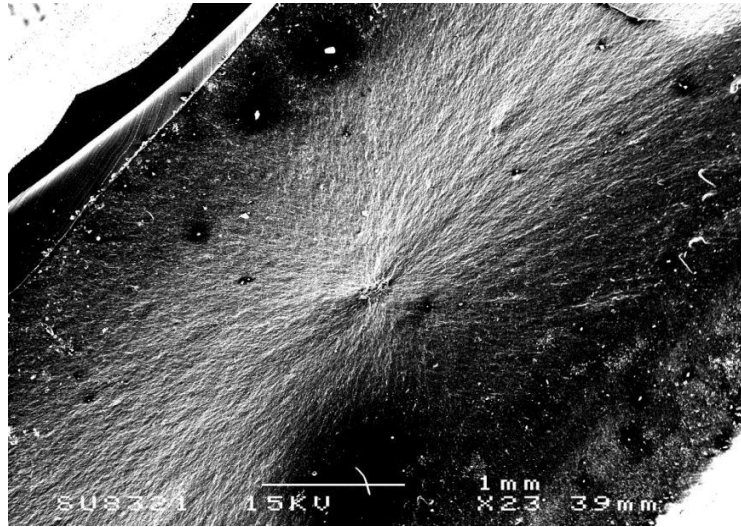
**Fig.7** Fracture surface of a spring seal displaying multiple small cracks initiating from an inherent flaw.

Fig. 7 displays the fracture surface of a spring seal containing small multiple cracks propagating from an initiation point in the centre of the spring seal. The relatively rough and bright region in Fig. 7 is the slow propagation region, which is mainly characterised by small multiple cracks propagating away from an initiation point. Similar to O-rings, the spring seals have a higher slow crack propagation region towards the inner circumference compared to the outer circumference. Fig. 8 displays a magnified image of an inherent flaw with cracks propagating at 90° angle from the flaw. The flaw region contains multiple irregular shaped cavities of different sizes. This type of flaw was likely a result of multiple voids in close proximity rupturing during the decompression cycle and coalescing to form bigger wider voids.

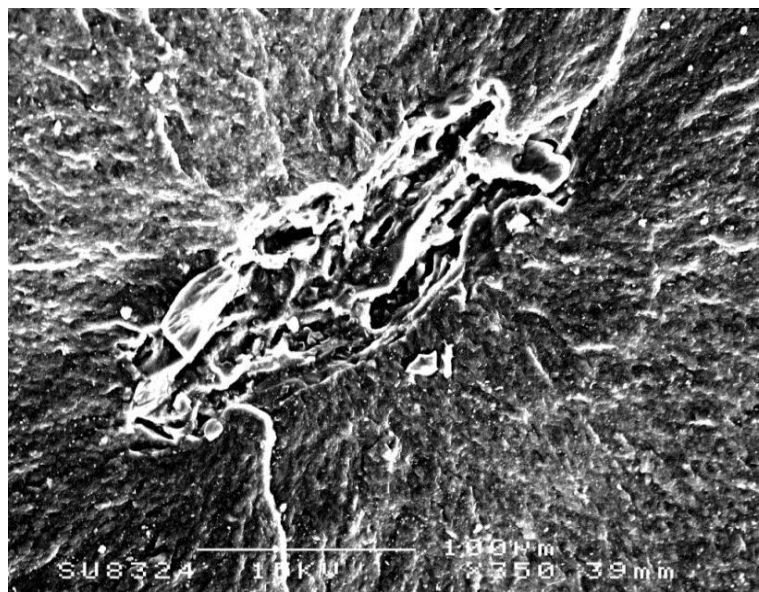
**Fig.8** Magnified fracture surface showing microcracks propagating from an inherent flaw.

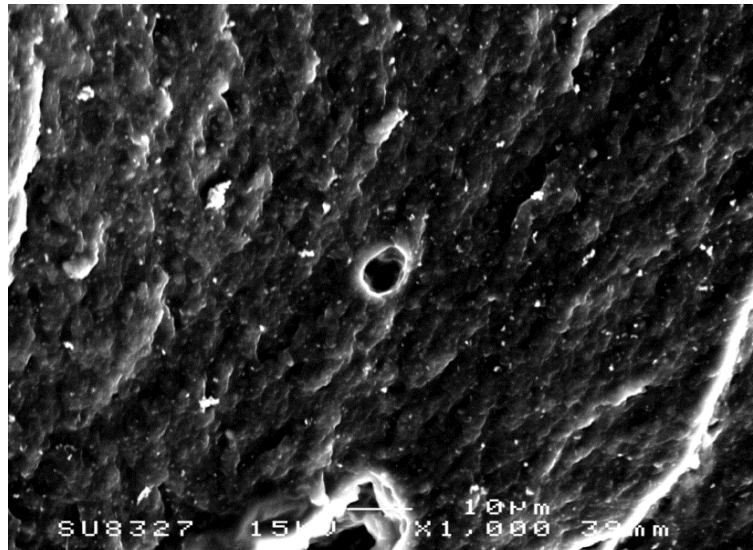
**Fig.9** Fracture surface of a Spring seal displaying tear lines and a void present on the fracture surface.

Fig. 9 shows the fracture surface of the spring seal in the slow crack propagation region, the surface contains tearing lines and an open void with a diameter of approximately 7.14 nm. Voids are usually introduced into O-rings and spring seals during processing and are almost impossible to avoid. During rapid gas decompression the voids inflate resulting in tensile stresses or strains in the void walls. If the stresses are higher than the strength of the elastomer, cracks initiate and propagate. The void in Fig. 9 seems not to be the cause for crack initiation in the spring seal, however these open voids in the matrix act as stress raisers and offer an easy path for the tear to follow, thereby reducing the overall strength of the material. Fig. 10 is the fracture surface of a spring seal in the rapid crack propagation fracture region. These regions are characterised by relatively little or no macroscopic visible plastic deformation and they require relatively less energy to form. The fracture surface in Fig. 10 contains pits and particles with varying diameter sizes between 0.736 Nano meters to 9.6 Nano meters.

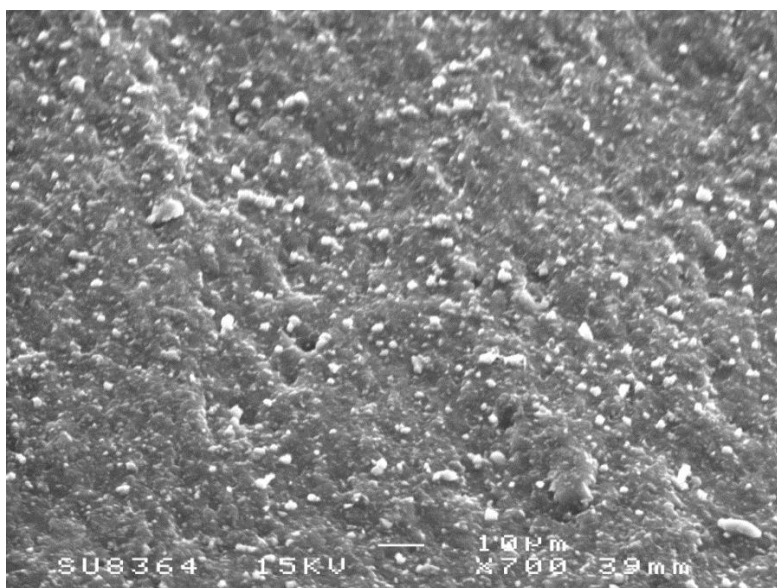
**Fig.10** Fracture surface of a spring seal with surface debris and pits.
