THERMOGRAPHIC NON-DESTRUCTIVE INSPECTIONS OF WIND TURBINE BLADES USING UNMANNED AERIAL SYSTEMS

Keywords: Non Destructive Testing, IR-Thermography, Wind blades, Unmanned Aerial Vehicles.

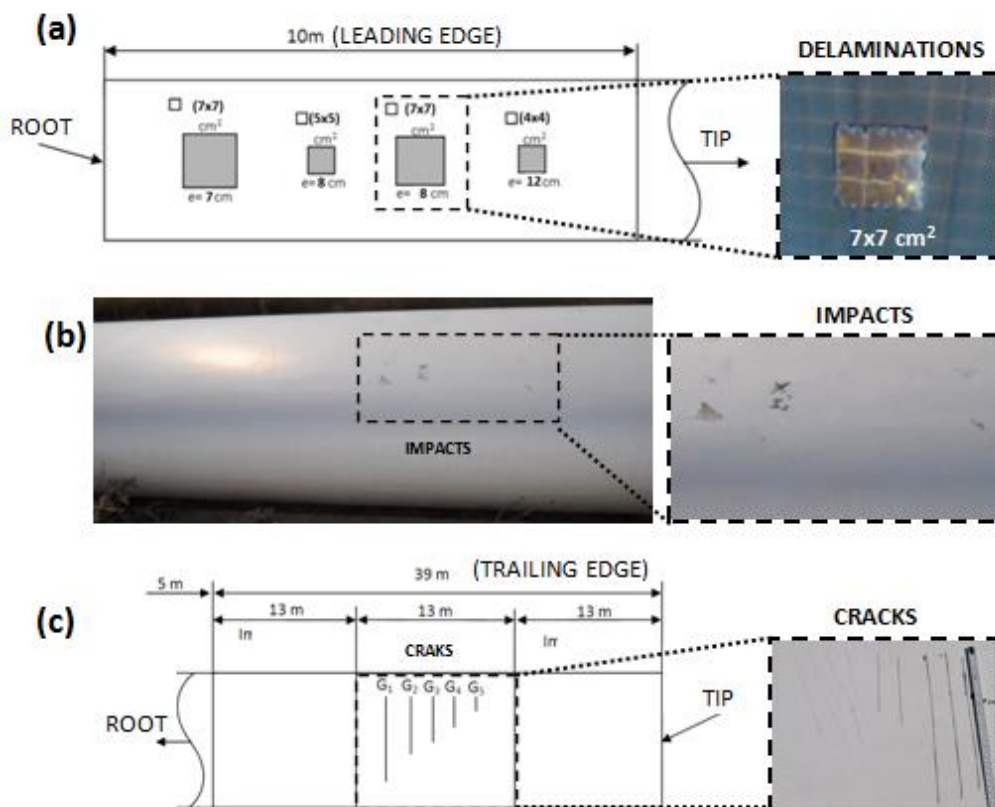
Figure 1. Schematics representation and views of artificial defects introduced into the blade: (a) delaminations, (b) impacts, and (c) cracks.

Inner blade material has been removed in the leading edge in order to simulate a 70x70 mm² delamination with 80 mm thickness (Fig. 1.a). Elements with different weights (from 1 to 5 kg) were used to simulate impact damage in the leading edge with different grade of severity (Fig. 1.b). Cracks from 0.55 to 1.25 mm thickness have been manufactured on the trailing edge as well using cutting discs (Fig. 1.c).

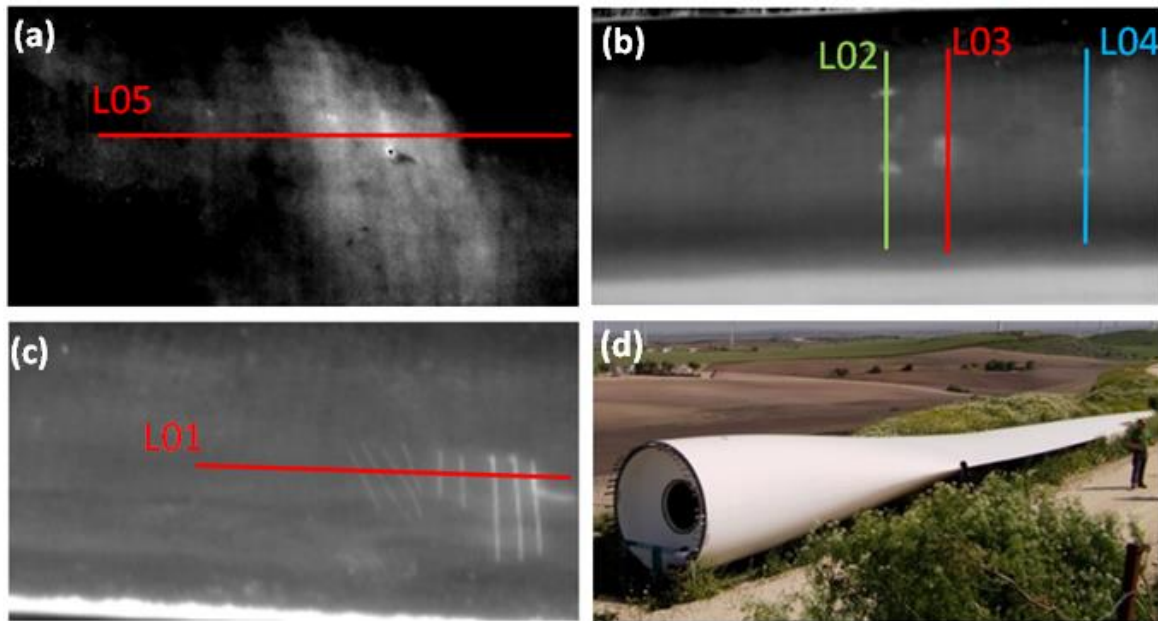
Figure 2. Thermographs with indication of artificial defects: (a) delaminations, (b) impacts and (c) cracks; (d) View of inspected “on-ground” blade.

During thermographic inspections, the optimal testing parameters and environmental conditions have been defined. The recorded IRT images (Figure 2) has been registered using passive thermography, taking in advantage the temperature ambient changes induced in the element during the day. Thermographic results have shown 100% detectability of the 70x70 mm delamination, impacts and the artificial cracks (Figure 2.a, b and c, respectively).

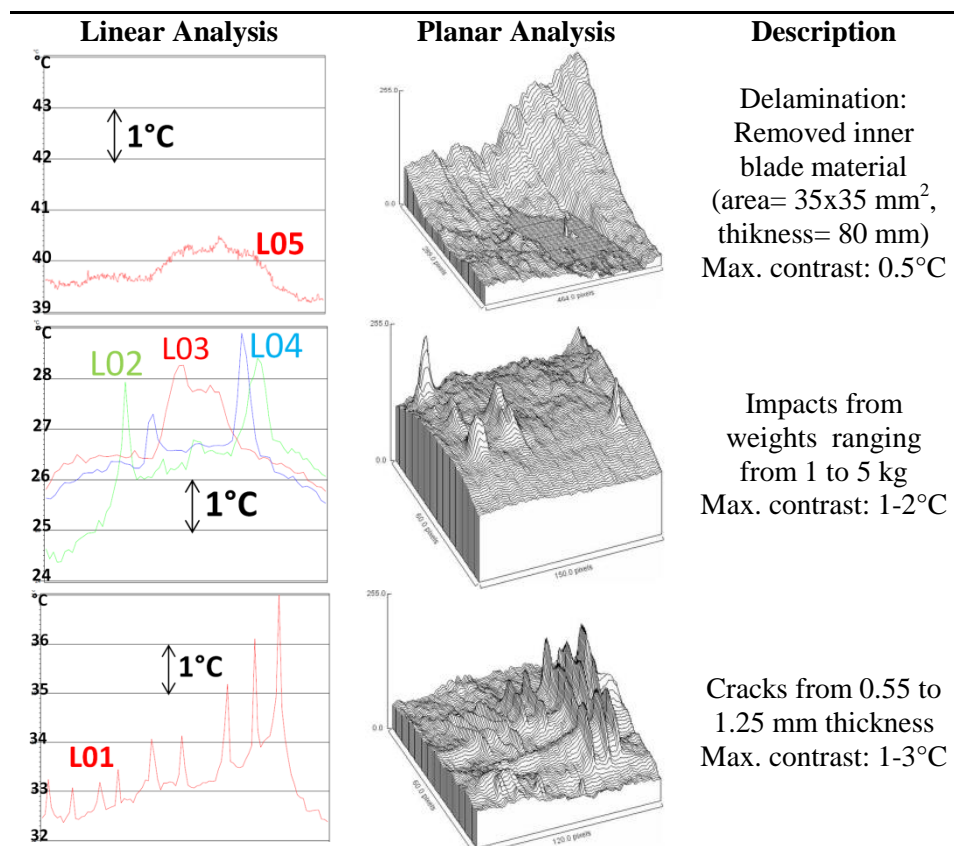
Table 1. Linear and plane thermographic analyses.

In order to improve the ability of the operator for defect detection, different software processing methodologies have been investigated. Linear and planar analyses (Table 1) were carried out in all thermographs in order to establish the temperature variation caused by the artificial defects. Linear analysis (Table 1) show how the delamination introduce 0.5°C in the thermal pattern (L05), impacts introduce from 1°C to 2°C (L02-L04), and cracks from 1°C to 3°C (L01). Planar analyses show a 3D representation of each thermogram, making easier the interpretation of the results.

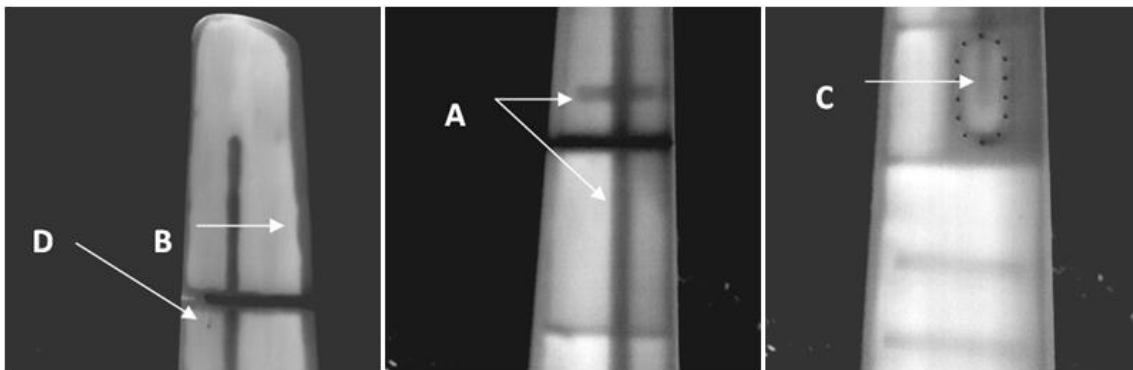
Figure 4 shows changes in the thermal pattern produced by the internal structure and other external sources: (A) pitch brake system, (B) bonds between upper and lower shell, (C) access gate and (D) surface roughness.

Figure 4. Thermographic in-flight results of the inspection conducted in 10m blade in Tarifa, Spain.

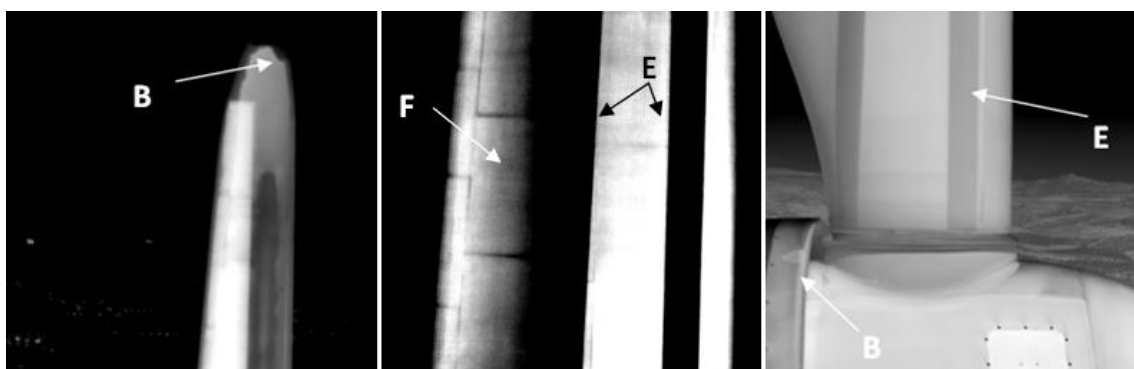
The results obtained after 2nd flight testing campaign are presented in Figure 5. In this case, a much larger wind turbine located in Granada, Spain, was selected. Due to the blade size (40 m long) the distance between the blade and the UAS has been set in 10 m. The results show variations in the thermal pattern caused mainly by: (E) bonds between shells and beam, (B) bonds between upper and lower shell, (F) balsa wood and (G) indications of unknown provenance.

Figure 5. Thermographic in-flight results of the inspection conducted in 40m blade in Granada, Spain.
