THERMO-MECHANICAL DAMAGE DUE TO LIGHTNING IMPACT IN CARBON/EPOXY COMPOSITES: EXPERIMENTS AND SIMULATIONS

Raúl Muñoz^a, Sofia Delgado^b, Federico Sket^a, Carlos González^{a,c,*}, Bernardo López-Romano^b
De-Yi Wang^a, Javier LLorca^{a,c}

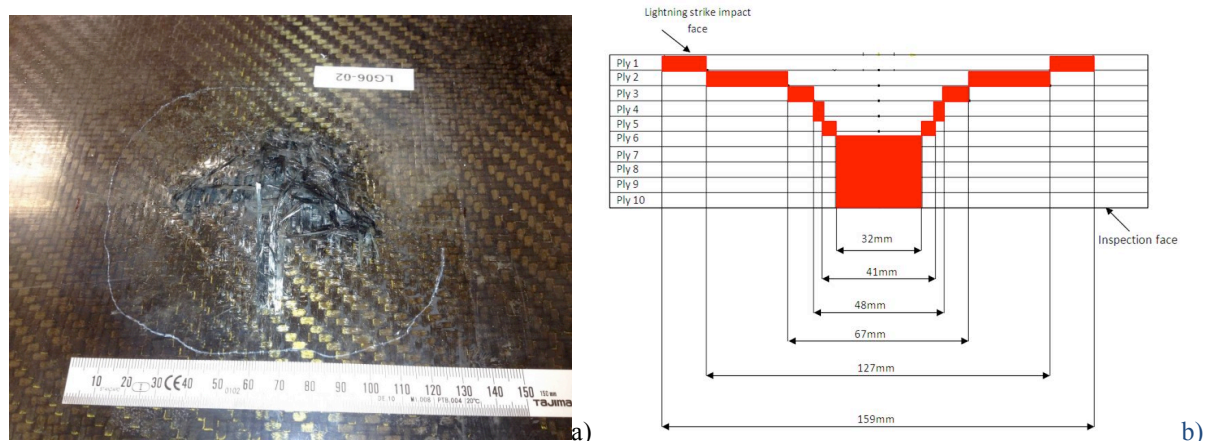
Figure 2. a) Detail of the damage around the lightning attachment point for A waveform impact. The rear zone of the panel remained visually unaffected, b)

The rapid expansion of material plasma around the attachment point creates strong shock waves that could lead to damage by spallation in the through-the-thickness direction. Damage by such spallation decreased with the distance to the attachment point of the lightning, even though evidence of resin thermal degradation (for example, open porosity) was observed in the region surrounded with a white line in Figure 2a). The circular shape of the damage zone is likely to be controlled by the isotropic in-plane thermo-electric properties of the twill fabric, as opposed to the behavior found in multiangular unidirectional composite laminates. Thermo-gravimetric analyses were performed using a thermo-balance (Q50 from TA Instruments) to examine the thermal degradation of the resin. The composite samples were heated at 10°C/min up to 500°C in N₂ and then in air from 500°C to 1000°C. The mass loss as a function of temperature showed that the thermal degradation of the resin took place in the temperature range between 200-600°C which can be used to estimate of the damaged area by temperature in the simulations. The damage penetration depth was also determined by means of ultrasound inspections, with the results obtained for the Level 1 in Figure 2b) in terms of penetration depth and average damage diameter. The inspections were performed from the

rear surface of the impacted panel. It should be mentioned that even if the rear face was visually unaffected, the ultrasound inspections revealed substantial attenuation when compared with the undamaged area which may be explained as being due to resin degradation caused by the thermal gradients or mechanical damage induced by electromagnetic and acoustic pressure.

However, the numerical simulations of the through-the-thickness damage penetration of 1.53 and 0.90mm for Level 1 and Level 2 impacts underestimated the experimental results obtained by ultrasounds, which showed significant attenuation signal below the attachment point, Figure 2b). The differences could be attributed to other sources of damage, such as the mechanical stresses produced by the electromagnetic and acoustic pressures. In this case, the acoustic and magnetic pressure gives rise to high bending stresses in the impacted area and damage by matrix cracking or delamination induced by these effects that could extend the damaged zone caused by Joule effects. In addition, such acoustic and electromagnetic actions also generate compressive through-the-thickness stress waves that rebound as tensile stresses at the rear face of the panel, leading to cracking and delamination by spallation.

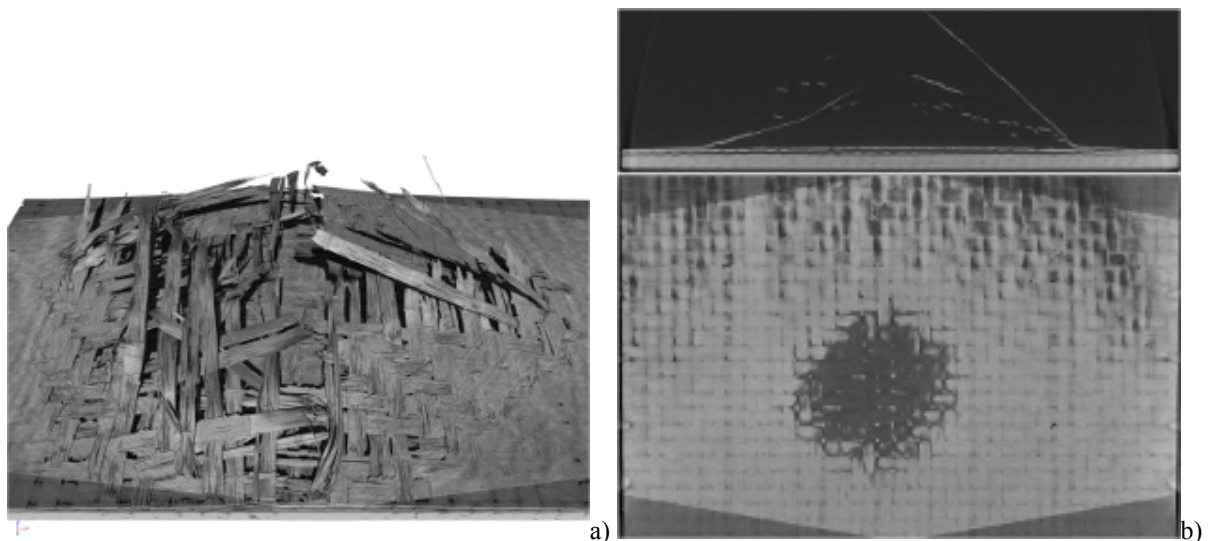
The failure mechanisms were also studied by XCT using a Nanotom 160NF (Phoenix). The tomograms were collected at 100 kV and 210 μ A using a tungsten target. A Copper filter of 110 μ m was used to harden the X-rays. For the tomogram, 1800 radiographs were acquired with an exposure time of 1000 ms. The detector was moved perpendicular to X-rays to obtain a larger field of view (virtual detector, 2 tiles). Tomogram voxel size was set approximately to 29 μ m/voxel. The tomograms were then reconstructed using an algorithm based on the filtered back-projection procedure for Feldkamp cone beam geometry. Figure 3 shows the tomogram reconstructions where delamination are clearly observed in the first two-three layers of the laminate. However, the remaining material did not show significant macroscopic damage although the attenuation obtained by the c-scan signal indicated possible diffused damage.

Figure 3. X-Ray tomography inspection of the impacted zone: a) Detail of the damage around the lightning attachment point for A waveform impact, b) Planar views showing extensive delamination in the first 2-3 layers of the composite laminate.

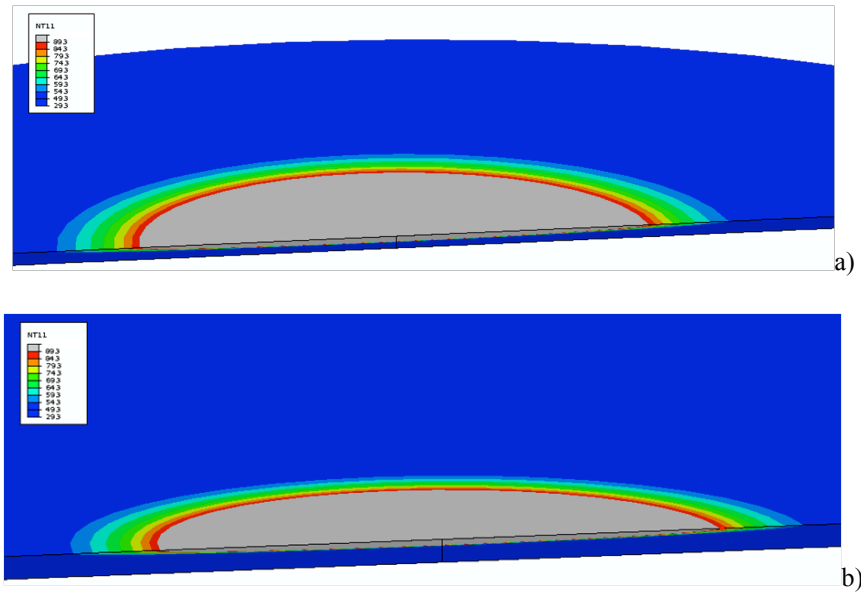
Figure 5: Contour plot of the temperature distribution immediately after application of the current waveform ($t \approx 500 \mu s$), a) Level 1 (Action integral $2.77 \times 10^6 \text{ A}^2 s$), b) Level 2 (Action integral $0.23 \times 10^6 \text{ A}^2 s$). Axisymmetric model sweep in the circumferential direction. Not scaled images.

Despite these unrealistic temperature values at the attachment points, the shape of the affected zone is reasonable and in good agreement with the experimental results. Following the work of Ogasawara [7], the zones affected by the heat were estimated from the temperature distribution obtained from the simulations. According to the thermo-gravimetric analysis performed on this material, the degradation of the resin took place in the temperature range of 200-600°C. This temperature range was selected as an objective criterion of thermal damage for quantification purposes from the contour plots obtained with the finite element model, Figure 8.
