INVESTIGATING DAMAGE RESISTANCE OF HYBRID COMPOSITE-METALLIC STRUCTURES USING MULTI-SCALE COMPUTED TOMOGRAPHY

Abstract

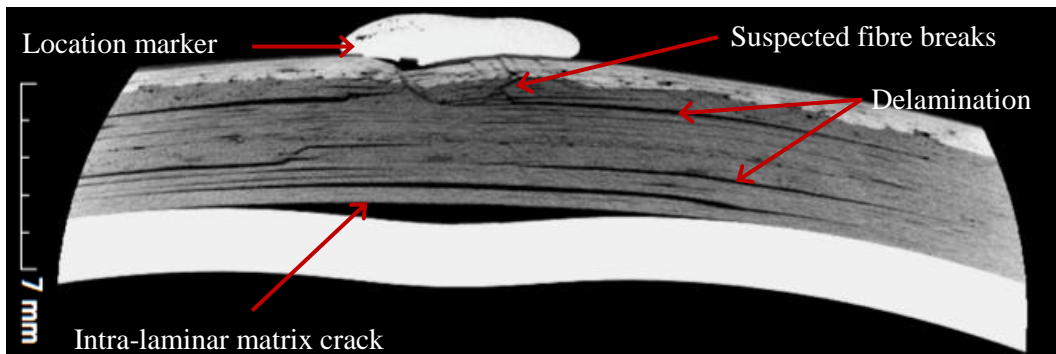
The scan of the impact site revealed substantial subsurface damage (Figure 1, Figure 2). A 3D visualisation of the impact site is presented in Figure 3. Several damage mechanisms are present in the CFRP layer. It is also clear from the scan data that plastic deformation of the metal layer has occurred. The maximum depth of this dent measured 0.75mm (Figure 2).

Figure 1: A single slice from the macro CT scan of the impact site perpendicular to the axis of the HCMS

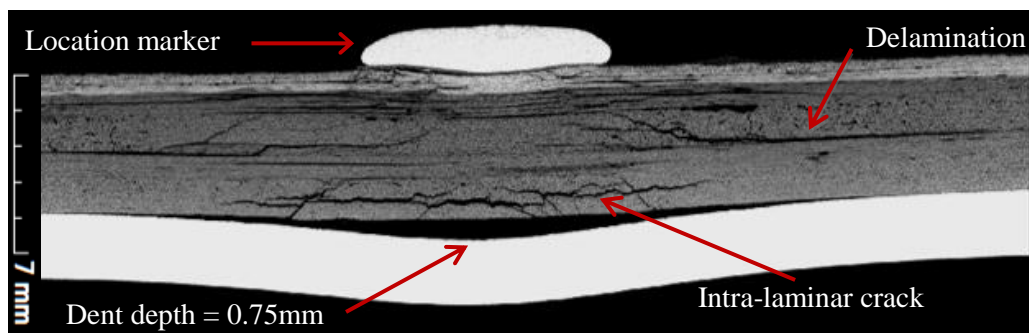
Figure 2: A single slice from the macro CT scan of the impact site in the long axis of the HCMS

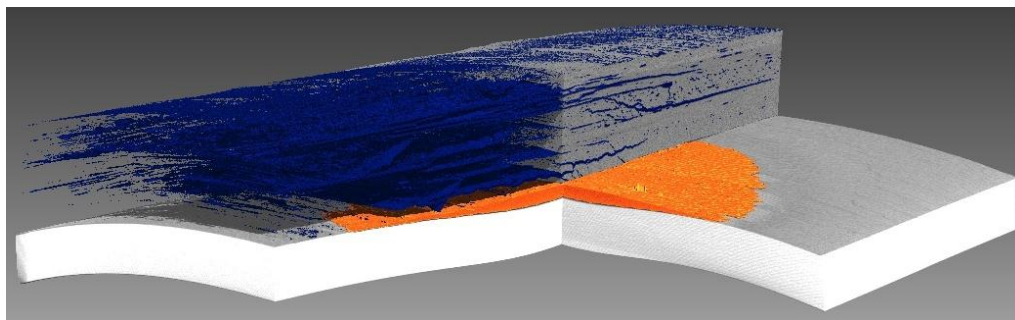
Figure 3 A 3D visualisation of the impact site with section cutouts. CFRP damage and voids are segmented in blue. The orange section is the dent in the metal layer

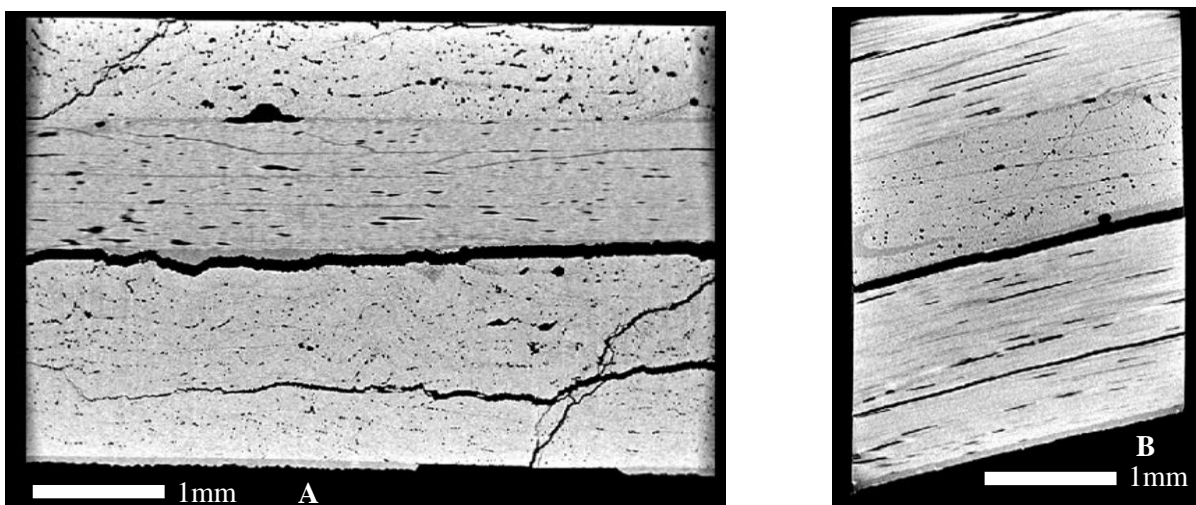
The higher resolution scans (4.6 μ m voxel size) give more fidelity of damage features that are not resolved at the 24 μ m resolution macroscopic impact site scans. Small intra-laminar cracks can be seen within the longitudinally wrapped ply (Figure 6B). At this length scale more detail of the crack path can be seen, showing multiple crack-void interactions. The ability to resolve more damage features shows that damage quantification at macro-scale impact site scales may not provide a complete picture of the material condition after impact. In these scans there is no evidence of fibre fracture within the material.

Figure 6: Longitudinal (A) and axial (B) view, 10mm from impact centre

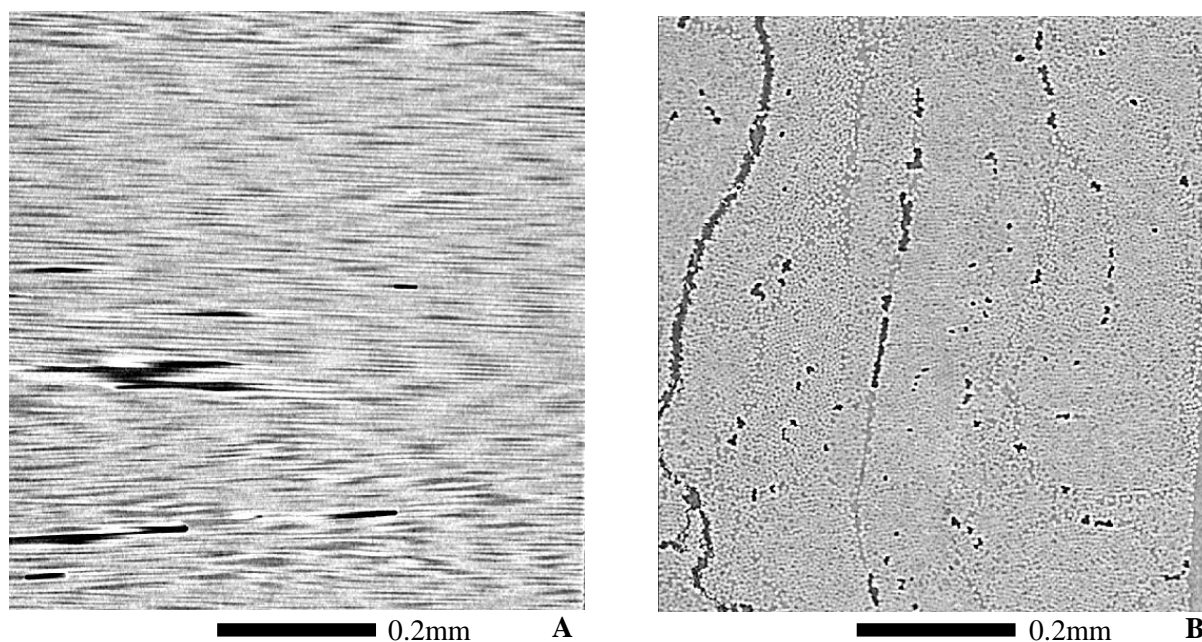
The presence of voids, of a similar size to a single fibre diameter, makes quantifying fibre breaks through automated segmentation tools difficult. Previous experience of the research group in assessing fibre breaks in similar resolution scans gives confidence in the ability to clearly distinguish between fibre breaks and micro voids due to the distinct morphology of fibre breaks [8, 9, 10]. Assessing all the scans generated, there is no evidence of individual fibre breaks within the CFRP in the scanned ROIs. As such, it is not expected that the tensile strength and stiffness of the circumferential CFRP layer have been significantly affected by the impact event and subsequent load cycle.

Figure 7: Longitudinal (A) and axial (B) views of micro-structure CT scans of $\sim 1\mu\text{m}$ resolution at the innermost circumferential wrapped ply.
