DIAGNOSTICS OF DAMAGED COMPOSITE SKIN ZONES OF AIRCRAFT AFTER THE IMPACT OF LIGHTNING BOLT USING THE METHOD OF ACOUSTIC EMISSION

A. Urbahs^{a*}, M. Banovs^a, S. Bratarchuk^{a*}, P. Serebrjakovs^b, V. Turko^{bfi}

Abstract

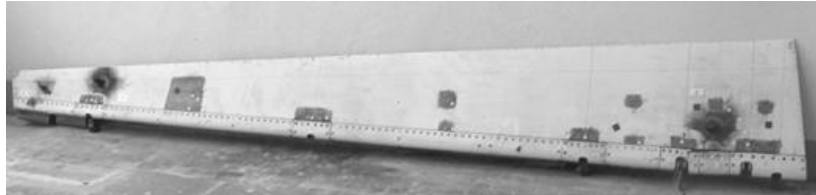
The destruction damage tests have been conducted in 2010. In the result of the tests, the failure load of elevator by a lightning bolt was identified and comprised 110% from the total failure load.

Figure 1. Elevator after the impact of a lightning bolt at the end of the static test.

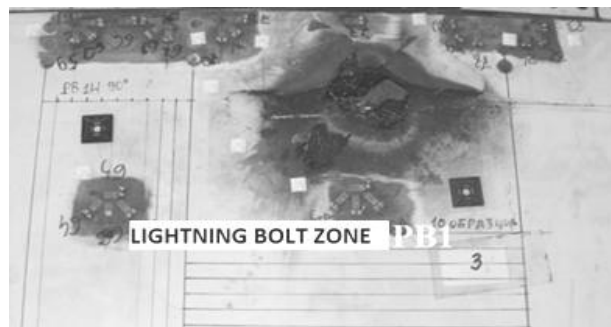
The zones of a lightning bolt impact in the zone of the root and the tip parts are shown in figure 2. One impact spot is visible at the root segment and two at the tip (figure 3).

Figure 2. Root segment: cut zone PB1

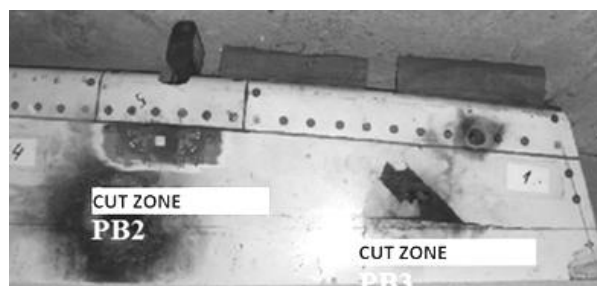
Figure 3. Tip segment: cut zone PB2, cut zone PB3

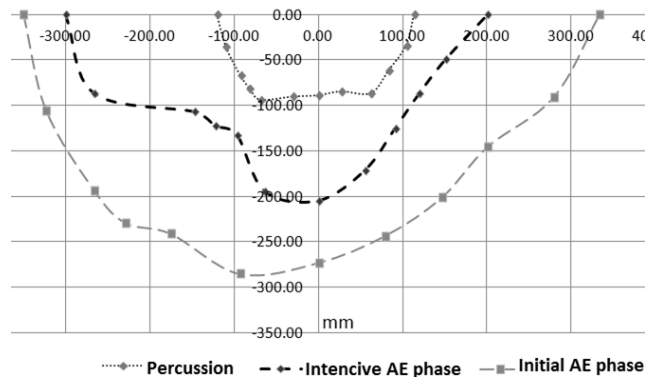
Figure 7. Diagnostics of the PB1 zone in the elevator's root area.

The closest to the centre line shows the zone that is determined by the percussion method (tapping with a hammer). The second line – is the intensive evidence of failure (the AE method). The third line – shows the initial damage (the AE method)

In the process of elevator examination in the zones of a lightning bolt impact the following results have been obtained: diagnostics of structural changes in composite material of the elevator in the zones of a lightning bolt impact PB1, PB2 and PB3 was conducted; composite material structural change zones in the area of a lightning bolt impact were determined; the zone of fatal structural changes was determined by skin tapping around the impact area. It had an elliptic form (for the zone PB1) with dimensions 100x200 mm.

The zone of intensive and initial structural changes of composite material was determined by using the AE method (intensive AE zone is 350 by 500 mm)

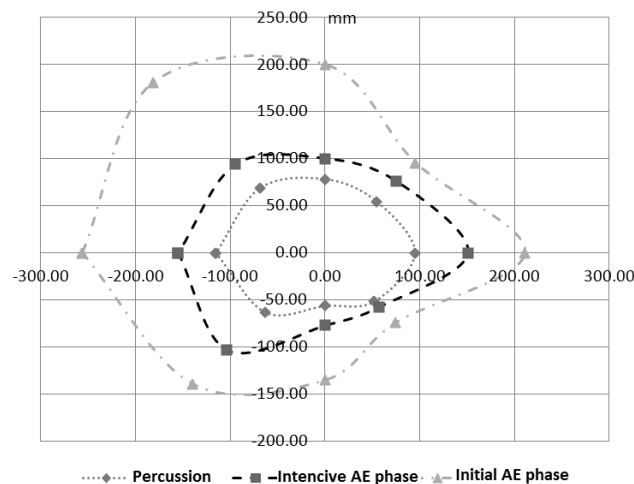
Figure 8. Diagnostics of the PB2 zone in the elevator's root area

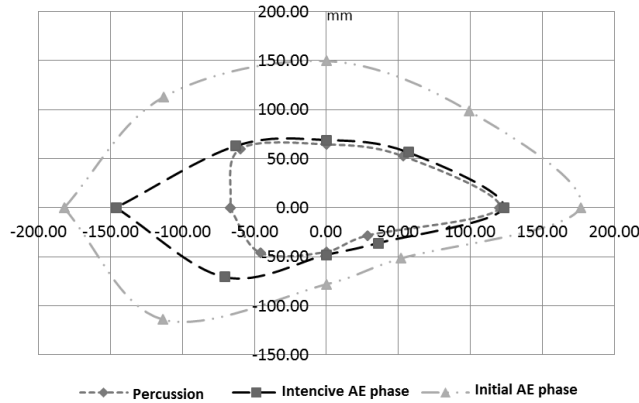
Figure 9. Diagnostics of the PB3 zone in the elevator's root area

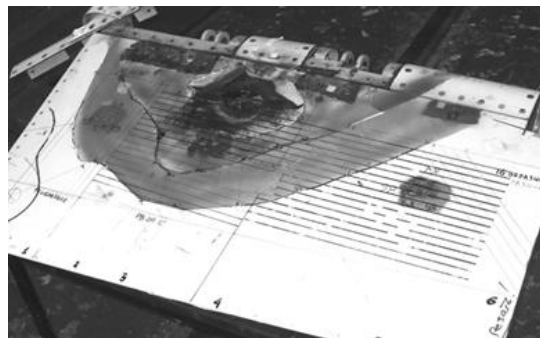
Figure 10 shows the elevator's root area colored zones PB1: the central uncolored part is the material exfoliation in the process of percussion (AVIATEST); inner colorings are the noticeable AE zone; outer is the faint AE zone.

Figure 10. Elevator diagnostics zones (PB1)

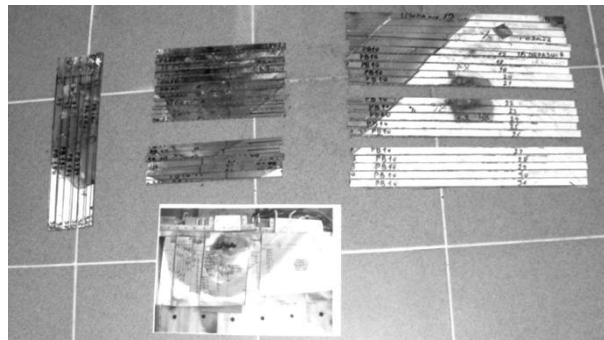
Figure 11. Samples cut from the elevator's cellular panel (zone PB1).

After cutting samples, zone coloring was preserved. The black color shows the most noticeable zone of damage, green shows the intensive structural change zone, orange is the initial damage zone. Samples were stretch-tested according to the standard GOST.

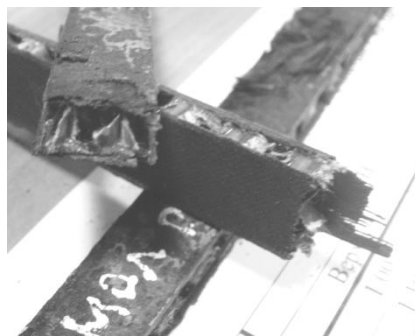
Figure 12. The character of destruction of a sample below the impact zone

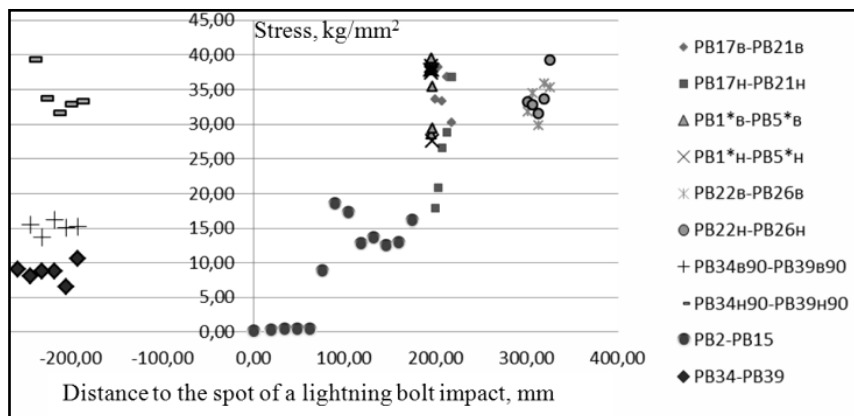
Figure 15. Strength limits of cellular-filling samples and additional samples depending on the distance to the spot of a lightning bolt impact.

The data in figure 15 shows that zone of intensive strength characteristics decline of the lower and upper skin varies in the interval between 0 and 230 mm around the lightning bolt impact. Zone of initial strength characteristics change is located 230 to 400 mm around the lightning bolt impact. The tensions in mono-layer are equal to the tensions in the process of stretching the sample, divided by the coefficient of volume part of fiber with 0 degrees packing (for the elevator this coefficient equals $3/7=0.4286$). In the following tests tensions in the mono-layer KMKU-2.120.E01 are observed. Failure tensions in the mono-layer lower and upper

panel samples PB1*-PB5* are located in the range of 80 to 86 kg/mm². Failure tensions of the upper panel samples are in the range of 40 to 86 kg/mm². Failure tensions of the lower panel samples are in the range of 40 to 86 kg/mm².
