THE QUALITATIVE EFFECT OF VARIOUS PREFORMING RELATED DEFECTS WITHIN AS MOULDED PREPREG CARBON FIBRE LAMINATES

Richard Russell, Composite Manufacturing Engineer, Rolls-Royce Plc

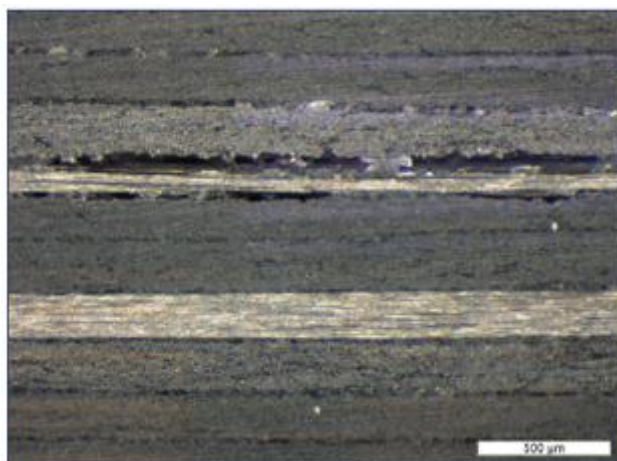
As expected, the addition of acetone to the preform caused significant delamination and absence of resin in between the affected plies. The images of the acetone damage in Figure 1 show the instantaneous damage of the uncured prepreg ply which corresponds well with the through thickness as moulded cross sectional damage and delamination in between plies as per Figure 4.

Figure 4. Acetone damage in between post cured plies.

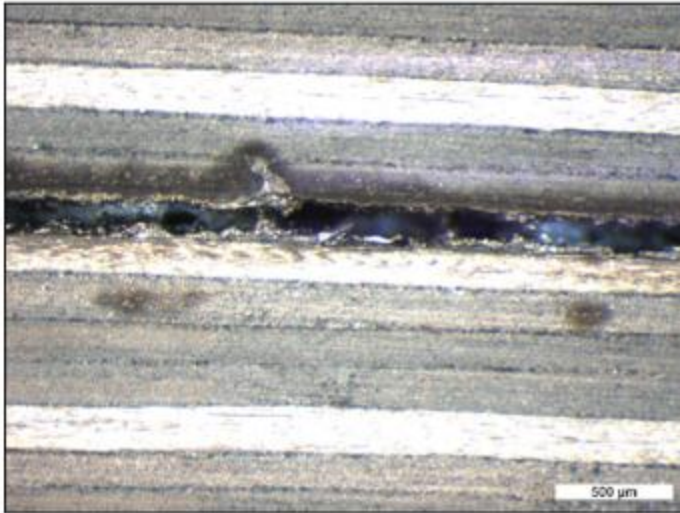
The autoclave grease was the most aggressive and damaging defect / feature introduced into this package of work. It was seen that the grease, as expected, had flowed and spread itself to a much greater area than the initial addition and also spread in between affected through thickness plies during cure. The grease appeared to have taken away resin matrix in between the affected plies and also caused some apparent heat damage / scorching affects on the surrounding regions indicating that there may have been a local exothermic reaction in the region affected. This is shown below in figure 5.

Figure 5. Autoclave grease damage in between post cured plies, showing significant damage and heat damage / discoloration within surrounding affected plies.

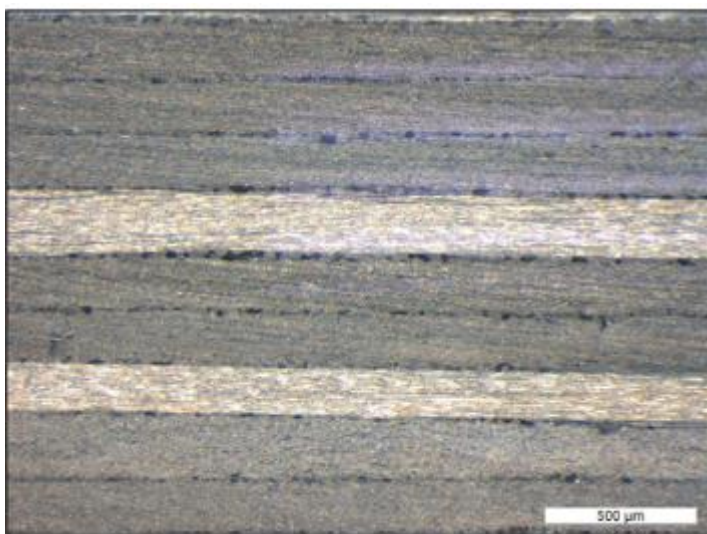
No significantly discernable difference between the plies with water sprayed onto them and those without was seen post cure. Arguably local regions of slightly higher porosity in between affected plies may be deduced and further image analysis work would be required to make a more firm conclusion, however little effect was found in this work.

Figure 6. Water damage, showing little effect in between affected cured plies.

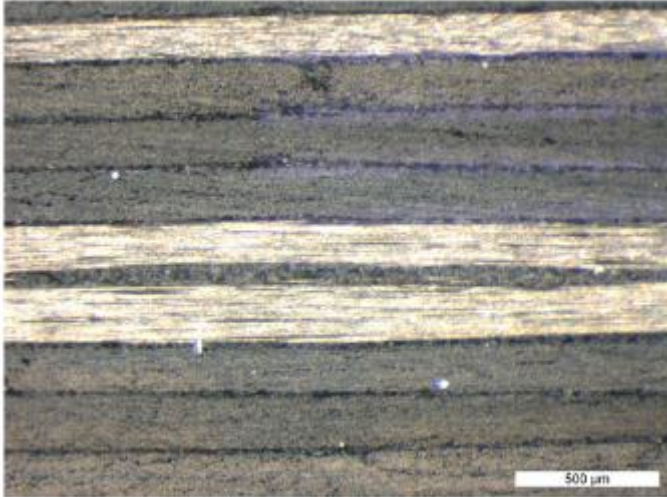
Similarly to water additions, no significant differences between affected plies with local additions of resin flakes (from parent material system) was found. Small regions of resin richness were occasionally seen on close examination of the ply affected across the panel, however this was very minute differences to the unaffected parent material and therefore was deemed insignificant.

Figure 7. Local resin flake additions, showing little effect in between affected cured plies.

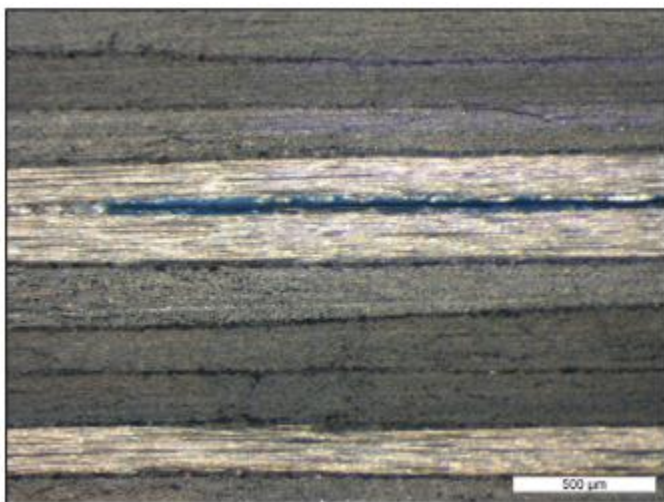
As expected the addition of the prepreg backer film showed a clear delamination and dis-bond between affected ply zones post cure. The dis-bond did not appear to extend past the edge of the backing film.

Figure 8. Backing film showing clear delamination / dis-bond between affected plies.

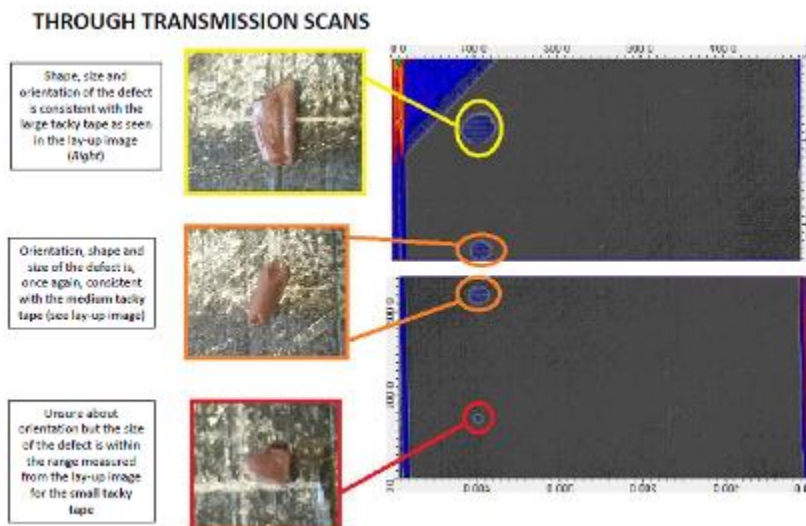
Unfortunately the tacky tape was not found during microscopic evaluation at the time of writing and further work is required to detect this defect type and assess its effect on the cured laminate. It can however be determined that through the NDE test work on the panel that significant delamination and dis-bond between plies was caused, as expected. The NDE, ultrasonic through transmission scan work is shown in Figure 9.

Figure 9. Through transmission assessment work carried out on tacky tape defects within cured laminate.

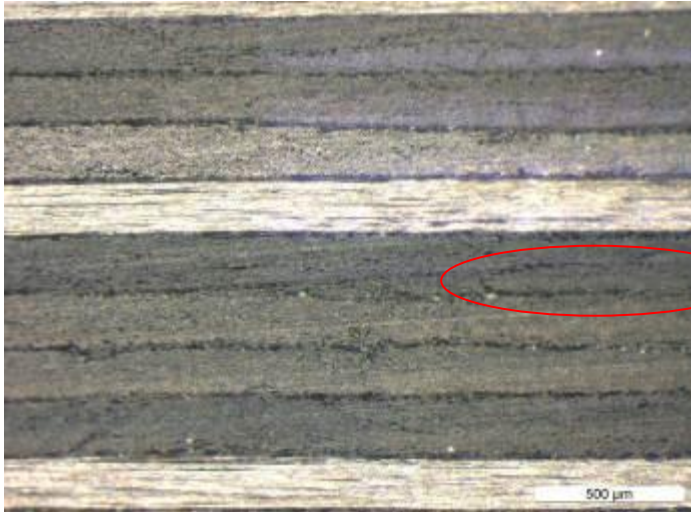
Loose / stray fibres were shown to have some effect on the NDE test work performed and on the microscopy work they were also detected as local regions of out of plane deviations as shown in Figure 10.

Figure 10. Loose fibres detected through thickness as moulded condition.
