FAILURE ANALYSIS OF IMPACT-DAMAGED / HYGROTHERMALLY AGED FIBER-REINFORCED POLYMER MATRIX COMPOSITE JOINTS SUBJECTED TO BEND LOADING

J. R. Tarpani^{a,*}, C. E. G. Castro^b, S. G. Pickering^c, D. P. Almond^c

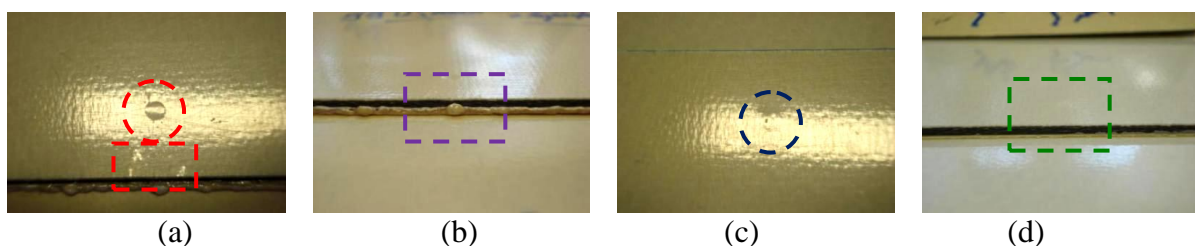
Figure 2 depicts front and back views of an impacted PPS-C joint, showing a well contoured indentation (Fig.2a: red dashed circle), indicating high irreversible deformation by impact. This figure reveals damage at the free edge of the laminate (red dashed box), resulting from the low edge constraint to the deformation and fracture mechanisms of the laminate. However, Figure 2b does not indicate major damage (e.g., delamination) through the laminate thickness (purple dashed box). Figure 2c (blue dashed circle) displays only slight damage generated on the rear (non-impacted) surface, without the occurrence of damage next to the free edge of the rear laminate or delamination along its thickness (Fig.2d: green dashed box).

Figure 2. PPS-C test coupon impacted at 10 J: (a) Impacted side; (b) Corresponding weldline; (c) Rear side; (d) Respective weldline.

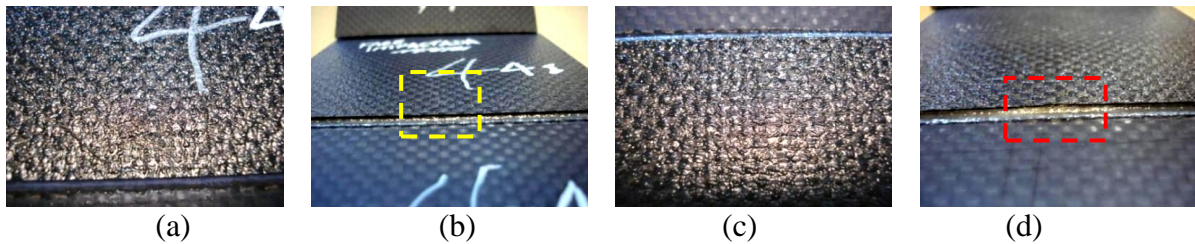
Views identical to those in Figure 2 are given in Figure 3 for the EPX-C bonded joint. In Figure 3a, there are no signs of indentation caused by the impact of 10 J. Figure 3b shows damage surrounding the point of impact and spreading towards the free edge (yellow dashed box), like that observed in the PPS-C joint. Figure 3c shows no damage on the surface opposite to the impacted one. However, the top view of the rear laminate (Fig.3d) shows delaminations along with detachment at the bonded interface close to the point of impact (red dashed box). The analysis indicates that PPS-C joint exhibits less visually detectable damage than the EPX-C one, i.e., the welded thermoplastic joint is more resistant to impact damage.

Figure 3. EPX-C test coupon impacted at 10 J: (a) Impacted side; (b) Corresponding weldline; (c) Rear side; (d) Respective weldline.

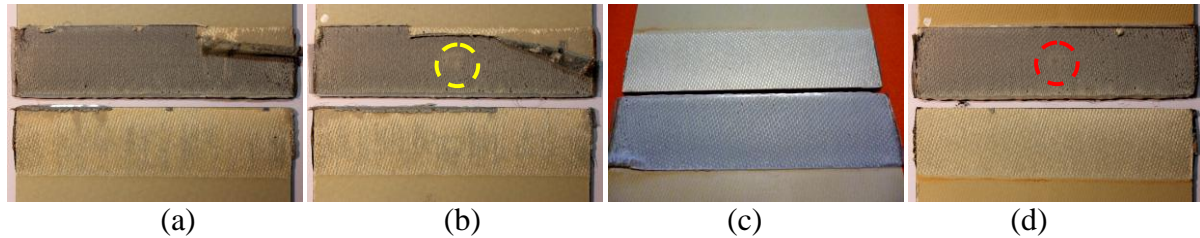
Figure 5 shows that the predominant failure mode of the PPS-C joints in the V and I conditions was debonding and tearing of the heat generating element (metal mesh), albeit without damage to the welded laminates. Damage in the mesh started at the edges and proceeded towards the center of the welded area. The similarity between the values of

ultimate load in 4PB of these two test coupons (Fig.4a) corroborates the macrofractographic analysis. In condition C, the test coupon shows exclusively debonding between metal mesh and composite laminate, and in the condition IC, failure is also caused by mesh/laminate debonding, but the central impact (red dashed circle) favors the spread of this mechanism from the center to the edges of the welded area. The very close values of ultimate load in the conditions C and IC (Fig.4a) substantiate the macrofractographic analysis.

Figure 5. Macro-fracture surfaces in 4PB of the resistance-welded PPS-C specimens in the four test conditions: (a) V, (b) I, (c) C, (d) IC. The yellow dashed circle indicates the dent caused by the impact of 10 J applied to the test coupon. The impacted laminate is always the one occupying the upper position in the photographs.

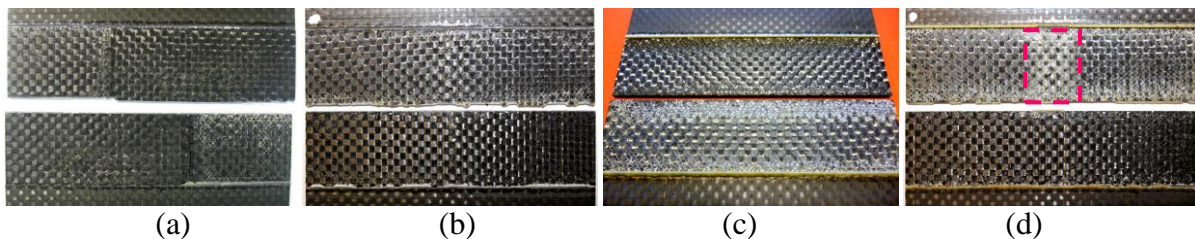
Figure 6 shows that the failure modes of the bonded EPX-C joints can be classified as cohesive (demanding more energy), adhesive (less energy) and a combination of these two competing fracture mechanisms. In condition V (Fig.6a) the fracture was mainly cohesive in nature, while in the IC condition (Fig.6d) it was basically adhesive and clearly favored by the application of the impact prior to the hygrothermal conditioning treatment (magenta dashed box). In conditions I and C (Figs 6b and 6c, respectively), the failure mode varied between predominantly cohesive and predominantly adhesive, respectively. The ultimate load results in Figure 4a faithfully reflect this hierarchy between the failure modes depicted in Figure 6.

Figure 6. Macro-fracture surfaces in 4PB of the adhesive-bonded EPX-C specimens in the four test conditions: (a) V, (b) I, (c) C, (d) IC. The impacted laminate is always the one occupying the upper position in the photographs.

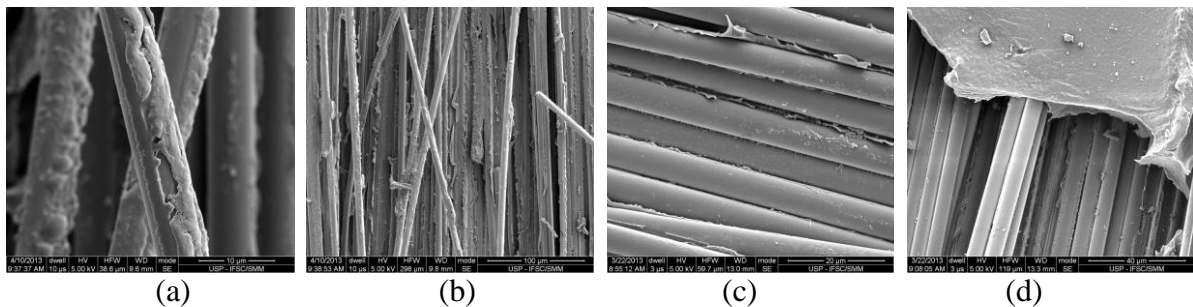
Figure 9a reveals the optimal interaction between the PPS thermoplastic polymer and the reinforcing glass fibers that coated the welded adherents of a joint without any previous treatment (V), which was ruptured in 4PB. A less magnified image (Fig.9b) allows for the inference that the joint fractured due to cohesive failure of the polymer along with some fiber rupture. In Figures 9c,d, which depict an impacted and aged joint, one can note the almost complete denudation of the fibers when compared to the original PPS coating, indicating that fracture of the joint by 4PB occurred via the mechanism of adhesive failure of the polymer/fiber interface. Notice that Figure 5 shows no damage in the adherents under any of the evaluated conditions of PPS-C joints, indicating that their carbon fiber cores were probably not exposed by the 4PB induced fracture.

Figure 9. Fracture surfaces of PPS-C after 4PB in the conditions: (a,b) V, and (c,d) IC.

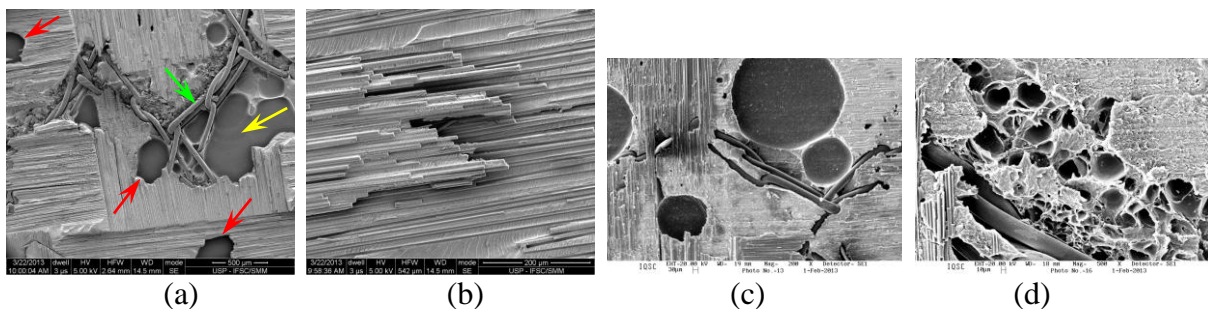
Figure 10a shows numerous voids or bubbles (red arrows) at the fracture surface of a virgin EPX-C joint, as well as interwoven polymeric threads forming a reticulated mesh (green arrow), whose main objective is to prevent the liquid adhesive from squeezing out during the laminates bonding step. This practice clearly favors the formation of resin-poor regions (yellow arrow), although voids are also generated by air entrapped during bonding, or even by the previous presence of bubbles in the adhesive itself because of stirring and/or poor vacuum deaeration practices.

Figure 10. Fracture surfaces of EPX-C under 4PB in conditions: (a,b) V, and (c,d) IC.

Figure 10b, on the other hand, indicates that in the absence of the aforementioned manufacturing defects, the bond between matrix and reinforcement fibers is of excellent quality, which can be inferred from the cohesive fracture of the matrix associated with the predominance of fiber rupture mechanism. Figures 10c,d correspond to the I+C condition of the EPX-C joint, where, again, one can see a wide range of void sizes in the epoxydic adhesive (Fig.10c). A broader view (Fig.10d) shows small alveoli in the adhesive resin film, which probably deteriorated by hygrothermal treatment.
