LATE-STAGE FATIGUE DAMAGE IN A GLASS/EPOXY NON-CRIMP 3D ORTHOGONAL WOVEN FABRIC COMPOSITE

L Baiocchi^{a,b}, T F Capell^b, S A McDonald^c, S L Ogin^{b*}, P Potluri^c, M Quaresimin^a, P A Smith^b, P J Withers^c, A Bogdanovich^d

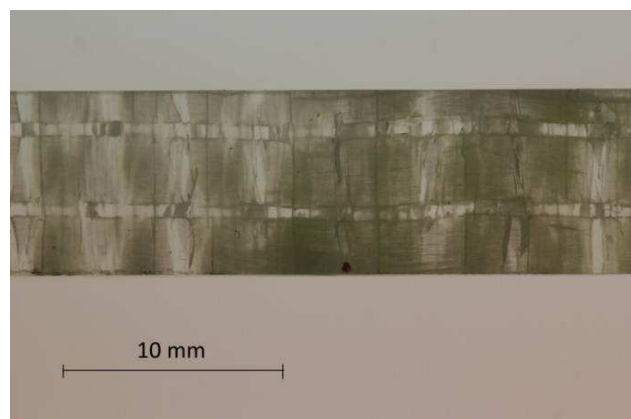
Figure 4 shows a low-magnification image of a specimen which was cycled with a maximum stress of 175 MPa for 46,740 cycles, to the end of the second stage (as the S-N curve shows, Figure 2, the expected number of cycles to failure at this stress level is somewhere between 50,000 and 100,000; the test was interrupted when audible fibre fractures were heard).

Figure 4. Low magnification image (X-Y plane) of a section of a specimen after 46,740 fatigue cycles

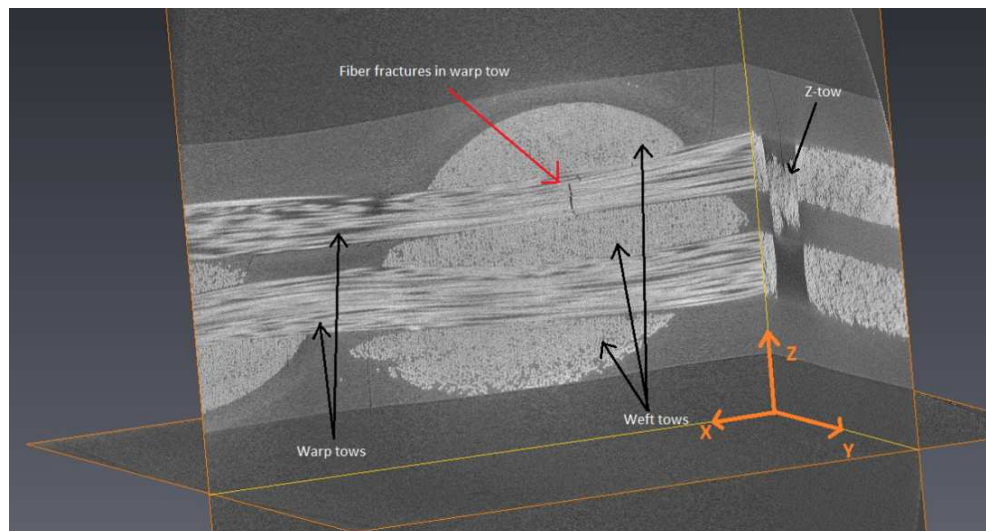
An X-ray μ CT image of the plane labeled as “1” in Figure 5 is shown in Figure 6. Note that the coordinate system shown at the bottom right of Figure 6 is the same as in Figure 5. Hence, with the plane of the z-tow taken as $Y = 0$, then the plane shown in Figure 6 is Y-negative; it is possible in this image to see the edge of the z-tow, and the end of the z-tow can be seen clearly in the X-Y plane. The significant feature within this image is, however, the presence of extensive fibre fractures in the warp tow; the fractures shown are actually located towards the edge of the warp tow. In addition, the fibre fractures are located, approximately, at the maximum thickness of the surface weft tow, close to where the z-tow crowns over the surface weft tow. Interestingly, no fibre fractures were found within the equivalent section of the lower warp tow of Figure 6. Figure 7 shows another section in the X-Z plane, but 0.5 mm closer to the z-tow. Clustered fibre fractures can again be seen across the thickness of the warp tow, although the fractures are now a little more dispersed.

Figure 6. CT section showing extensive fibre fracture towards the edge of a warp tow, located adjacent to the largest thickness of the surface weft tow; note the absence of tow fractures in the lower warp tow.

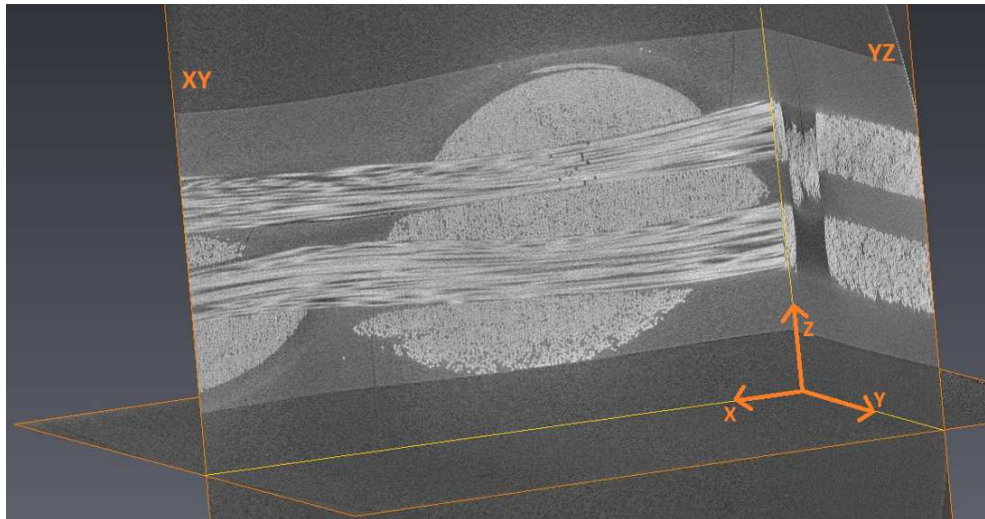
Figure 7. A virtual section at the same X-Z location as Figure 6, but 0.5 mm closer to the plane of the z-tow.

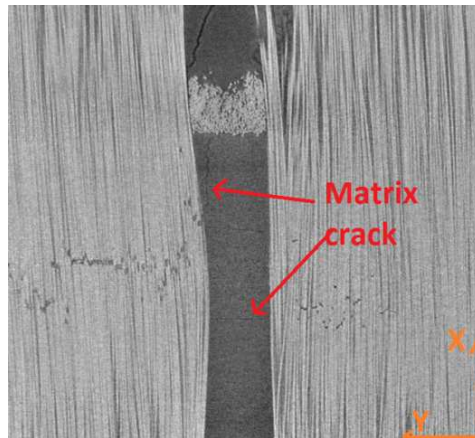
The μ CT technique enables virtual slices in orthogonal planes at the same location to be seen. Figure 8 shows a virtual section in the X-Y plane at the same location as the fibre fractures shown in Figures 6 and 7. This image suggests that fibre fractures develop initially at the edges of the warp tows. The figure also shows evidence of matrix cracks within the resin pockets between the two warp tows close to the location of the fibre fractures, though evidence of cracking within the resin pockets is more easily seen in the optical micrographs (see below).

Figure 8. Evidence of matrix cracking in Y-Z plane within the resin pocket between two warp tows adjacent to fibre fractures.

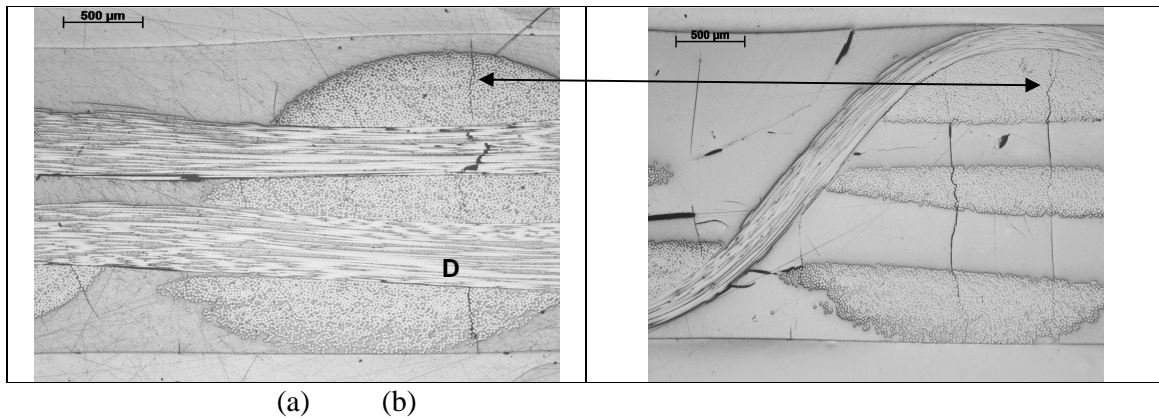
Figure 9 shows two optical micrographs produced after sectioning and polishing the specimen; the plane of Figure 9(a) is almost exactly the same plane as the μ CT image of Figure 6 (i.e. Y-negative), and the same cluster of warp tow fibre fractures can be seen. Immediately above the cluster of fibre fractures in the image of Figure 9(a), a matrix crack in the surface weft tow can be seen. Figure 9(b) shows the same X-Z location as Figure 9(a), but at position $Y = 0$ i.e. the plane of the z-tow (which is the plane labelled “2” in Figure 5). In this plane, the warp tows cannot be seen and the gap between the weft tows is filled by resin pockets. It is evident that the matrix crack in the resin pocket is an extension of the matrix crack in the surface weft tow. Indeed, the same matrix crack appears to extend from the resin pocket through the middle weft tow, through the second resin pocket, and through the surface weft tow adjacent to the opposite surface. Such combined X-ray μ CT/optical micrograph observations of matrix cracking and tow fractures were confirmed in a second specimen.

These observations suggest that the cluster of fibre fractures at the edge of the warp tows are the consequence of stress concentrations caused by cracks which extend around the circumference of the warp tows near the edge of the tows (matrix cracks in the weft tows and extensions of these cracks in the resin pockets). The absence of fibre fractures in the lower warp tow, at D in Figure 9(a), may be a consequence of the micro-delamination which has formed from the matrix crack at this location; this would reduce the stress concentration due to the matrix crack in this surface weft tow.

Figure 9. (a) Optical micrograph of sectioned and polished specimen showing the same tow fracture as seen in Figure 6 (i.e. the X-Z plane). (b) Optical micrograph at the same X-Z location but for the plane $Y = 0$ (i.e. the plane of the z-tow). The arrow indicates the matrix crack in the surface weft tow which continues through the resin pocket that is located between the warp tows (the warp tows cannot be seen in this cross-section).
