FAILURE ANALYSIS OF SKIN-STRINGER INTERFACES

B. Gómez¹, J. Reinoso^{*1,2}, J. Justo¹, A. Blázquez¹

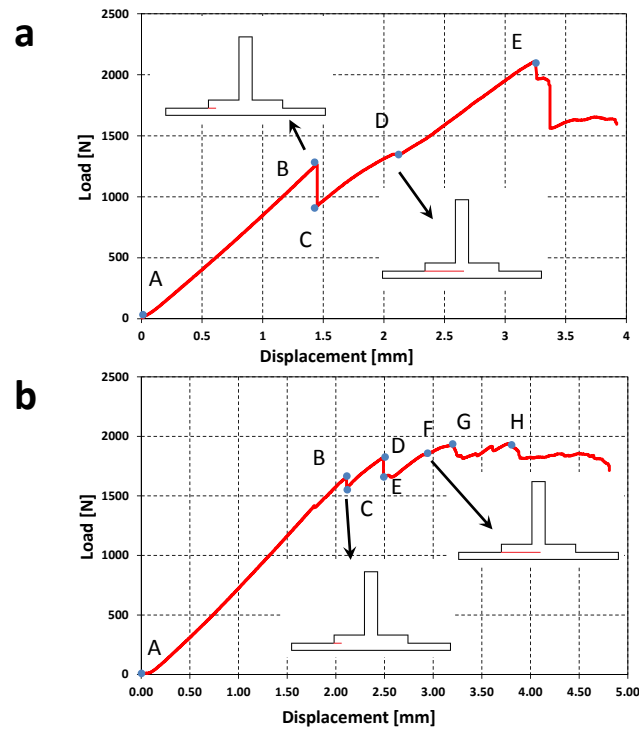
Figure 3. Load displacement evolution curves: (a) Type-A-1 specimen, (b) Type-A-2 specimen

Load-displacement evolution curves of the mobile end of the testing machine corresponding to Type-A-1(1) and Type-A-2(1) specimens (the label into brackets stands for the specimen number for each of the typologies analyzed) are shown in Figure 3. Results for all Type-A specimens are reported in Table 2. Referring to the Type-A-1 coupons, a smooth evolution, preserving the linear proportionality between applied load and the deflection (A-B) was recorded until the first kink of the evolution. This variation of the response was registered to occur within the interval 1-1.2 kN for each of the specimens tested, see Table 2, and it was simultaneous with the appearance of a crack at one of the outer longitudinal extremes of the skin-stringer interface. After this, every specimen withstood higher loadings and experienced subsequent variations in the stiffness (C-D and D-E), which were consequence of: (1) further propagation of the existing damage towards the specimen center, or (2) onset of an additional damage event at the skin-stringer interface at the opposite longitudinal end of the skin-stringer interface, which only occurred for the Type-A-1(3) specimen.

A similar analysis can be performed to the experimental data corresponding to the Type-A-2 specimens. Thus, based on the deflection evolution depicted in Figure 3, it can be observed that after the initial linear evolution (A-B), the first kink in the stiffness took place at very advanced stages of the test (point B), near the maximum load level (around 1.8-2 kN). From this point until collapse, several kinks in the load-displacement evolution curves were registered. In line with the previous typology analyzed, during the tests, for every coupons, the initiation of a

crack was detected at one of the outer longitudinal ends of the skin-stringer interface, which progressed throughout this interface, reaching the axial center underneath the roving, and after this provoking the structural collapse.

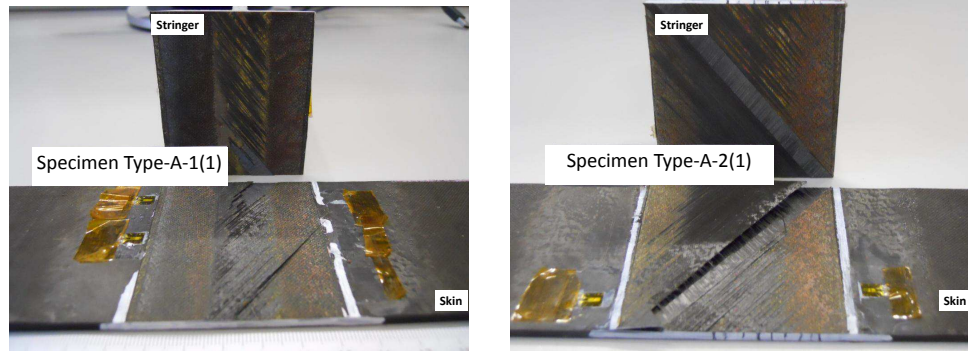
Figure 4. Fracture surfaces after test: Type-A-1(1) specimen and Type-A-2(1) specimen

Performing a visual inspection of the fracture surfaces for both Type-A (A-1 and A-2) specimens, significant differences among them were observed, see Figure 4. Hence, whereas small delaminations were identified at the central region of the Type-A -1 coupons and the edges of the joint damage was mainly due to skin-stringer debonding, for Type-A-2 specimens, the main difference with respect to the former typology concerned the presence notable detachment of the top layer of the skin forming a diagonal mark along the central area of the surface that coincided with the material orientation of this layer.

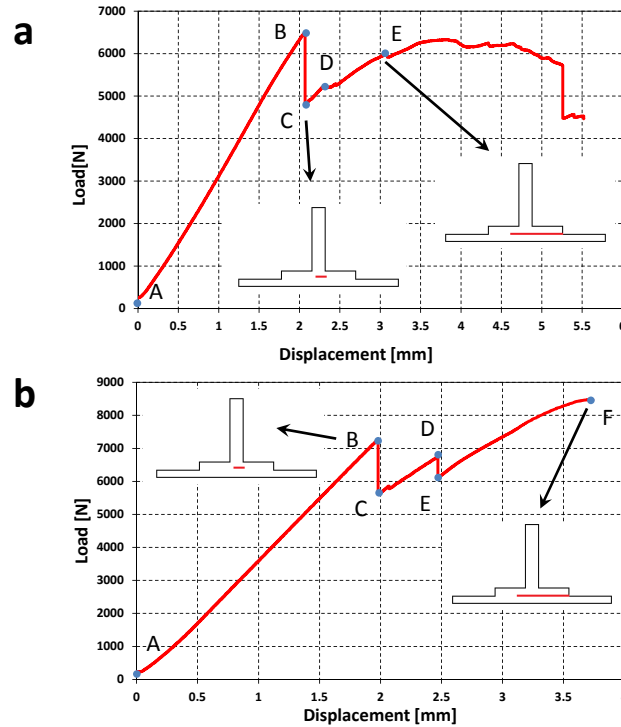
Figure 5. Load displacement evolution curves: (a) Type-B-1 specimen, (b) Type-B-2 specimen

First, common to all the specimens tested, at point B, the most significant drop in the component stiffness was experienced at high loading levels in comparison with the collapse load. This drop is associated to the initiation of the damage, as was noticed during the experiment. However, it is observed that for Type-B-1 coupons, this sudden variation of the response occurred at lower load levels (around 6-6.5 kN, see Table 3), differing from the alternative typology (Type-B-2 specimens), for which it took place between the interval 7.250-7.275 kN. It is worth mentioning that concerning the evolution after the first peak most of the components exhibited an unstable damage propagation, since no higher load levels were achieved any longer.

In comparison to Type-A coupons, significant higher load levels were achieved for every B specimens. In addition to this, the maximum load levels recorded during the experiments were not notably affected by the different laminate disposal with the exception of the case corresponding to the Type-B-1(1) coupon that had a different response (see Table 3). In both cases, a large first stage characterized by the proportionality of the applied load was recorded (A-B in Figure 5 for both evolution diagrams).

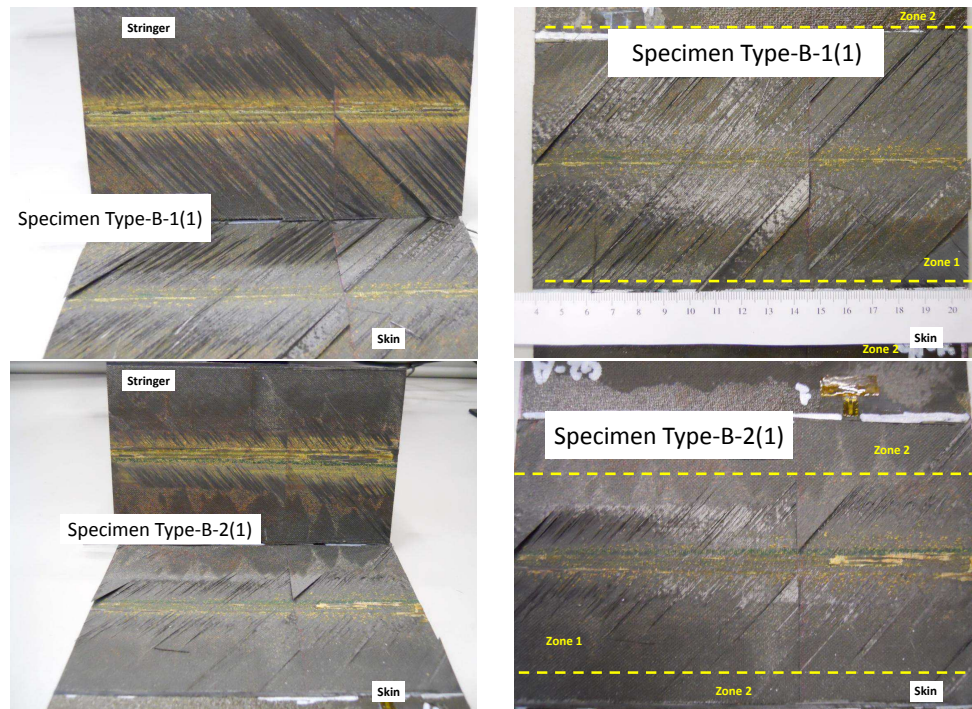
Figure 6. Fracture surfaces after test: Type-B-1(1) specimen and Type-B-2(1) specimen

With reference to the analysis of the fracture surfaces, as was previously highlighted, both specimen typologies B exhibited damage patterns starting from the center of the skin-stringer interface (underneath the roving) and progressing along the longitudinal direction until the ending edge of the joint. Note that this behavior completely contrasted with the performance of the specimens Type-A previously discussed.

Furthermore, performing visual inspection of failure surfaces, a common failure pattern mechanism was observed for both specimen Type-B typologies, in which two different zones were identified: (1) a central area that was characterized by the presence of significant delamination events forming 45-degrees with respect to the reference direction (Zone 1), and (2) a pair of lateral regions (at each of the axial sides of the joint) in which the predominant damage mechanisms regarded the debonding between the skin and the stringer (Zone 2).
