## THE EFFECT OF TOW GAPS ON COMPRESSION AFTER IMPACT STRENGTH OF AFP LAMINATES

A. T. Rhead<sup>1</sup>, T. J. Dodwell<sup>1</sup>, R. Butler<sup>1\*</sup>

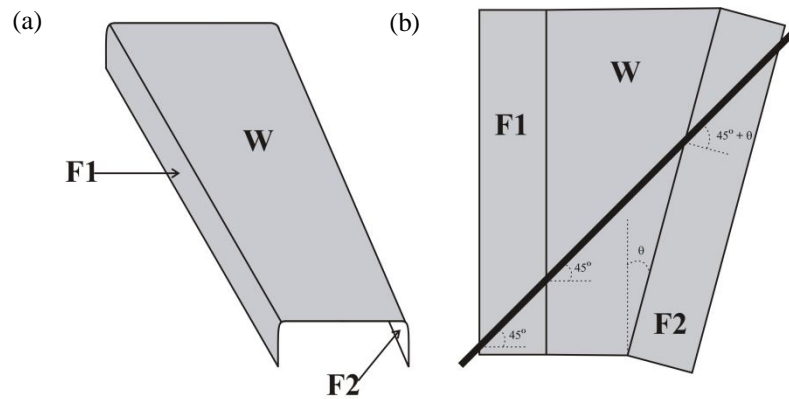
**Figure 1** (a) Shows a typical configuration of channel section with a tapering cross-section. (b) Shows an unfolded view of the channel demonstrating the path of a 45° fibre. Note that the path does not remain at 45° over surface S2.

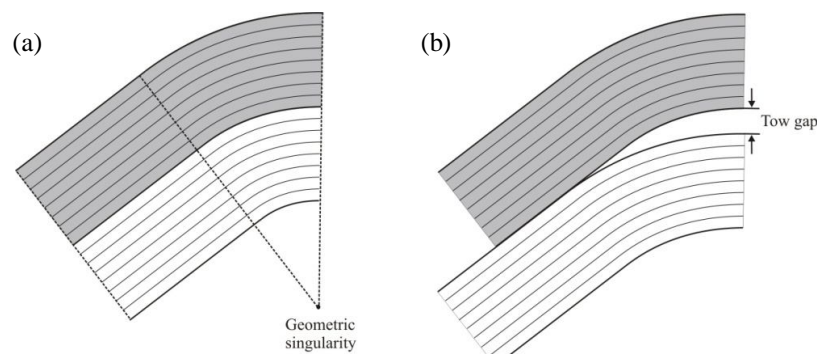
**Figure 2** Two possible configurations for adjacent courses of 8 steered tows. (a) Courses are laid down so that no gaps form between each course, consequently the curvature of each consecutive tow is forced to tighten. (b) By laying down identical courses next to one another, no such tightening of curvatures occurs, but at the sacrifice of gaps between courses.

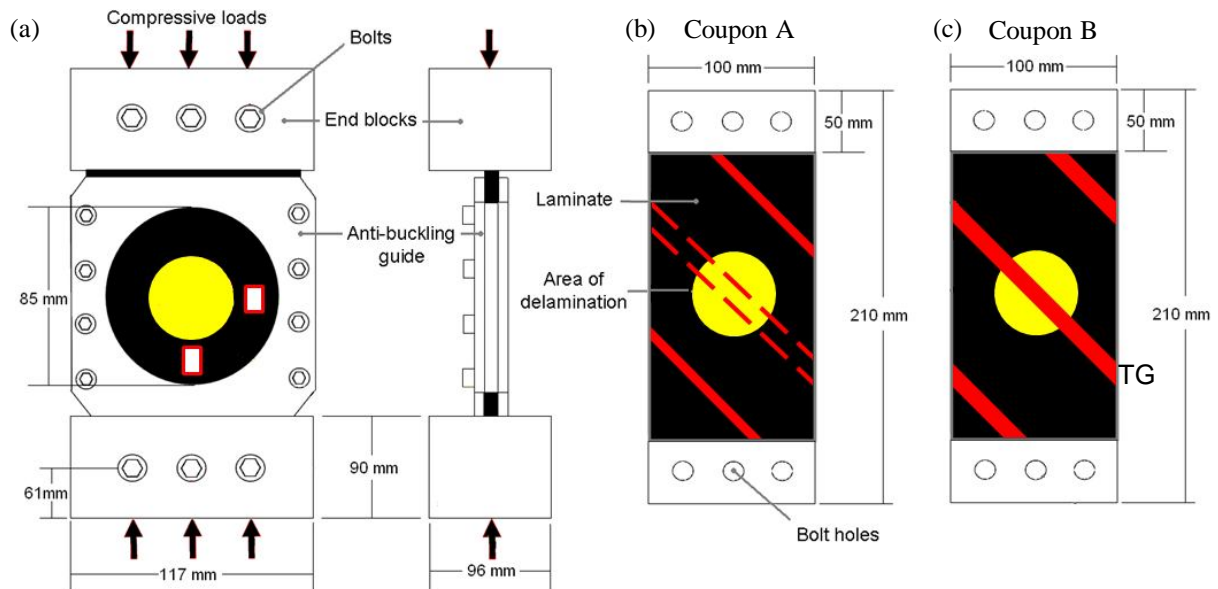
**Figure 3.** (a) Compression after impact test fixture, (b) and (c) schematics of coupons A and B respectively showing areal positioning of tow gaps and impact sites on the free surface. TG indicates the position of the photographic cross-section in Fig. 4(a).

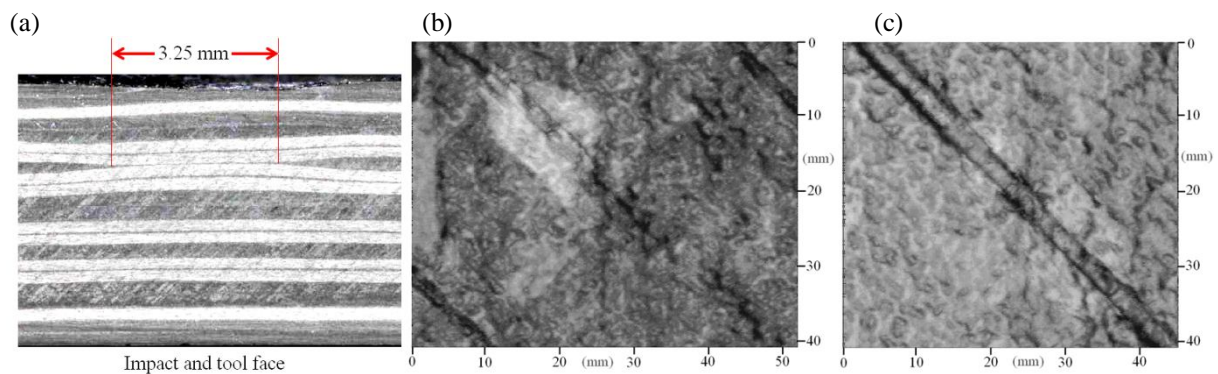
**Figure 4.** Tow gaps images: (a) cross-section photograph of the edge of coupon B at point TG in Fig. 3(c) showing a tow gap in the 8<sup>th</sup> layer. (b) and (c) C-scan surface images of A and B respectively.

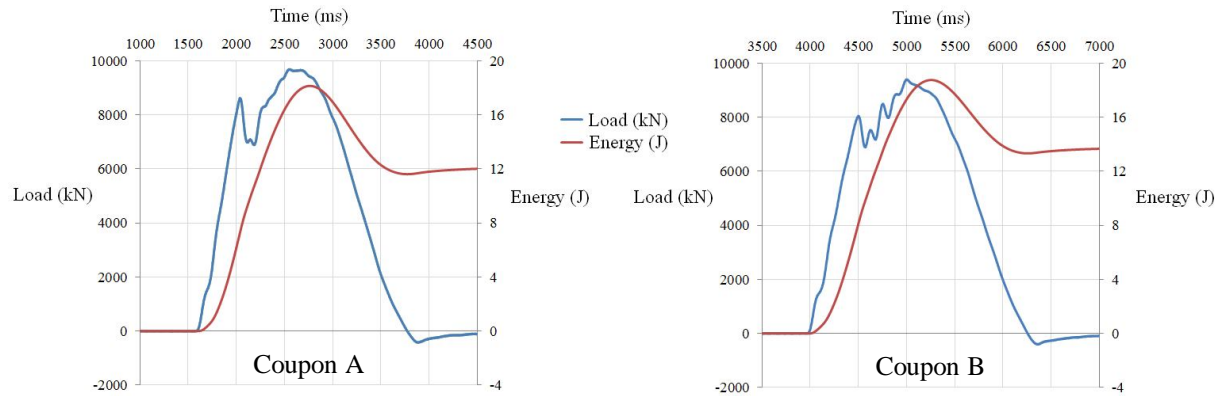
Figure 5. Impact load and energy versus time plots.

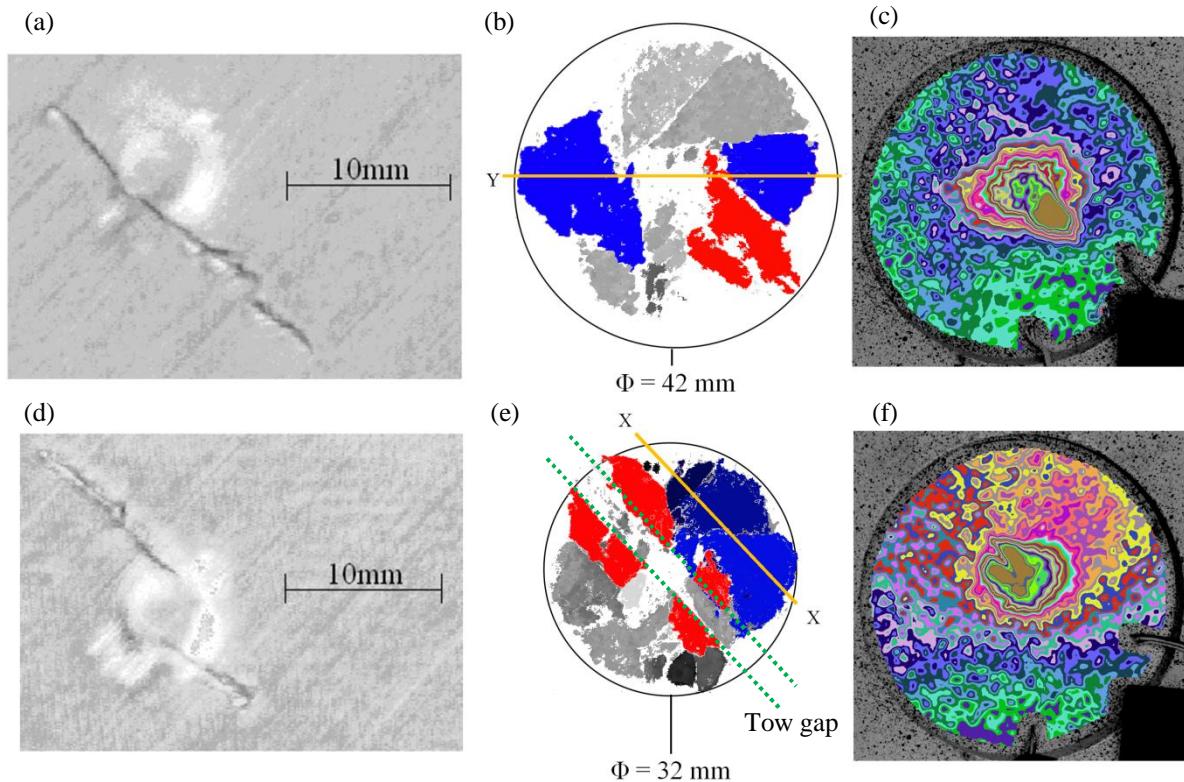
Figure 6. (a) and (d) surface C-scan images of impact sites, (b) and (e) time-of-flight C-scan images of impact damage in coupons A and B respectively. Red areas indicate delaminations involved in the 1<sup>st</sup> sublaminate buckle and blues areas relate to those involved in the second sublaminate buckling events. (c) and (f) DIC images at 184kN and 211kN of sublaminate buckles immediately prior to propagation for coupons A and B respectively.
