COMPRESSION AFTER IMPACT BEHAVIOR OF ELECTROSPUN NANOFIBER EMBEDDED FIBER GLASS COMPOSITE LAMINATES

E. Kimbro, A. Kelkar*, R. Mohan

Joint School of Nanoscience and Nanoengineering, 2907 East Lee Street, Greensboro NC 27401, USA
**kelkar@ncat.edu*

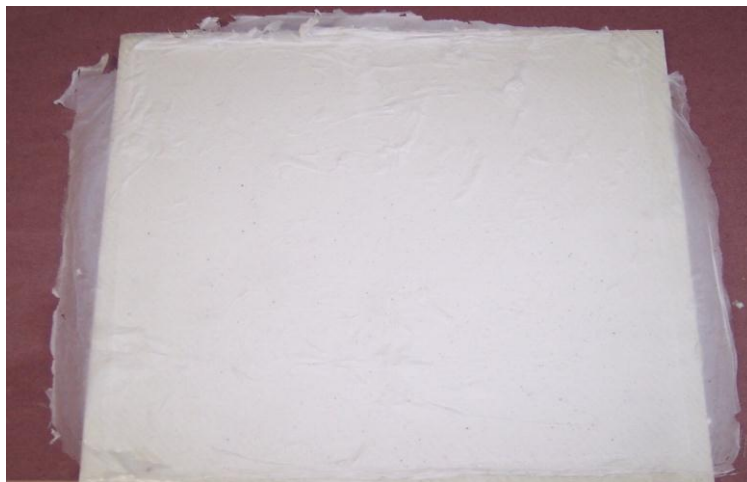
Thirty six nanofabric sheets were electrospun with dimensions of 36 cm x 36 cm. The glass nanofabric was post cured in a high temperature oven at 600°C for 6 hours. Post curing the nanofabric increases strength and decreases fiber diameters [4]. Pre-impregnated composite VTM264/7775 fabric was supplied by Advanced Composites Group. Four composite laminates measuring 36 cm x 36 cm were manufactured with electrospun nanofabric applied at the interfacial layer. The electrospun glass nanofabric was applied with great care at interface and de-bulked using a de-bulker for 15 minutes at every interface. Figure 1 shows application of electrospun glass fiber mat at a single interface.

Figure 1. Image of electrospun glass nanofabric applied to pre-impregnated fabric

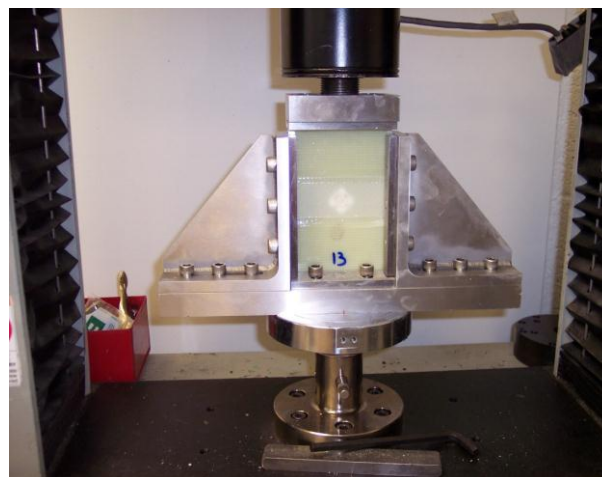
Compression after impact tests were performed on each specimen for residual strength comparisons. Impacted test specimens were cut and tabs applied in accordance with ASTM D7137 test standard. A test fixture that would not allow out of plane bending was used. The test fixture holds the specimen such that out of plane bending will not occur. Guides are used in the test fixture that allow the specimen to slide but do not clamp the edges. Tabs were installed to prevent failure in non critical areas of the specimen. Figure 3 shows an example of a specimen in the test fixture during a test. The test fixture was loaded into an Instron 30 kip load frame. Blue Hill software was used for application and data acquisition of the test. Data was collected at a rate of 50 hertz.

Figure 3. Compression After Impact fixture
