## **BONDED REPAIR OF CFRP PRIMARY STRUCTURE: TESTING AND ANALYSIS OF BONDED SCARF JOINTS.**

This paper presents test and analysis of secondary bonded scarf joints in carbon fibre / epoxy composites. The scarf joints were manufactured from composite material typical of that used in the latest generation of civil aircraft. Four 120°C cure epoxy film adhesives and 5 different scarf angles were tested. Photo-elastic analysis concluded that significant stress peaks were found at the bond line adjacent to the 0° ply interface and results were compared to failure predictions. Fractography and microscopy were used to characterise the failure mechanisms.

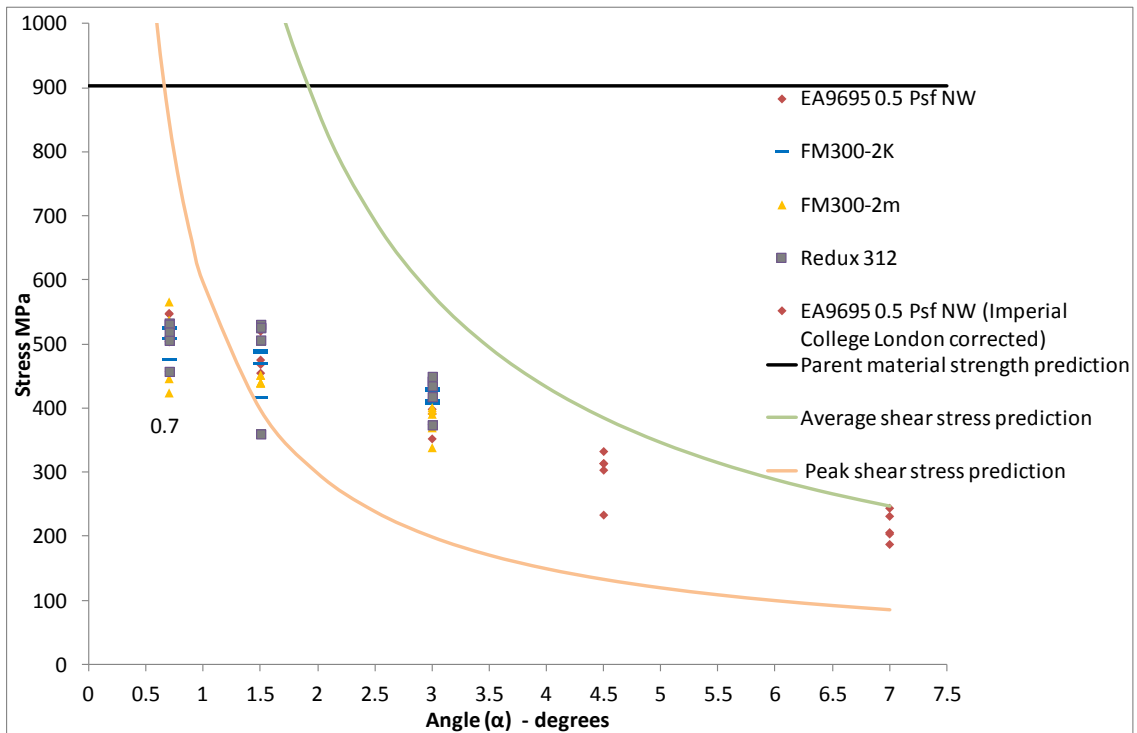
The test matrix is shown in table 2 and results are shown in Figure 3. Figure 4 then shows individual test results for the 3° samples, showing the degree of sample variability.

Figure 3. Scarf test results

Where  $E_{Lam}$  = Modulus of the laminate,  $t$  = Thickness of the laminate and  $E_0$  = Modulus of the  $0_0$  plies. Results of both prediction methods are shown in Figure 4.

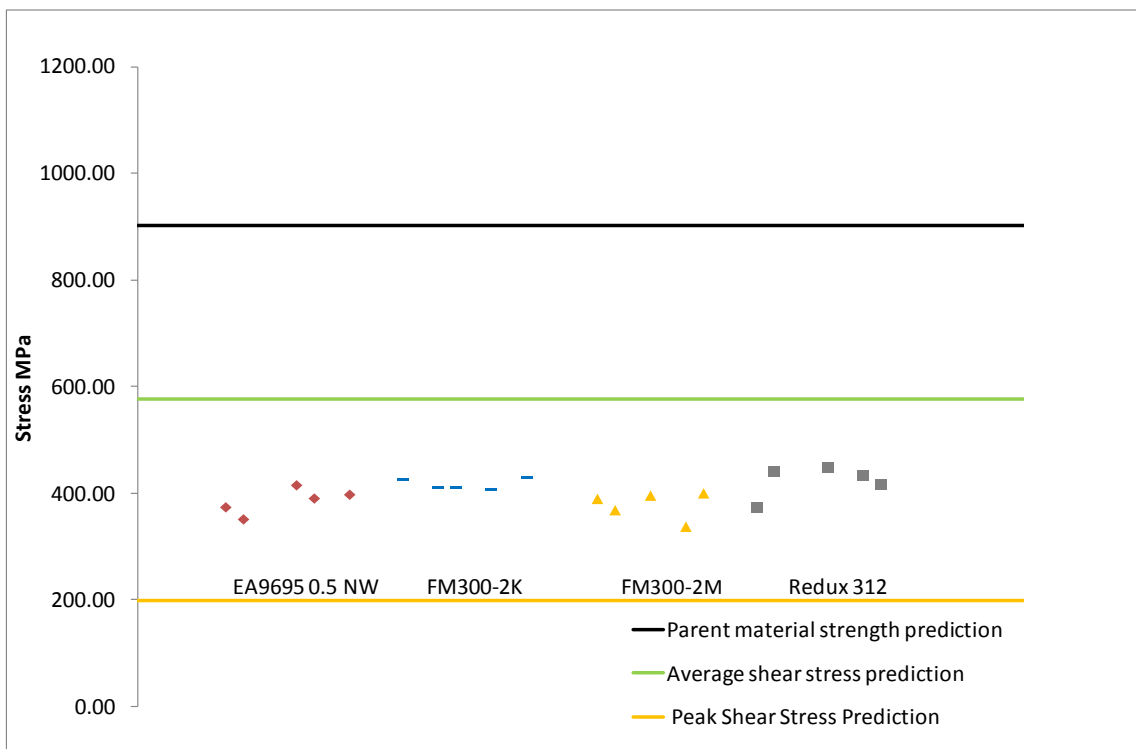
Figure 4. Individual test results for the 3° scarf angle samples.

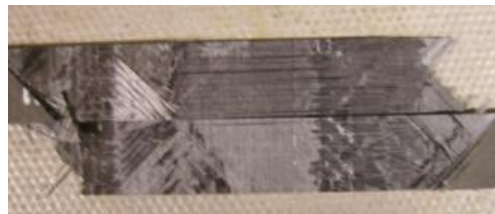
**Figure 5.** Mode A = Cohesive failure except on the 90° plies where fibre pull out is evident scarf angle 3° adhesive Redux 312

Fractography shown in figures 5-7 identified the failure modes and the likely initiation locations for the failure. Figure 8 shows cross sections through the bond with two adhesives showing differences at the feather edge. The failure modes varied with the scarf angle rather than the epoxy adhesive used. It is clear from the test results that the coupons that have scarf angles of 3° and above exhibit a predominantly cohesive failure mode within the adhesive, apart from the 90° plies where matrix and fibres are pulled away, suggesting that the adhesives are stronger than the matrix epoxy of the composite. Although there is some scatter in the results, the shape of the two prediction methods used reflects the pattern of failures at these angles above 3° with the failure load increasing as the scarf angle decreases. The peak shear stress prediction could be improved by using lap shear data from a shorter overlap or calculating the peak shear stress value on a shear stress curve which would then shift this line up towards the test results. The average shear stress method appears to be optimistic as expected, which is probably due to the failure being linked to the stress peaks at the 0° ply bond line interface. The photo elastic analysis shown in figure 9 confirms the existence of these stress peaks and confirms that there are stress peaks at the feather edge of the repair. A reduction in these stress peaks would likely to improve the performance of the scarf joint. These peaks are similar to those shown in [4] and offer an explanation into likely failure locations.

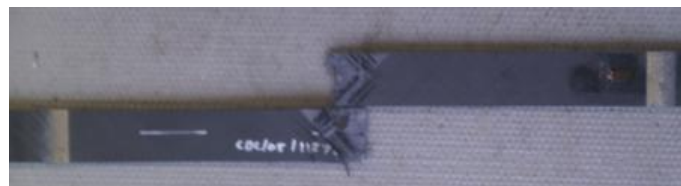
**Figure 6.** Mode B = Fibre pull out, (interlaminar and intralaminar failure) scarf angle 0.7° adhesive Redux 312

Failure for the 1.5° and 0.7° scarf coupons is more complex and although failure initiates in the bond line, it doesn't follow the cohesive failure mechanisms of the of the scarf angles 3°, 4.5° & 7°. For the 1.5° scarf angles and a small proportion of the 0.7° angles the failure mode appears to move from the bond line into an interlaminar / intralaminar failure within the composite matrix, with the initiation point being the 0° fibre bond line interface. These failure modes are shown in [1] but appear to be layup dependent as they are seen at shallower angles than those observed in this paper. For the 0.7° scarf angle coupons, the main failure mode was what appeared to be net section failure initiating in the 0° ply / bond line interface midway through the length of the bond line. This would indicate that for this layup there are 3 failure modes of which 0.7° is on the border between net section and fibre pull out. The shallower the angle, the less likely failure is to occur at the feather edge of the coupon. This is probably due to peel forces being reduced as the scarf angle reduces. There are some strength benefits from the use of shallow scarf angles below 3° however the benefits of this has to be weighed up with the large amount of material removal required the extra size of the joint and the added
