## TEXTILE REINFORCED MORTAR FOR STRENGTHENING REINFORCED CONCRETE BEAMS

A. H. Al-Saidy<sup>1\*</sup>, K. S. Al-Jabri<sup>1</sup>, A. S. Al-Harathi<sup>1</sup>, S. M. Al-Zadjali<sup>2</sup>

<sup>1</sup>Department of Civil and Architectural Engineering, Sultan Qaboos University, Sultanate of Oman

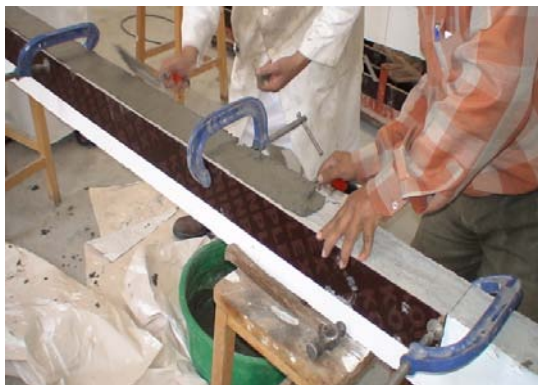
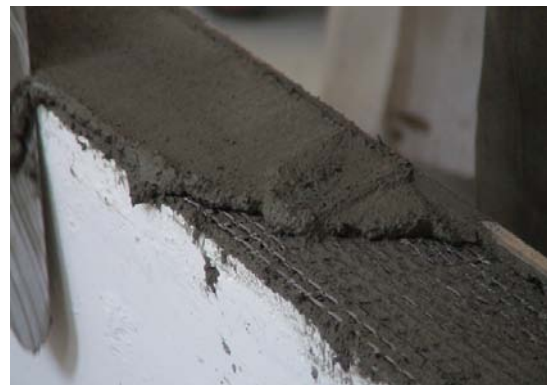
**Figure 1.** Application of mortar and textile layers

a) Application of first layer of mortar

b) Application of second layer of mortar

c) Carbon Fiber textile

A total of 6 reinforced concrete beams were tested in this study as summarized in Table 1. Beam BC was a control beam without strengthening, while beam SILE was strengthened by bonding carbon fiber (CF) textile at the bottom of the beam using epoxy. On the other hand beam S1LM1 was strengthened by bonding CF textile at the bottom of the beam using readymade repair mortar that only required addition of water. One layer of mortar is first applied on the concrete surface with 2 mm thickness followed by placing the textile and then the second layer of the mortar is applied (see Figure 1). Beam S1LM1U is strengthened similar to S1LM1 with the addition of U-shaped CF textile strips applied on top of the CF textile around the cross-section (see Figure 2).

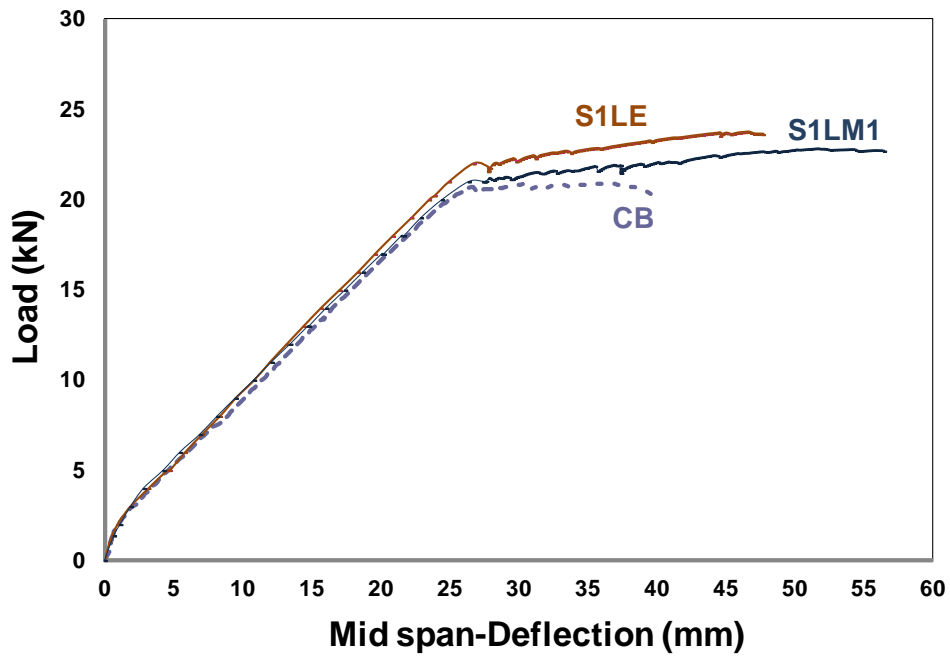
Figure 3. Load-deflection curves comparing epoxy vs mortar

Figure 3 presents the load-midspan-deflection curves for the beams that were strengthened with one layer of textile bonded with epoxy in one beam (S1LE) and with mortar in the other beam (S1LM1) and both were compared to the control beam (CB). The results showed that beam strengthened with epoxy bonded CF textile was slightly better in terms of load transfer between the CF textile and the beam concrete surface in comparison to beams strengthened with mortar bonded CF textile. The beam strengthened using epoxy bonded CF textile (beam S1LE) was able to resist a load of 24 kN at failure compared to a failure load of 23 kN in beam S1LM1. However, both beams resisted higher load than that of the control beam (CB) which failed at 21 kN. The failure of beam S1LE was due to rupture of the CF textile (Textile Rup.) and the other two beams failed by crushing of concrete (Con. Crush) as shown in Table 2 which summarizes the test results. Figure 4 shows the effect of adding more layers of mortar bonded textile. The beam that was strengthened with two layers (S2LM1) failed prematurely by bond failure of the textile layer without any gain in strength. To enhance the bond between the concrete beam and the textile layer, U-shaped strips were added to anchor the main textile layer in the remaining beams. This is observed in Figure 5 when comparing the behavior of beam S2LM1 and beam S2LM1U. The later included U-shaped strips and performed better in strength and deformation. This clearly indicates that adding U-shaped strips can enhance the bond that is required to transfer the load between the textile layer and the strengthened concrete beam. However, anchoring the textile layer cannot replace the bond strength provided by the mortar layer itself as can be observed when adding a third layer of textile such as in beam S3LM1U shown in Figure 6. It can be seen that adding a third layer resulted in minor gain in strength when comparing the failure loads of beams S2LM1U and S3LM1U in which beam S3LM1U failure was initiated by bond failure. This clearly indicates that the mortar was not able to provide the bond strength needed to utilize additional strength supported by a third layer of mortar. Table 2 summarizes all results with comparison in behavior between strengthened beams and the reference control beam.

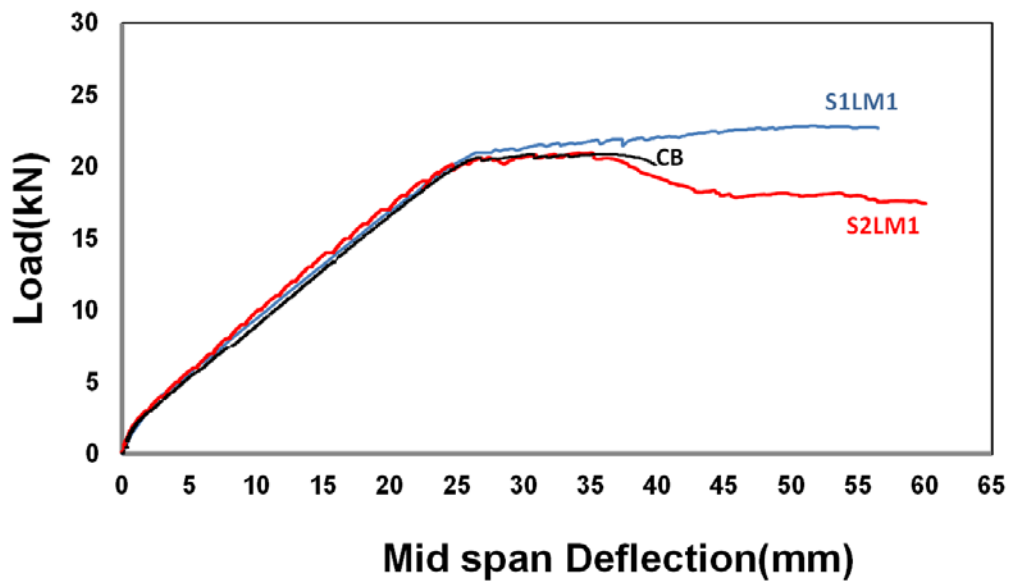
Figure 4. Load-deflection curves comparing effect of layers

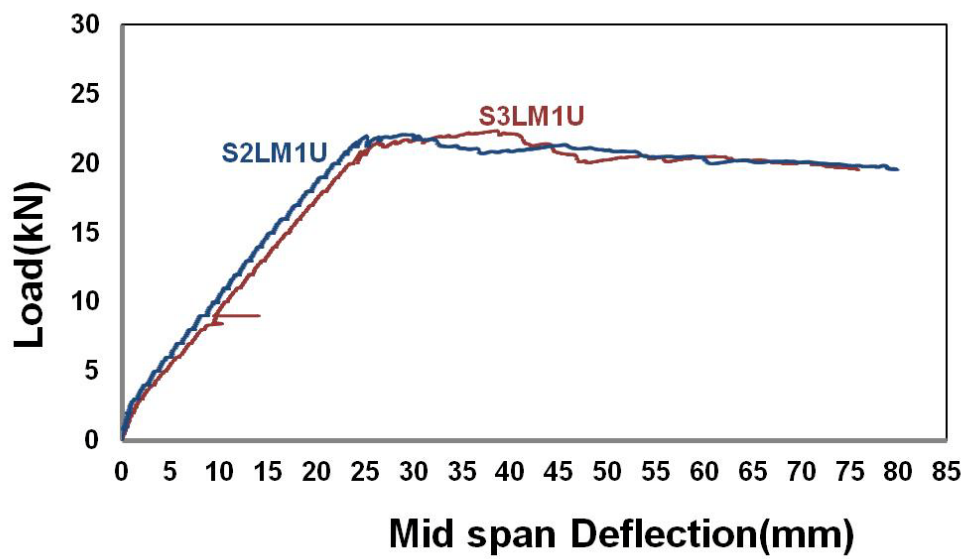
Figure 6. Load-deflection curves comparing effect of anchorage on additional textile layers
