IN SITU CT BASED DAMAGE CHARACTERISATION OF TEXTILE-REINFORCED CFRP COMPOSITES

Keywords: In situ CT, damage, textile composites, testing

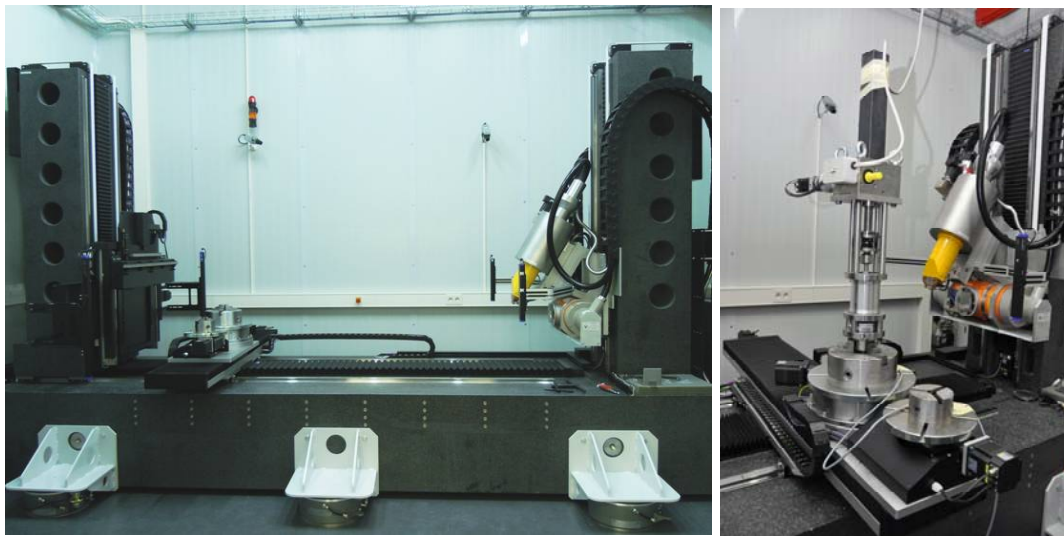
For damage analysis of textile composites, an in-situ CT test device has been developed using the high resolution CT-system V|tome|x-L 450 (GE Phoenix X-Ray) with a 300 kV microfocus and a 450 kV macrofocus X-ray tube. The CT consists of a flat panel detector with 2048 x 2048 14 bit pixels where one pixel is 200 x 200 μm^2 . Due to large optical scaling, the maximal resolution of the CT is 1 μm . Fig. 1 shows the used CT with the novel in situ device.

Figure 1. Computer tomograph V|tome|x-L 450 (left); In situ CT test device (right)

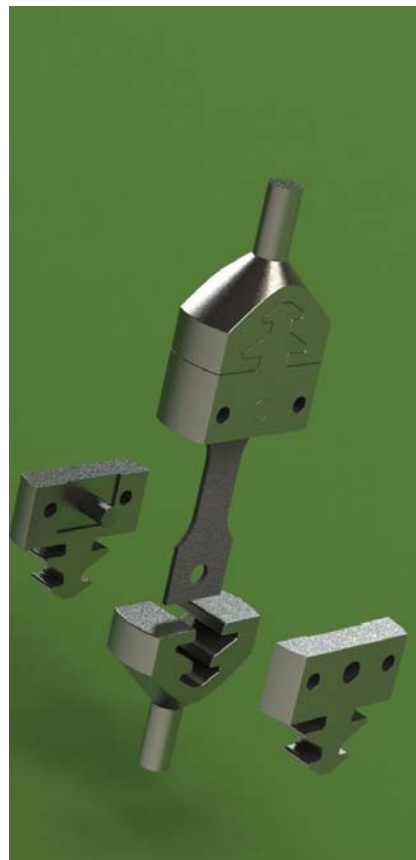
the same load transfer unit is used. However, in this case, the load clamping system has to be adapted (Fig. 3).

Figure 3. Clamping system for in-plane loading
