DAMAGE OF AA2124/SiC METAL MATRIX COMPOSITE UNDER FATIGUE CONDITIONS

A. Rutecka^{a*}, P. Gutkiewicz^a, P. Grzywna^a L. Dietrich^a

Abstract

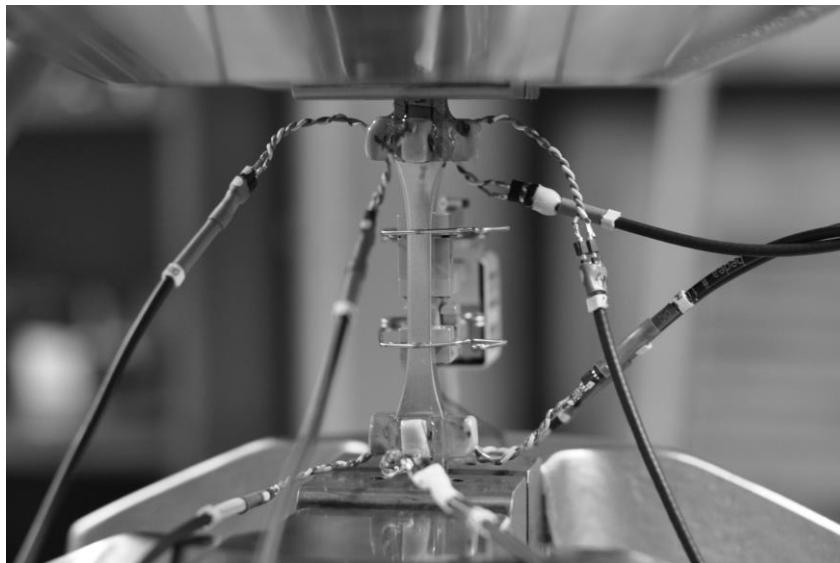
Figure 1. Test facilities for fatigue with ultrasonic probes

Ultrasonic wave measurements were performed during fatigue tests. Two pairs of 4 MHz longitudinal wave probes and two pairs of 4 MHz Rayleigh wave probes were attached to fatigue specimens before tests (Fig. 1). Pulse amplitudes and time of flights were measured in 4 ms intervals during whole fatigue tests.

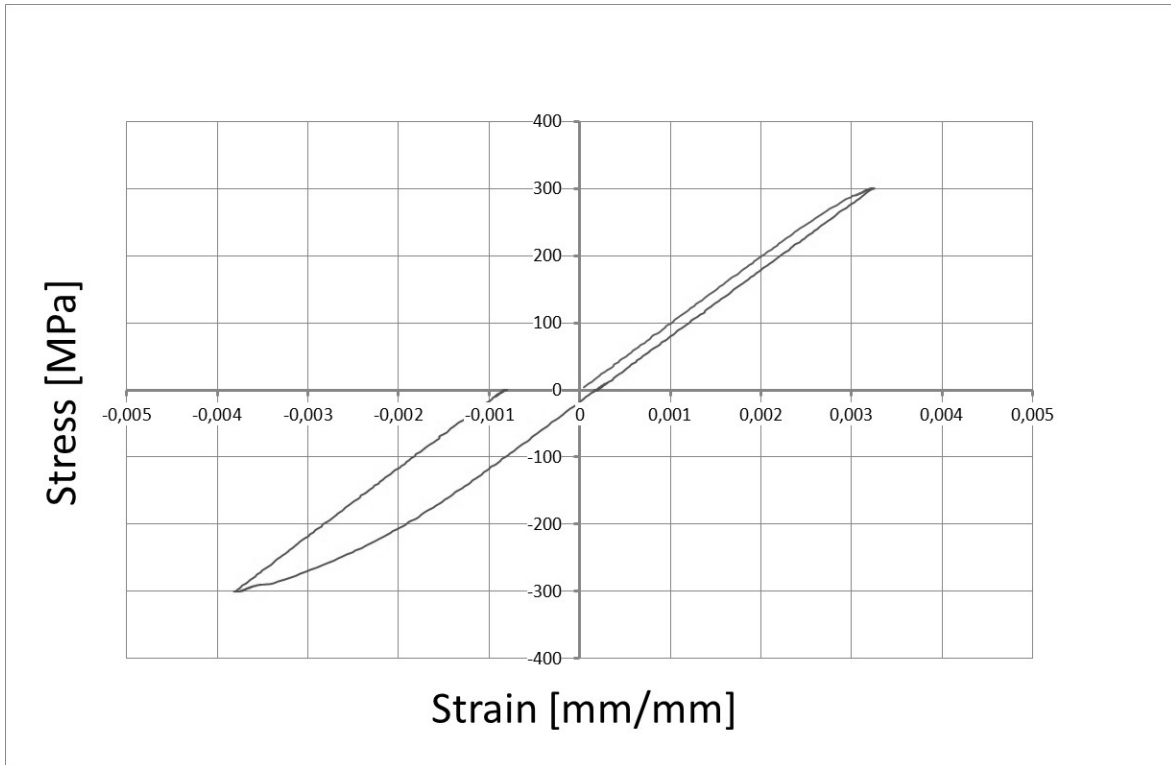
Figure 2. Hysteresis loop for AA2124+17%SiC (specimen 17_xe_zm_7) – first cycle

Cyclic plasticity followed by ratcheting was observed during fatigue tests. Hysteresis loop width enlarged during first cycle towards negative strains (Fig. 2 and 3). Subsequently hysteresis loops widths became narrower during next cycles (Fig. 4) and ratcheting towards negative strains was observed (Fig. 5). Inelastic strain amplitude and mean inelastic strain during subsequent cycles were calculated. In the case of AA2124 + 17% SiC (specimen 17_xe_zm_7), inelastic strain amplitude reached the value of 0,0005 mm/mm at the beginning of test (Fig. 6a), decreased during next 10 000 cycles and then stabilized at strain value equal to about 0,00005 mm/mm (Fig. 7). Mean inelastic strain remained negative during test (Fig. 6b, 8). At the beginning it decreased to the value of -0,0004 mm/mm, than increased slightly and after about 150 cycles decreased up to -0,0015 mm/mm. Thus, mean inelastic strain cannot be used as a simple fatigue damage indicator.

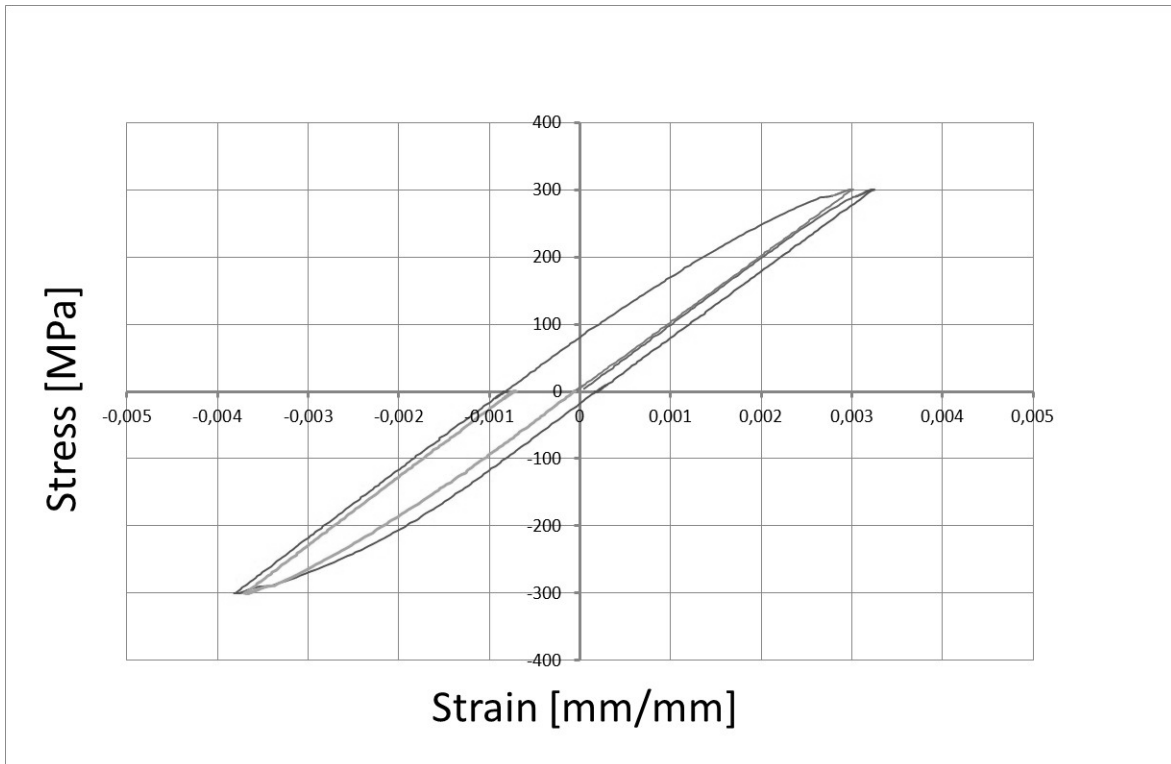
Figure 3. Hysteresis loops for AA2124+17%SiC (specimen 17_xe_zm_7) – first and second cycles

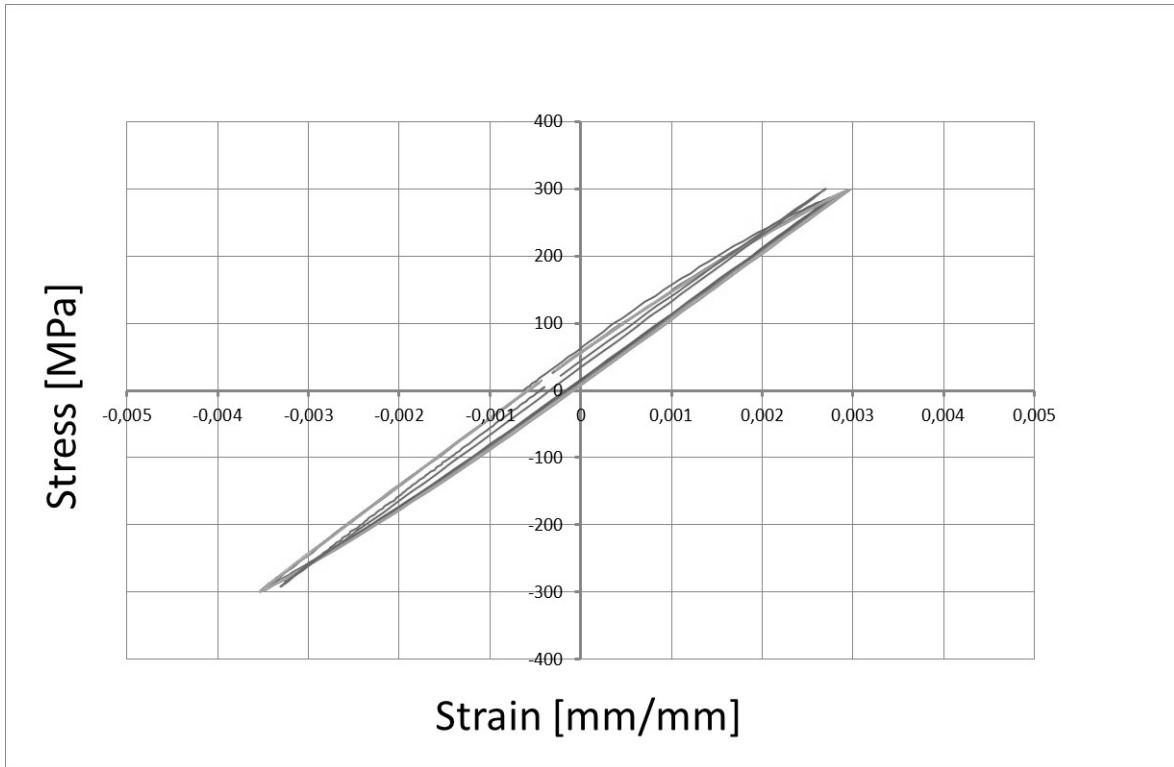
Figure 4. Hysteresis loops for AA2124+17%SiC (specimen 17_xe_zm_7) 3 – 502 cycles

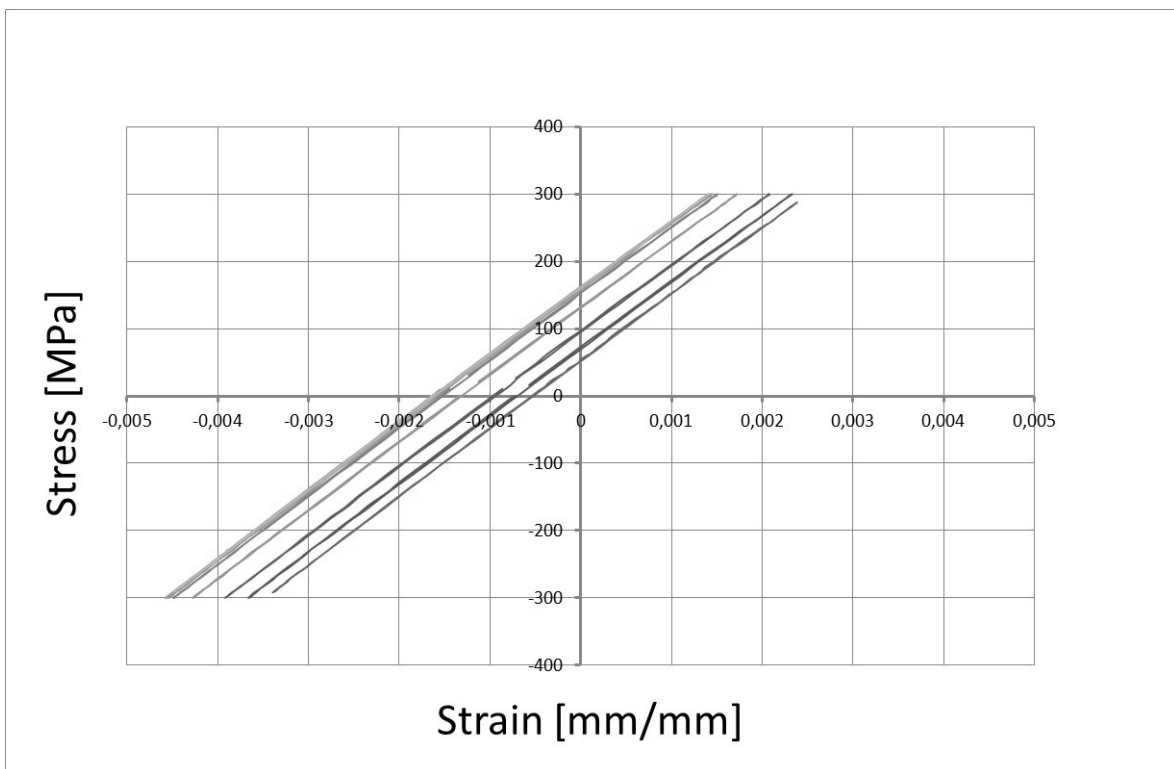
Figure 5. Hysteresis loops for AA2124+17%SiC (specimen 17_xe_zm_7) 503 – 5 000 cycles

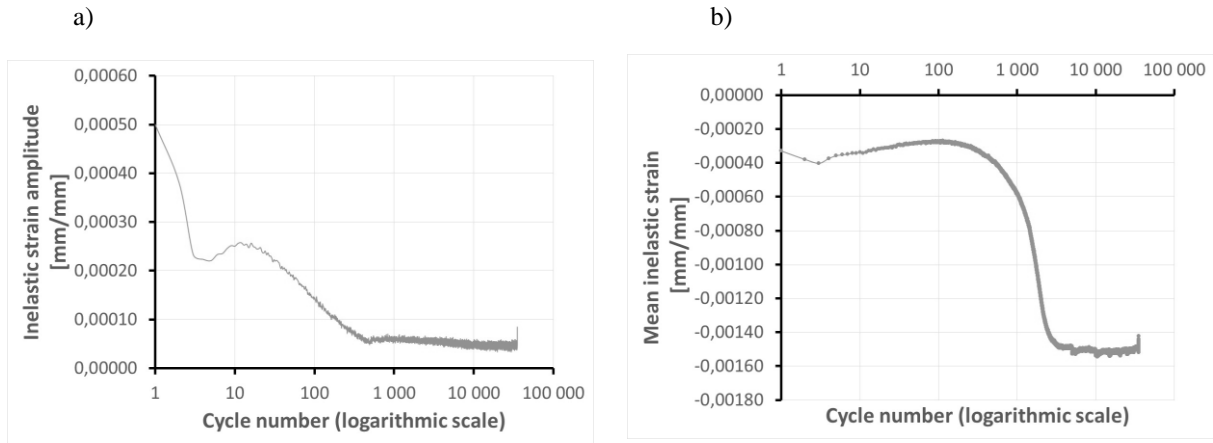
Figure 6. a) Inelastic strain amplitude (logarithmic scale) for AA2124+17%SiC (specimen 17_xe_zm_7); b) Mean inelastic strain (logarithmic scale) for AA2124+17%SiC (specimen 17_xe_zm_7)

Shakedown effect was observed during first cycles. Initial voids and cracks were closing until 10 000 cycles. Afterwards inelastic strain amplitude stabilized, while mean inelastic strain increased slightly until fracture. It can be explain by creating of new fatigue defects. Thus, the fatigue damage process was dominated by ratcheting effect.

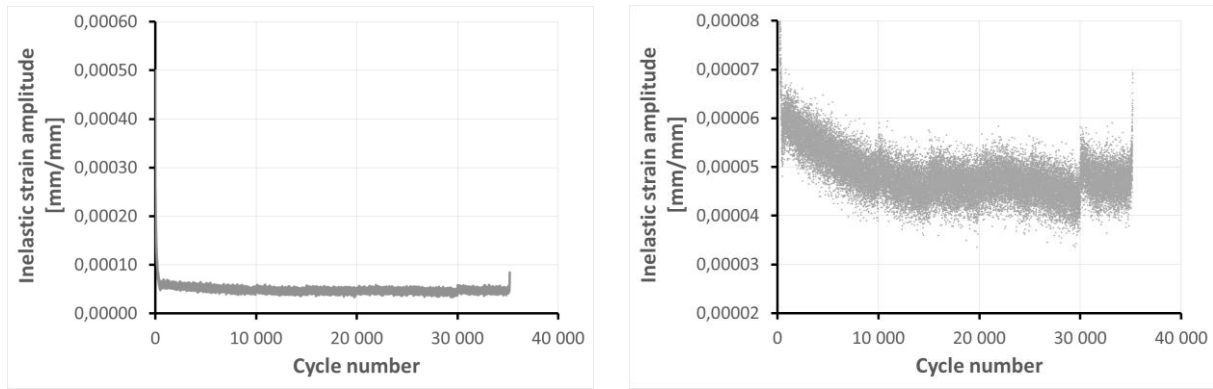
Figure 7. Inelastic strain amplitude for AA2124+17%SiC (specimen 17_xe_zm_7)

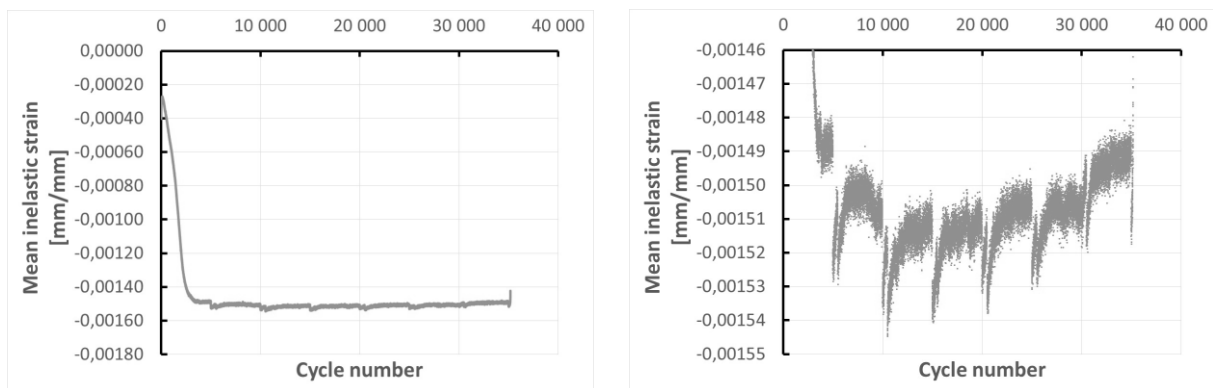
Figure 8. Mean inelastic strain for AA2124+17%SiC (specimen 17_xe_zm_7)

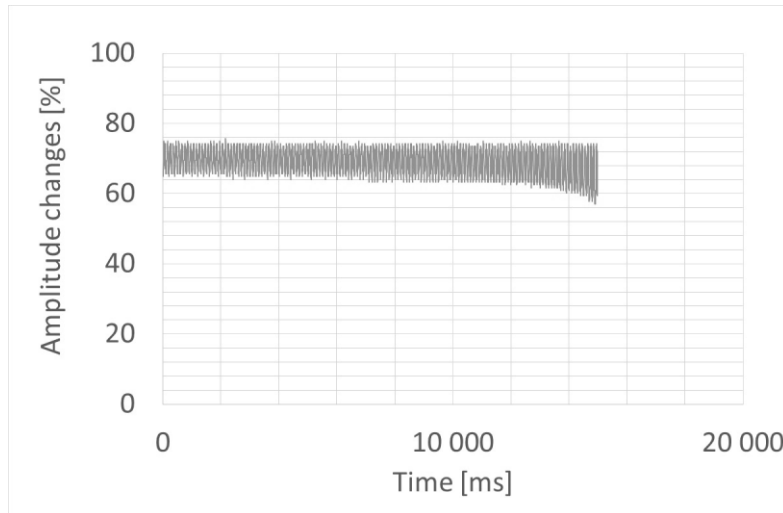
Figure 9. Amplitude changes of longitudinal ultrasonic pulse in AA2124+17%SiC (specimen 17_xe_zm_7) during last 15 s of specimen fatigue life

Ultrasonic measurements during fatigue tests were carried out. Amplitude and time of flight of longitudinal and Rayleigh wave pulses were observed. Preliminary investigations showed decrease of longitudinal wave amplitude during fatigue process, which can signal damage evolution in specimen under fatigue conditions. Further investigations were performed to verify the results obtained. Unfortunately, the longitudinal wave amplitude did not change during subsequent cycles. But the amplitude changes of longitudinal waves during last cycles were observed (Fig. 9). Increase of attenuation was noticed in the last seconds of specimen fatigue life.
