EXPERIMENTAL STUDY OF IMPACT DAMAGE RESISTANCE AND TOLERANCE OF E-GLASS/EPOXY SKINNED SANDWICH PANELS

P. Nash^a, G. Zhou^{a*} and S. Gahlay^b

^aDepartment of Aeronautical and Automotive Engineering, Loughborough University, Loughborough, Leicestershire LE11 3TU, UK

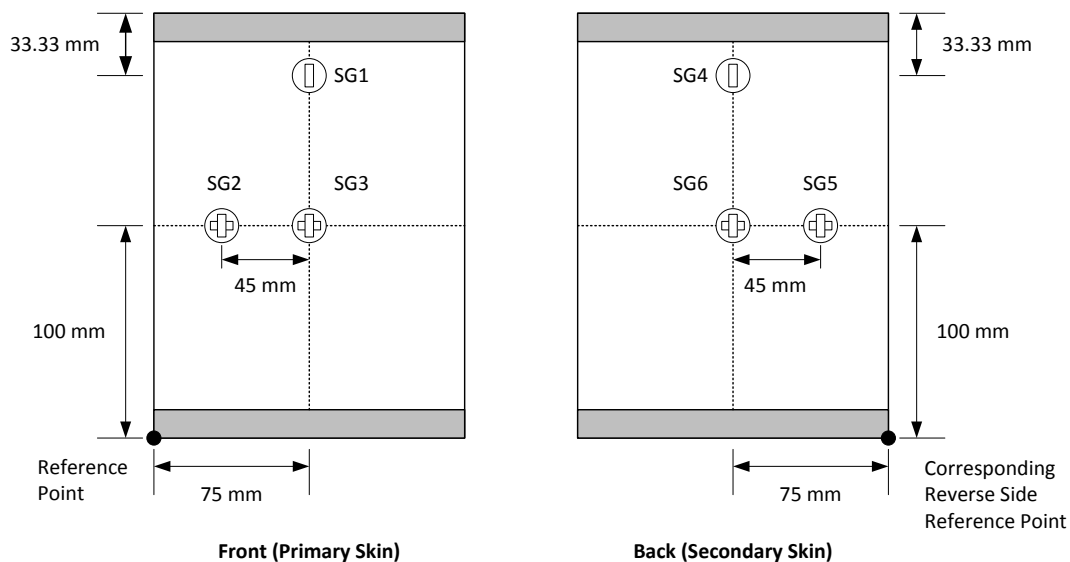
Figure 1. In-plane compressive panel showing specimen dimensions and strain gauge locations

The cross-ply E-glass/epoxy skins of 300×300 mm with two different thicknesses were made with a UD prepreg of PPG1062/LTM26 in a lay-up of (0/90)_{2s} and (0/90)_{4s}, respectively. They were cured in an autoclave at 60°C under a pressure of 0.62 MPa (90 psi) for 6 hours. A 12.7 mm thick 5052 aluminium honeycomb core with a density of 70 kg/m³ was used. The 0° direction of glass fibres within the skins was aligned with the ribbon direction of core. Each skin was separately bonded to the core in an oven at 60°C for 6 hours under a pressure of 0.1 MPa (15 psi) with VTA260 adhesive. The sandwich panel was then cut into two nominal 200 mm×150 mm specimens with the longer side aligned with the direction of compressive loading. All sandwich panels had their ends potted in epoxy and machined to enhance initial contact with patens of testing machine. Back-to-back strain gauges were then bonded on the panel surfaces at selected locations in both the longitudinal and transverse directions (see Fig. 1) to monitor global and local strains.

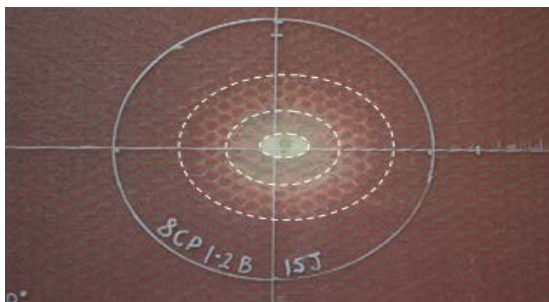
Figure 4. Damage mechanisms in an 8/8 CP E/glass skinned sandwich panel impacted at 15J

Impact damage inflicted in the E-glass/epoxy panels was very evident due to the translucency of the skins without the need for destructive inspection. Fig. 4 shows an example of a surface image of a panel impacted at 15 J, in which two annular ringed areas surround the central circular area as indicated by the 3 dashed circles. The centrally circled area shows a uniform creamy colour without a visibility of honeycomb cells underneath. It indicates a mix of delamination in the impacted skin, debond and core crush. In the immediate annular ring,

although the skin and honeycomb cells are still visually separable, the walls of individual honeycomb cells underneath became much thickened, suggesting a limited crushing of those cells in the immediate bonding region with the skin. This forms a clear contrast with the outer annular ring, in which open cell spaces are clearly separated from the slightly blunted cell walls. Towards the dashed circular line, the cell walls became much less visible, as from there outwards they remain pretty much intact. This affected area is in a shape of a depressed dent in the impacted skin as shown in Fig. 5. Several panels impacted at various levels of IKEs were cut up with the respective extents of crushed core and skin delamination measured. A cross section of one cut up panel, impacted at 18 J, as shown in Fig. 6 confirms a mix of a single delamination, debonds and crushed core. Core crush extent can be seen to be extending much beyond the delamination extent. In all impacted panels, their respective bottom skins remain undamaged, though those impacted at the higher end of impact energies show a shallow dome in addition to fibre fracture at impact location.

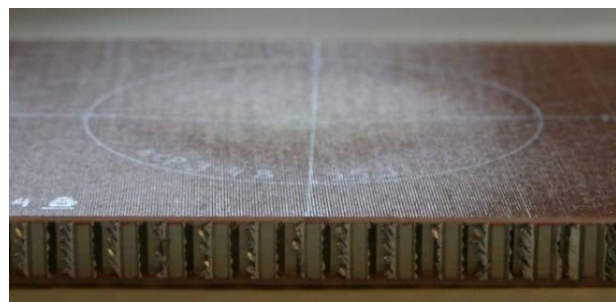
Figure 5. Dent depth in an 8/8 CP E-glass/epoxy skinned sandwich panel impacted at 25J

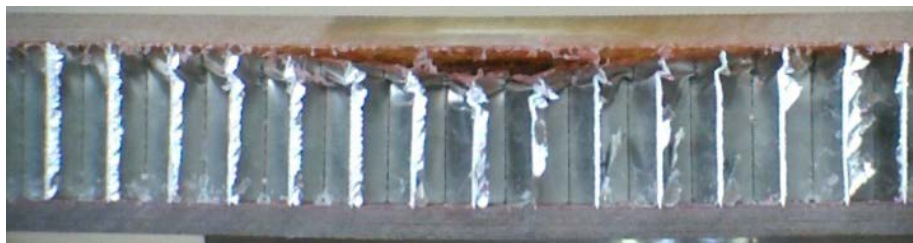
Figure 6. A cross section of a 16/16 CP E-glass/epoxy skinned sandwich panel impacted at 18J

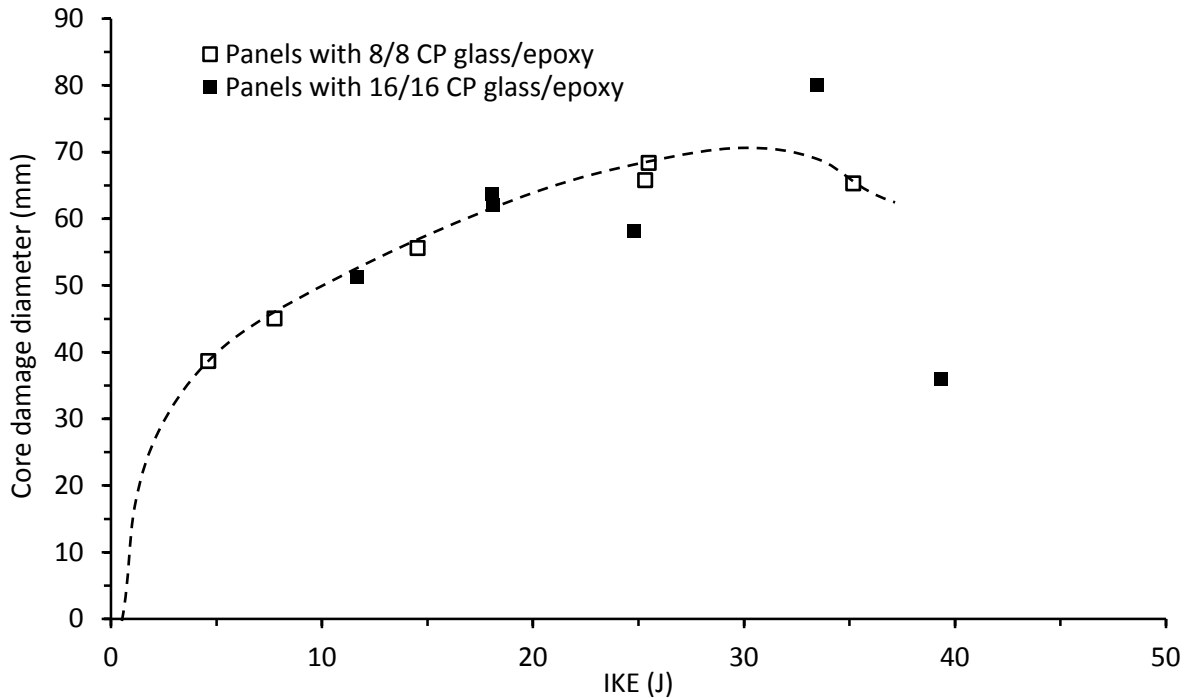
Figure 7. Core crush diameter vs IKE for E-glass/epoxy skinned sandwich panels

The four identified damage mechanisms of core crushing, skin delamination, skin fibre fracture and skin-core debond could occur both sequentially and in parallel, though in general the latter two occur after the first two at relatively high IKEs. Their respective initiation and propagation characterise the impact damage performance of these sandwich panels as shown in Figs 7-9 in terms of crushed core extent, delamination extent and dent depth against IKE. The 70 kg/m^3 core has the lowest resistance threshold and was easily crushed first. Their extrapolated crush thresholds shown in Fig. 7 were dependent on skin thickness. The thicker the skin was, the greater shielding it provided to the core. An initial sharp increase of the lateral extent of crushed core (as well as in the impact direction) leads to the promotion for the occurrence of delamination in the impacted skin shown in Fig. 8. Once the delamination started propagating, the rate of the lateral extent of crushed core decreased substantially. Moreover, the lateral extents of crushed core from both thin and thick skins became inseparable, suggesting an increased localisation after the occurrence of delamination. This localisation intensified when the extent of delamination quickly levelled off, indicating the significant increase of core crushing in the impact direction. This eventually led to fibre

fracture beyond 35 J for the thin sandwich panels, by which 95% of the IKE was absorbed. In addition, that the delamination extent in the 0° direction is marginally higher than in the 90° direction is expected, as the flexural rigidities in the former were fractionally greater than those of the latter. This resulted in an oblong shape of the delaminated area.

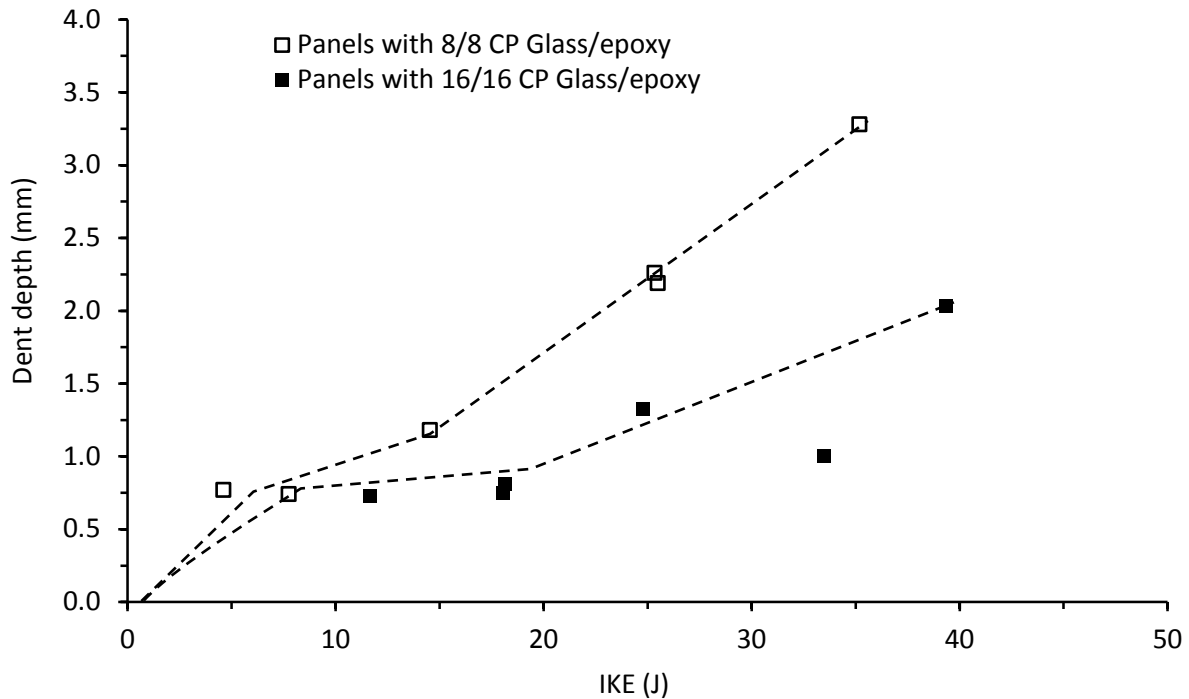
Figure 9. Dent depth vs IKE for E-glass/epoxy skinned sandwich panels

In sandwich panels, a residual dent depth generally indicates largely a degree of core crushing in the impact (or thickness) direction. Thus, the thicker the skin was for a given IKE, the less dent depth was obtained, as shown in Fig. 9. Contrary to the development of crushed core and delamination extents, the dent depths were smaller initially, less sensitive to skin thickness and started increasing with the increase of damage localisation. Naturally, the thin skin provided the less protection to the core underneath than the thick one and thus had much greater dent depth.

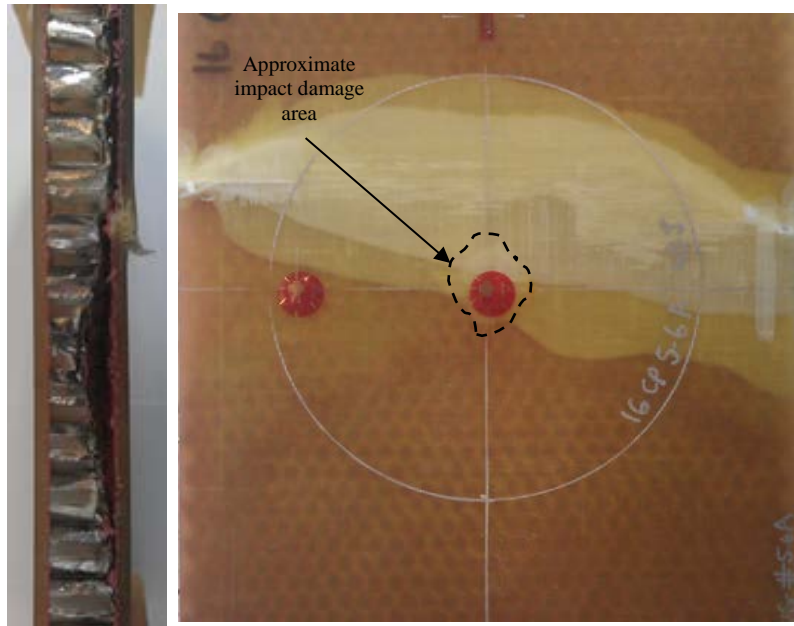
Figure 10. A side and front view of an impacted E-glass/epoxy skinned sandwich panel after CAI test

For the selected width-to-thickness and aspect ratios, intact or baseline E-glass/epoxy sandwich panels always failed prematurely close to one of ends, irrespective of panel thickness. This problem extended into the majority of the thick impact damaged panels, approving to be very ‘damage tolerant’. Their in-plane compressive strengths were clearly underestimated. Nevertheless, one of the thick panels that failed in the mid-section region is shown in Fig. 10. Due to the translucency, the original impact damage (enclosed by the dashed line) and its subsequent propagation during in-plane compression can be seen clearly. It appears that the impact induced delamination(s) in the central region could have instigated drastic local instabilities in the mid-section region, leading to the failure. The core crush pattern revealed at the unloaded edges shows the longitudinal sinusoidal mode of in-plane compressive failure, as similarly reported in [3]. Through the thickness fracture is also evident on the impacted skin along the transverse direction.

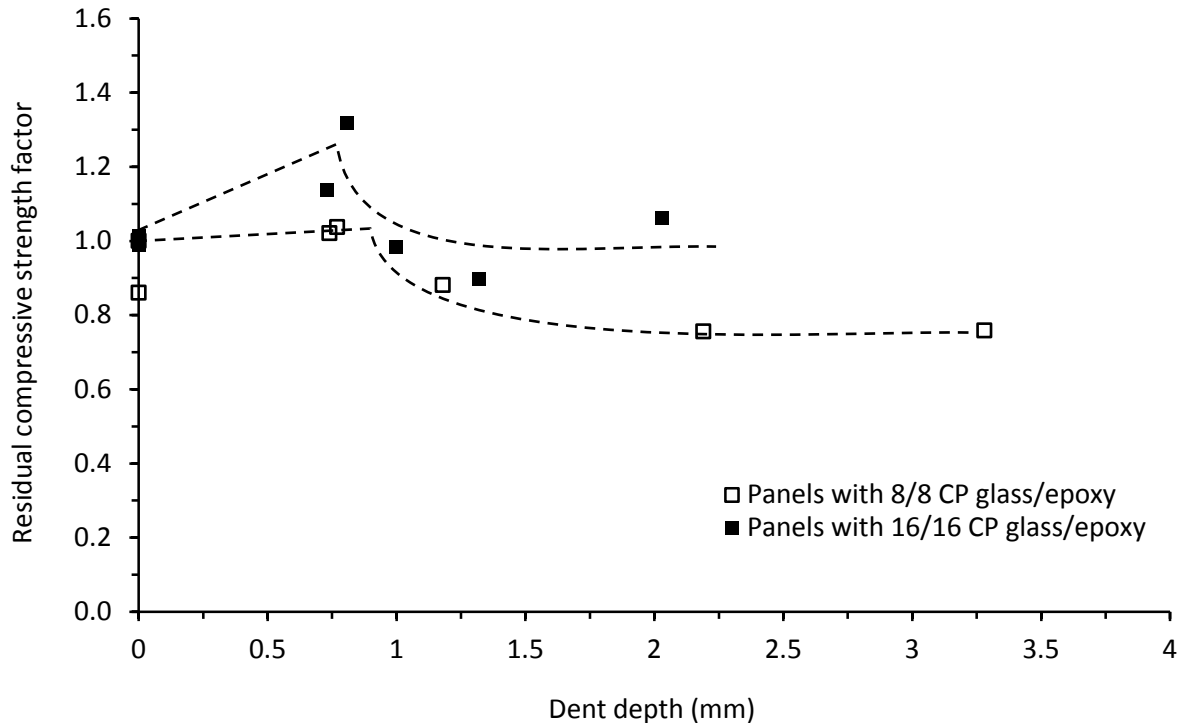
Figure 12. Residual compressive strength retention factor vs dent depth for E-glass/epoxy skinned sandwich panels

The conventional procedure of assessing impact damage tolerance requires the residual compressive strengths to be normalised with respect to an average baseline value, giving residual compressive strength factor. This is shown in Fig. 12 in terms of dent depth. It can be seen that these trends look similar to those shown in Fig. 11, suggesting that dent depth could

be a useful damage measure, as it combines both damage indication and reflection of local curvature. Nevertheless, the tolerance of impact damage could not be properly assessed, as both baseline and impact damaged panels did not fail in the similar way except for those two circled (in Fig. 11).
