DAMAGE ASSESSMENT OF IMPACT DAMAGES ON CFRP WITH LASER SHEAROGRAPHY

Raphael Schoen, Steinbichler Optotechnik GmbH, Neubeuern, 83115 Germany

Simon G. Pickering, University of Bath, Bath, BA2 7AY, UK

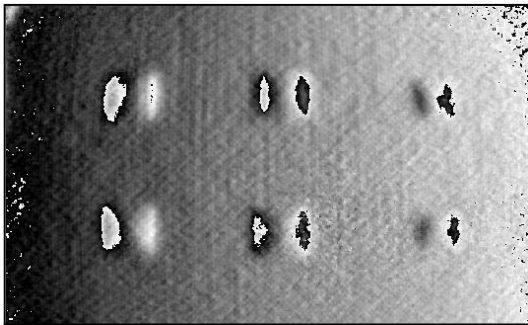
Figure 4. Exemplary image of six artificial defects in CFRP/ Honeycomb material with spatial 1st deviations of surface curvatures that indicate the flaws.
