INVESTIGATING DAMAGE RESISTANCE OF HYBRID COMPOSITE-METALLIC STRUCTURES USING MULTI-SCALE COMPUTED TOMOGRAPHY

Abstract

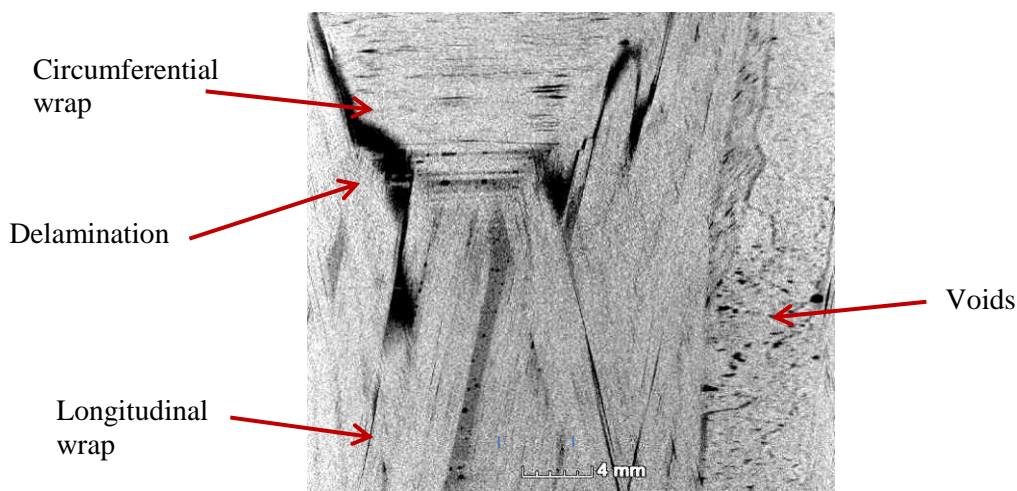
The scan of the impact site revealed substantial subsurface damage (Figure 1, Figure 2). A 3D visualisation of the impact site is presented in Figure 3. Several damage mechanisms are present in the CFRP layer. It is also clear from the scan data that plastic deformation of the metal layer has occurred. The maximum depth of this dent measured 0.75mm (Figure 2).

Figure 3 A 3D visualisation of the impact site with section cutouts. CFRP damage and voids are segmented in blue. The orange section is the dent in the metal layer

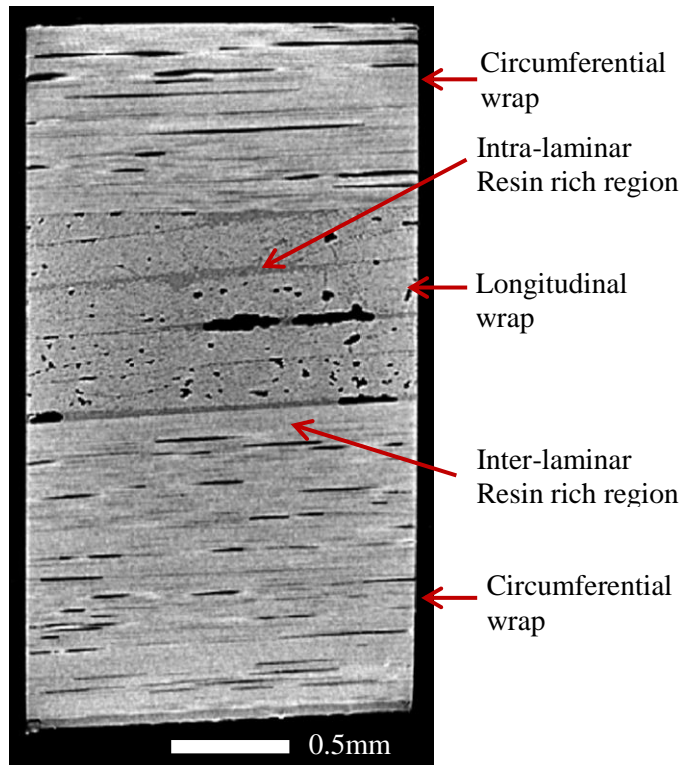
Scanning a reference sample from the same HCMS without the presence of impact damage enables quantification of the CFRP meso-structure. A 2D cross section of the reference matchstick sample reveals more detail as to the CFRP structure such as void content, void morphology and resin rich regions (Figure 5). Using the isosurface in-built tool in VGStudio max 2.1 the voids were segmented volumetrically and a void fraction, v_v , of ~3.5% was identified. At this resolution it is also possible to consider void morphology; two distinct geometries of voids are present in the CFRP (Figure 5). Long, thin voids that follow the fibre orientation within the plies are present in both the circumferential and longitudinally wrapped plies, forming in between fibres. More equi-axed, “globular” voids are also present; these have a tendency to occur either at ply boundaries or at the band overlap in the longitudinal layers. These locations are typically resin rich regions as highlighted in Figure 6.

Figure 5: Unimpacted reference sample slice perpendicular to the axis of the sample
