THE QUALITATIVE EFFECT OF VARIOUS PREFORMING RELATED DEFECTS WITHIN AS MOULDED PREPREG CARBON FIBRE LAMINATES

Richard Russell, Composite Manufacturing Engineer, Rolls-Royce Plc

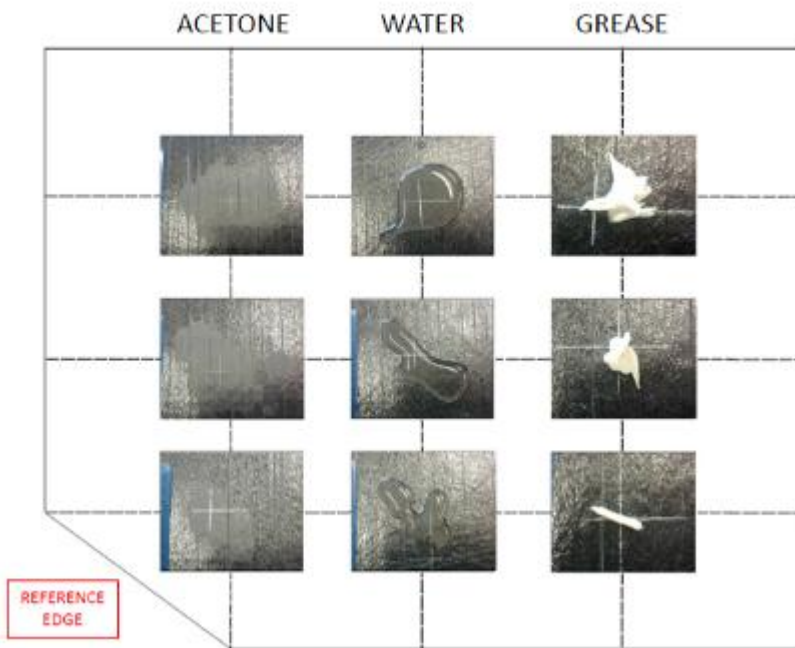
Figure 1. Defect / feature type identification and location in panel 1.

As expected, the addition of acetone to the preform caused significant delamination and absence of resin in between the affected plies. The images of the acetone damage in Figure 1 show the instantaneous damage of the uncured prepreg ply which corresponds well with the through thickness as moulded cross sectional damage and delamination in between plies as per Figure 4.
