FAILURE ANALYSIS OF IMPACT-DAMAGED / HYGROTHERMALLY AGED FIBER-REINFORCED POLYMER MATRIX COMPOSITE JOINTS SUBJECTED TO BEND LOADING

J. R. Tarpani^{a,*}, C. E. G. Castro^b, S. G. Pickering^c, D. P. Almond^c

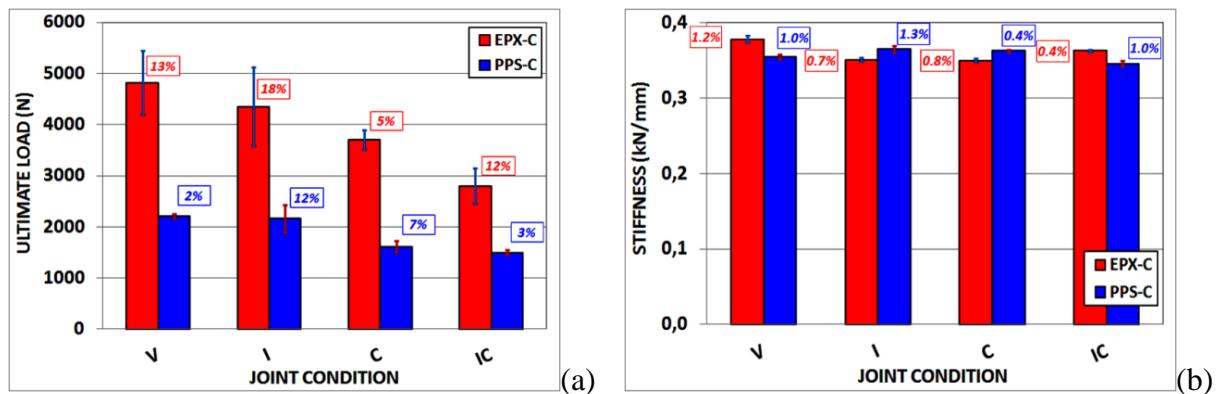
The bar graph in Figure 4a depicts the ultimate load reached in the 4PB test of the two types of joint, under the various conditions to which they were subjected. This figure shows the

mean values, their standard deviations and Pearson's coefficient of variation. Figure 4b illustrates the stiffness of the joints during the 4PB test.

Figure 4. Graphs of mean values, standard deviations and Pearson's coefficient of variation (inside boxes) of: (a) Ultimate Load (or Strength), and (b) Stiffness of the PPS-C and EPX-C joints 4PB tested in the conditions labeled V, I, C and IC.

Briefly, the main conclusions drawn from Figure 4a are:

As for Figure 4b, the most relevant observations are as follows:

ultimate load in 4PB of these two test coupons (Fig.4a) corroborates the macrofractographic analysis. In condition C, the test coupon shows exclusively debonding between metal mesh and composite laminate, and in the condition IC, failure is also caused by mesh/laminate debonding, but the central impact (red dashed circle) favors the spread of this mechanism from the center to the edges of the welded area. The very close values of ultimate load in the conditions C and IC (Fig.4a) substantiate the macrofractographic analysis.

Figure 6 shows that the failure modes of the bonded EPX-C joints can be classified as cohesive (demanding more energy), adhesive (less energy) and a combination of these two competing fracture mechanisms. In condition V (Fig.6a) the fracture was mainly cohesive in nature, while in the IC condition (Fig.6d) it was basically adhesive and clearly favored by the application of the impact prior to the hygrothermal conditioning treatment (magenta dashed box). In conditions I and C (Figs 6b and 6c, respectively), the failure mode varied between predominantly cohesive and predominantly adhesive, respectively. The ultimate load results in Figure 4a faithfully reflect this hierarchy between the failure modes depicted in Figure 6.
