LATE-STAGE FATIGUE DAMAGE IN A GLASS/EPOXY NON-CRIMP 3D ORTHOGONAL WOVEN FABRIC COMPOSITE

L Baiocchi^{a,b}, T F Capell^b, S A McDonald^c, S L Ogin^{b*}, P Potluri^c, M Quaresimin^a, P A Smith^b, P J Withers^c, A Bogdanovich^d

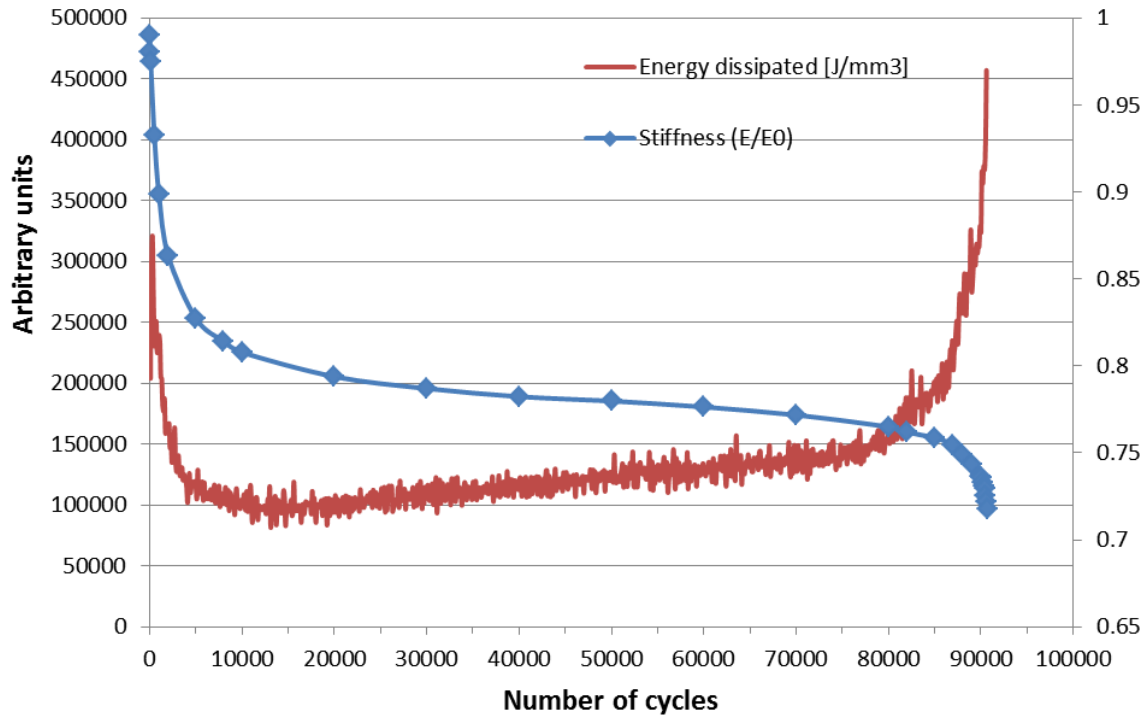
The stiffness reduction and energy dissipation show three distinct stages. In the first stage, rapid stiffness reduction, accompanied by high, but rapidly reducing, energy dissipation per cycle, is probably the consequence of rapidly accumulating matrix cracking. The crack density appears to saturate after about 15,000 cycles (for the specimen of Figure 3), leading into the second stage which shows a gradual loss of stiffness accompanied by slowly increasing energy dissipation per cycle. The third stage, leading to specimen ultimate failure, is characterized by a rapidly reducing stiffness accompanied by a large increase in energy dissipation per cycle. The beginning of the third stage was accompanied by audible fibre fractures.

Figure 3. Example of normalized stiffness reduction (right-hand side axis) and energy dissipation (left-hand side axis) with number of cycles for a specimen cycled with a maximum stress of 175 MPa.
