CRACK REPAIR OF STEEL VESSELS WITH BONDED COMPOSITE PATCHES – DAMAGE CONTROL WITH FBGS

Keywords: Repair, FBG, damage monitoring.

Abstract

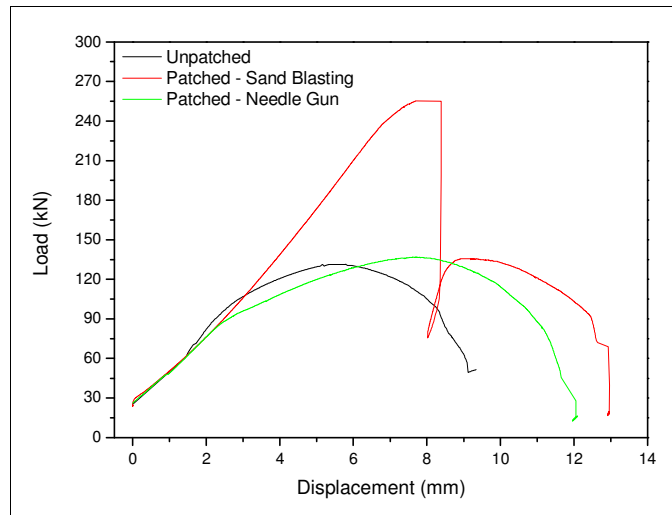
Figure 4. Elongation vs applied load.

Figure 4 is representative of the global behavior, showing the overall elongation as a function of the applied tensile load and Table 3 summarizes the failure values. The unpatched specimen exhibits a predictable behavior, with an initial linear elastic deformation to 76.5 kN, followed by entrance into plasticity to a maximum load value of 134 kN and finally crack opening occurs. These values match the theoretically calculated value using simple formulae of mechanics. Similar behavior has the patched-needle gun specimen which reflects a maximum load of 131.5 kN. However, the linear elastic response region of the patched-sand blasting is much bigger than the corresponding one of the unpatched specimen. This can be explained by the fact that, due to the presence of the patch, the steel substrate is loaded by lower stresses for the same applied load, thus it behaves elastically up to higher applied loads. In the sequence, failure of bonding between the patch and the steel plate is taking place at 258.5 kN, resulting in a sudden drop of the load carried by the specimen, since the patch is no longer carrying load and the plasticity of the steel occurs in this point as unpatched specimen.

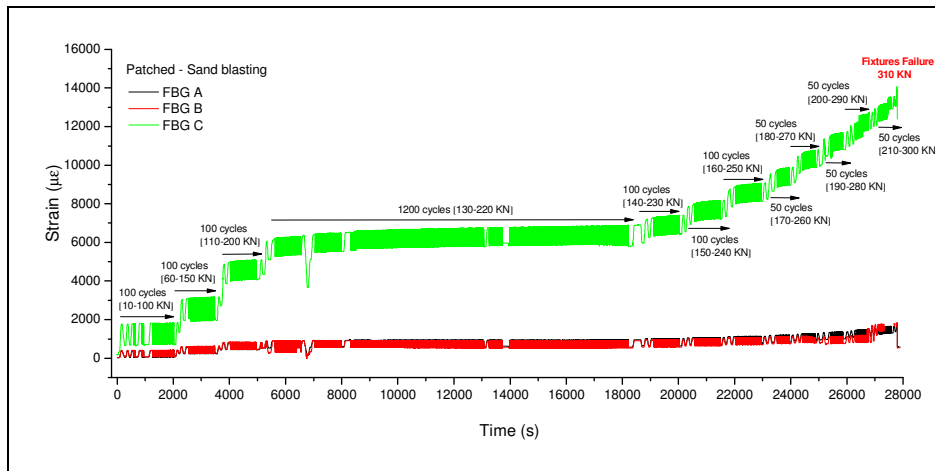
Figure 7. Strain values of FBGs during fatigue cycles of a patched-sand blasting.

The main objective of this test was to analyse the capability of FBGs to monitor patch debonding and crack opening. In the Figure 7 the cycles applied in a patched sand blasting specimen are shown. Increasing loading cycles show increasing strains, but at 310 kN the fixtures failure occurs before patch debonding. The most important information that can be

extracted from this test is the difference between strains below the patch (A and B) which are much lower than strains in steel side due to the effect of the composite patch. On the contrary, in a specimen patched-needle gun (Figure 8) the strains are similar in positions A, B and C up to 110 kN when patch debonding begin.

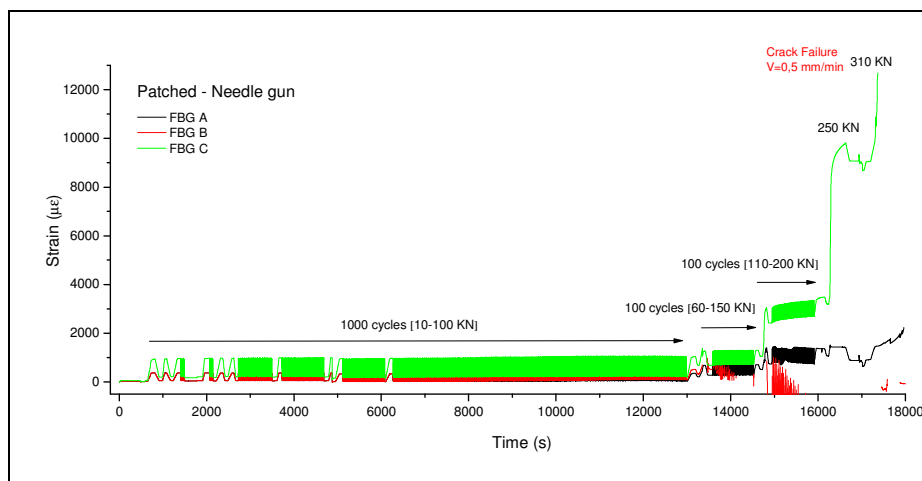
Figure 8. Strain values of FBGs during fatigue cycles of a patched-needle gun.

There is evidence that the patch in this case is not holding the crack. The crack opening occurs at 310 kN and the signals of FBGs were lost at this tensile load. In the Figure 9 the values of strain at the same loads and cycles are represented for unpatched and needle gun-patched.
