GROWTH OF DAMAGE IN ADDITIVELY MANUFACTURED METAL-COMPOSITE JOINTS

Abstract

The mechanical behaviour of a novel metallic-composite joining technology (HYPER) is investigated. Joints are strengthened with an array of pins built using additive layer manufacture. A new approach to pulse-echo ultrasonic evaluation was developed for this application in order to allow damage within joints to be monitored. It was found that the orientation of the specimen is critical due to the potential for the pins to scatter the incident ultrasonic wave. Damage was progressively induced within a batch of single lap HYPER coupons through repeated tensile loadings. The inspection methodology was successful at capturing the propagation of damage. It was found that the interface between adherends achieved a complete disbond without observable laminate damage or pin fracture. All pins then failed in a catastrophic manner due to excessive shear stress at their bases. Limit load was 21% higher than the ultimate load of a comparable unpinned joint. The ultimate load of the HYPER coupons was 650% higher than the same unpinned benchmark joint.

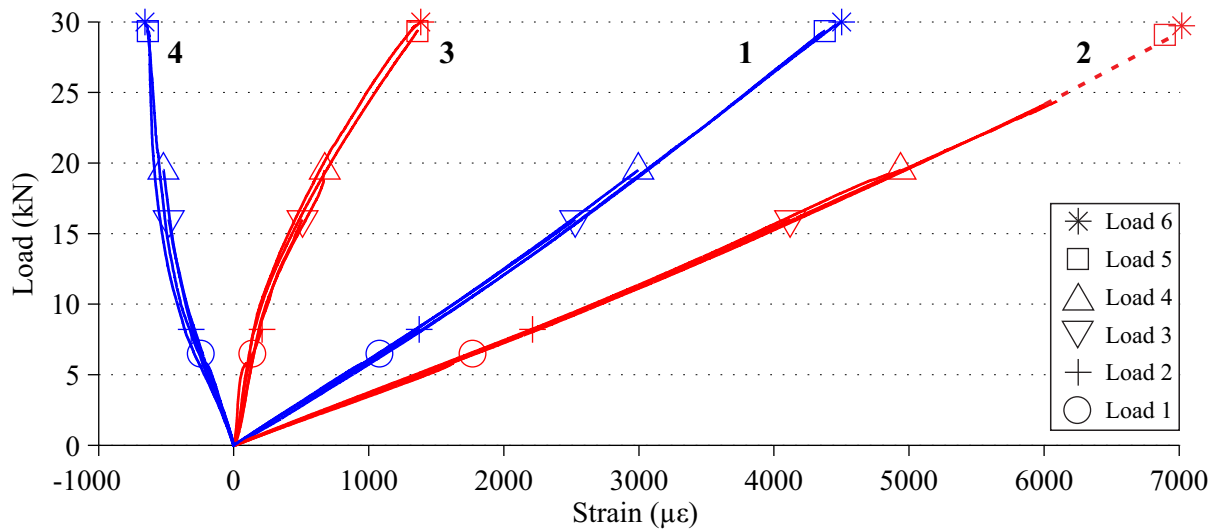
Figure 6. Recorded strains from gauges 1-4 for the six loadings of coupon ID13. Maximum force/strain for each loading shown with an individual marker. Dashed line shows extrapolation due to failure of SG2.

Coupon ID13 was loaded a total of six times before ultimate load was achieved. Figure 6 shows comparison of the loads/strains for each of these loadings. It can be seen that there was good correlation between consecutive loadings and variation resulting from the repeated setup procedure is considered to be negligible.

The non-linearity seen in Figure 6 was the result of the offset load path. This offset caused rotation of the overlap and subsequently, curvature was induced in the adherends - as depicted in Figure 5. This resulted in divergence of strain gauges 1+4 (Ti) and 2+3 (CFRP).
