## IMPACT TESTS AND SIMULATIONS FOR MULTIFUNCTIONAL MATERIALS

### Abstract

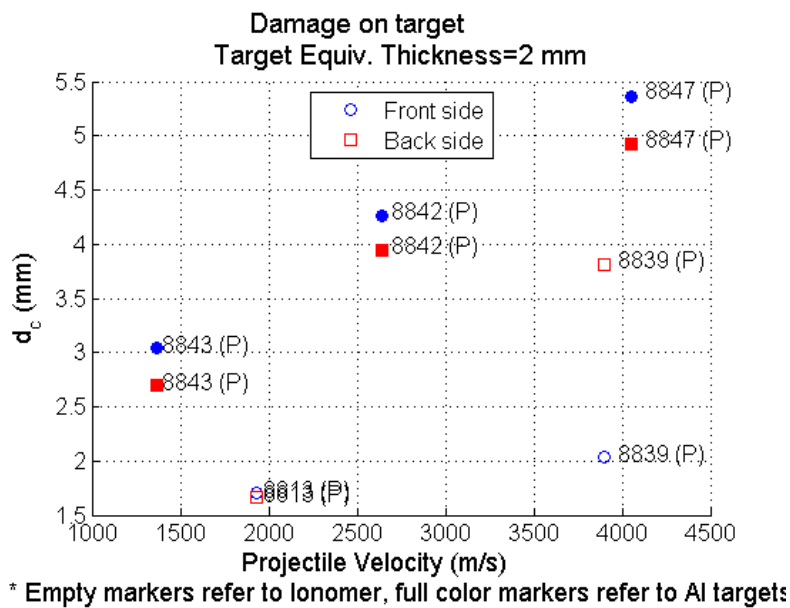
Figures 8, 9 and 10 report the crater/hole produced on target plates of equivalent thickness of 2 mm, 3 mm and 5 mm respectively, as function of impact velocity. Aluminum equivalent thickness is that obtained assuming the same local density as Surlyn 8940 density. Blue circles represent front side damage, red square represent back side damage; empty markers refer to impacts on ionomer target while full color markers refer to impacts on aluminum plates.

**Figure 8.** Target hole/crater diameter on front and rear shot side for tests on ionomer and aluminum plates with equivalent thickness of 2 mm as function of impact velocity.

Markers label reports the shot number and perforation or not perforation result (P/NP). Since it was not possible to analyse time evolution of ionomer healing process, it was not possible to distinguish between a not perforated target and a perforated-then-repaired one, so P/NP evaluation was performed by analysing the presence of craters on witness plate.

Comparing shots with same impact conditions and same target equivalent thickness it results that damage on ionomer after impact is smaller than that on aluminum. This seems to suggest that a partial healing process occurred, but this process completed only in the case of thick target and not high impact velocity. About witness plate damage, visual and first numerical analysis seem to confirm the results obtained with tests 8839 and 8847, as plates present more and smaller craters in the case of aluminum tests than in the case of ionomer test. Since good

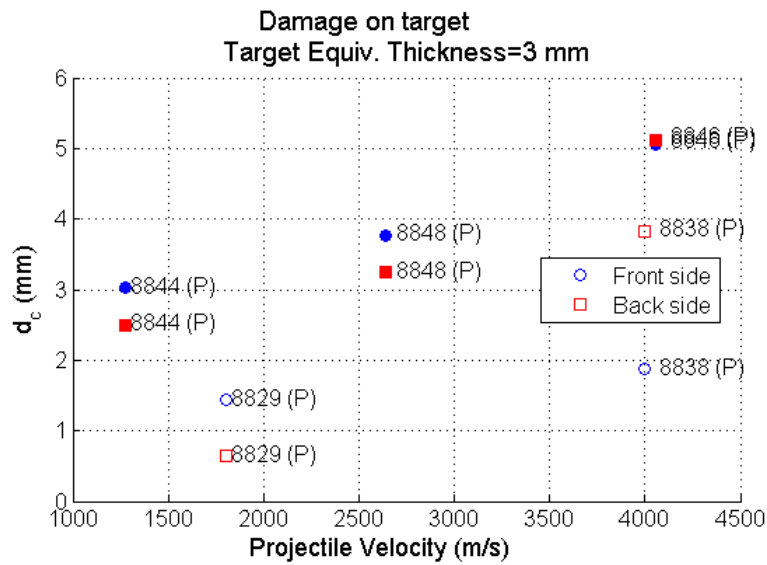
\* Empty markers refer to ionomer, full color markers refer to Al targets

Figure 9. Target hole/crater diameter on front and rear shot side for tests on ionomer and aluminum plates with equivalent thickness of 3 mm as function of impact velocity.

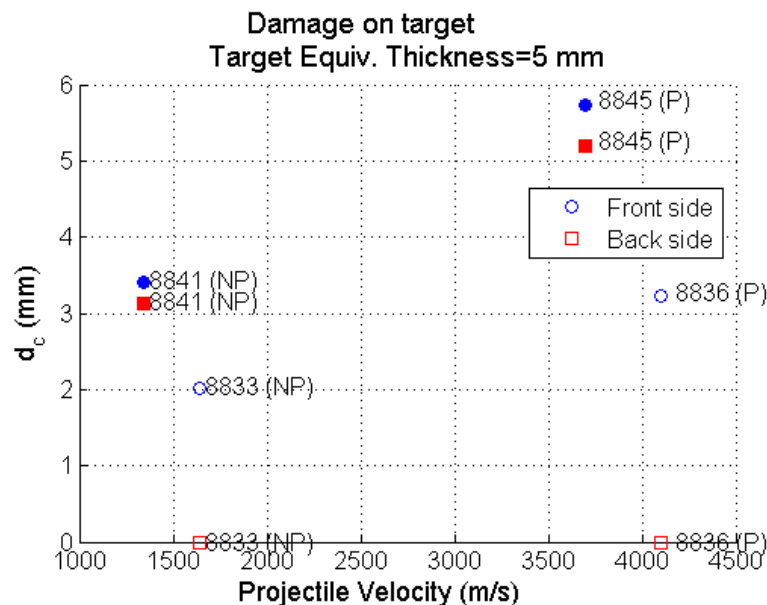
\* Empty markers refer to ionomer, full color markers refer to Al targets

Figure 10. Target hole/crater diameter on front and rear shot side for tests on ionomer and aluminum plates with equivalent thickness of 5 mm as function of impact velocity.
