## **INTEGRITY MONITORING OF COMPOSITE PATCH REPAIRS USING FIBER BRAGG GRATING SENSORS**

C S Shin and Yi-Chun Chen and Pei-Ying Chen

Department of Mechanical Engineering, National Taiwan University, No.1, Sec.4, Roosevelt Road, Taipei 10617, Republic of China E-mail: [csshin@ntu.edu.tw](mailto:csshin@ntu.edu.tw)

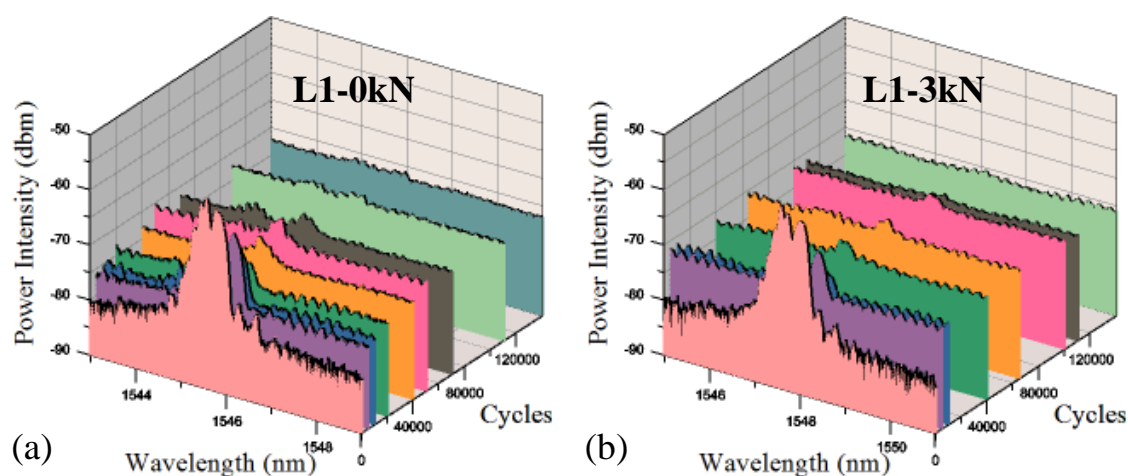
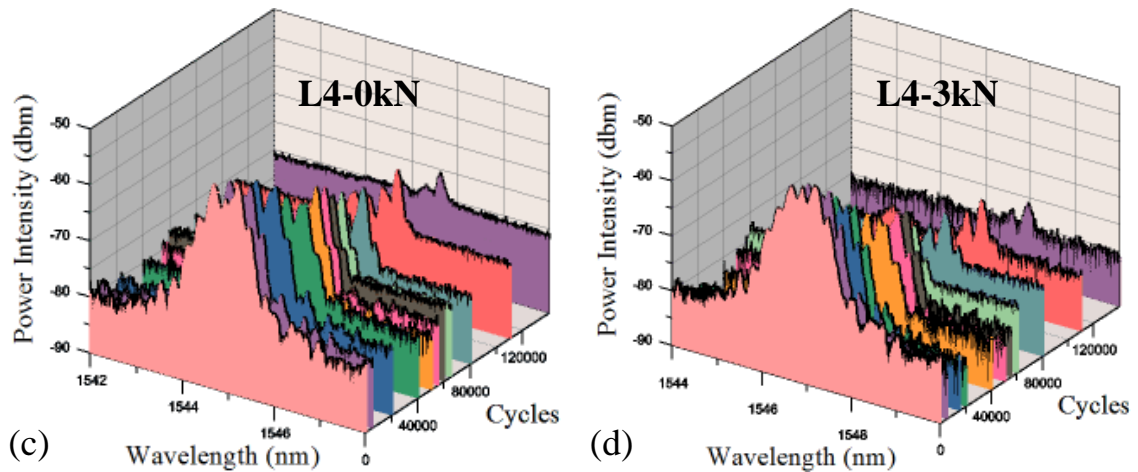
Fig. 4 Development of FBG spectra with fatigue loading cycles for: (a) L1 at 0 kN; (b) L1 at 3 kN; (c) L4 at 0 kN; (d) L4 at 3 kN.

Fig.4 shows the development of the spectra measured at 0kN and 3kN with the loading cycles. As loading cycle increases, the peak intensity gradually falls while the background intensity rises in both L1 and L4 spectra. Such development is more marked in the L1 spectra than that in the L4. Raising the loading from 0 kN to 3 kN not only shifts the spectra to the longer wavelength but also aggravates the above peak submerging phenomenon. By 40000 cycles, the peaks have practically disappeared under a loading of 3kN in the L1 spectra. C-scan results (Fig.5) show that at 50000 cycles after impact, the delaminated area has enlarged and extended to the edge of the specimen. If cyclic loading was continued, complete failure of the specimen would occur at ~140000cycles. In some specimens, test was interrupted to carry out patch repairing.

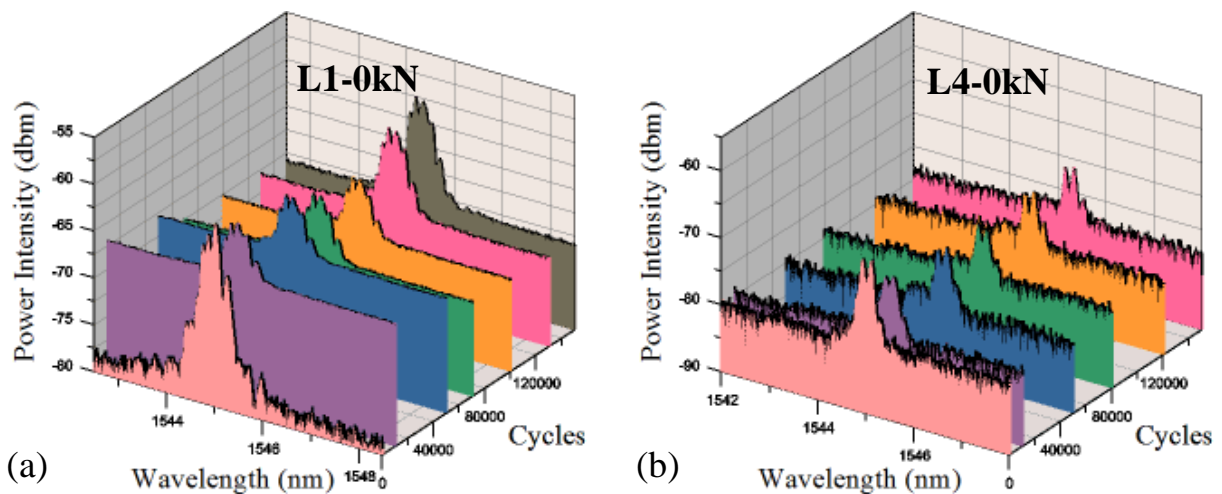
Fig.6 Development of the FBG spectra under 0 kN with fatigue cycling after patch repair from: (a) L1; (b) L4.

Just after curing of the repairing patch, the peaks in the FBG spectra have recovered significantly (Fig.6). However, on resumption of fatigue cycling, the background intensity quickly increased initially and then the whole spectra stabilized. Such a condition persisted to 150000 cycles while the specimen still remained intact, suggesting the internal impact damage has stopped growing. The spectra of the fiber sensors on the patch preserved a sharp narrow peak. The shift of these peak wavelengths with applied loading after different loading cycles are shown as series of curves in Fig.7 for each FBG. During the initial 10000 cycles, a marked vertical up-shift of the curves occurred, indicating a permanent extension of the specimen under cyclic loading shortly after repair. This up-shift slowed down and settled to a

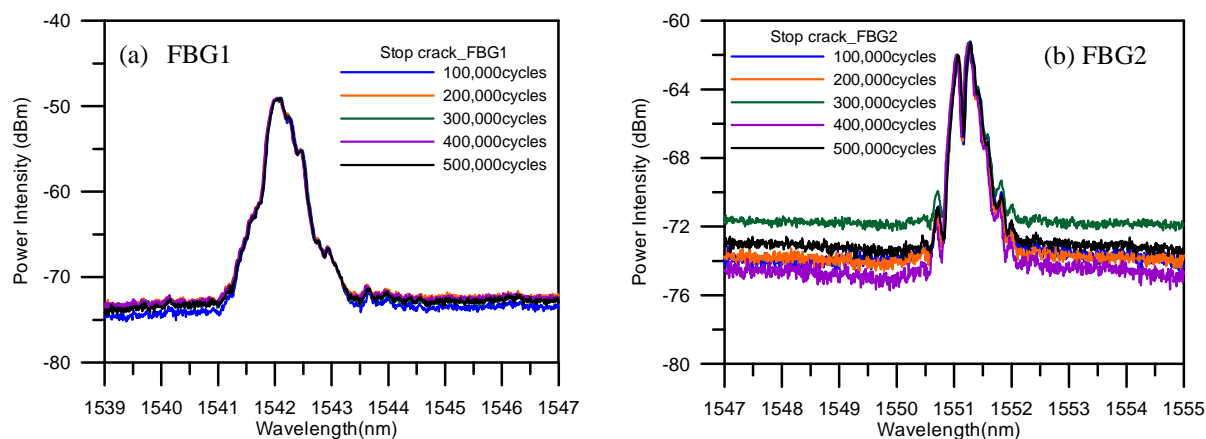
**Fig.9** Development of the FBG spectra from FBG embedded in the composite repairing patch when the crack has been arrested. (a) FBG1 was directly above the crack; (b) FBG2 is 1.5mm from the crack.

(Fig.9). Besides using the change in shape and wavelength of the spectra to monitor the development of a fatigue crack, the intensity of the highest peak in the spectra can also be employed. Fig.10a shows the peak intensity decreases continuously in a specimen when the fatigue crack is continuously growing. The initial sharper drop corresponds to a crack before patch repair. After repairing, crack growth rate decreased while the peak intensity showed a series of up and down. The spectra and peak intensity of the FBG embedded inside the patch is under the influence of both the residual stress in the patch and the underlying crack tip stress zone. The rise and fall in the peak intensity is attributable to the interaction between the crack tip field and the residual stress. When the crack has arrested, the peak intensity remained essentially constant (Fig.10b).

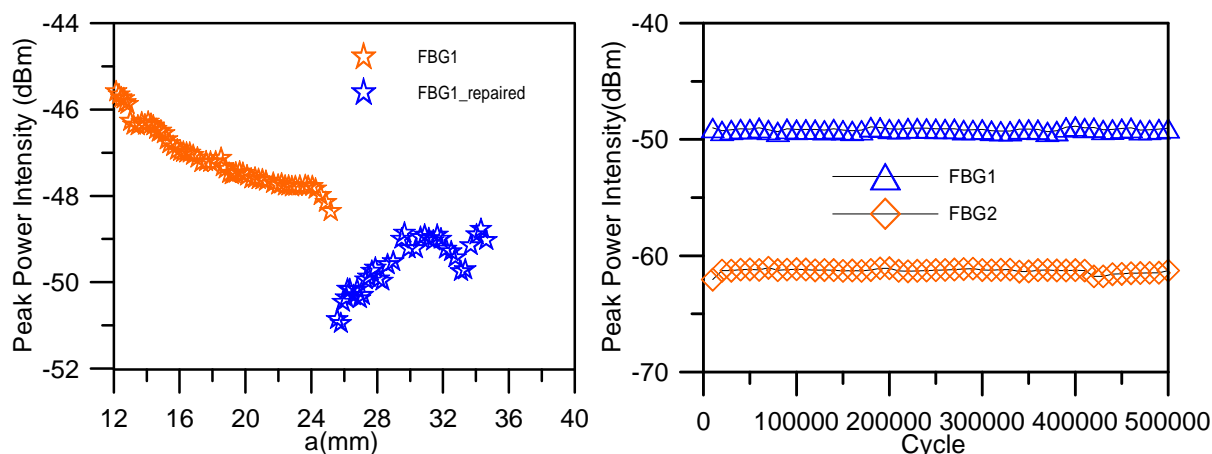
**Fig. 10** The change in peak intensity of the FBG spectra when (a) a continuously growing crack before and after repair; and (b) an arrested crack.
