## STUDY OF DOUBLE STEP LAP COMPOSITE REPAIRS ON CFRP EVALUATORS

*An innovative repair process and evaluation are proposed. Firstly, the originality of this work consists on the process used for the repair milling: an Abrasive Water-Jet milling. A double-step lap coupon is chosen to demonstrate the feasibility of the milling process. This specimen is made of M10.1/38%/UD300 CHS 460 from Hexcel Composites. After milling, the removed material is reconstructed laying up the same prepreg material with a one-ply shift in the stacking sequence. A Redux 609 adhesive film is used to ensure a correct bonding on the interface. Secondly, the originality concerns the mechanical characterization of the repair quality assessed through an innovative multi-axial mechanical test. It allows to choose multi-axial loadings according to the requirement. The selected test is a combined bending and compression test. Finally, results of mechanical tests are presented and discussed.*

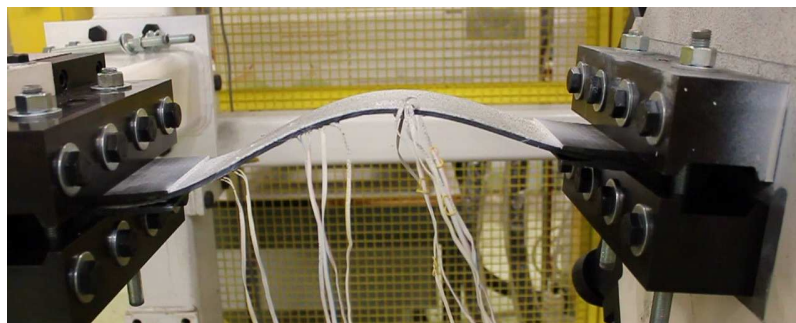
**Figure 8.** Deformed shape of repair evaluator just before final collapse.

Once the evaluators are equipped with the strain gages and the grips, they are tested in the multi-axial testing machine (See Fig. 8). Deformation shape and the global behavior are close to the predicted one by FE methods. Final loads are 10% higher than predicted. Nevertheless, the ultimate failure is far from the predicted one in terms of displacements: the repair plate breaks after a 20 mm compressive displacements, while the 2-D numerical simulation predicted 12 mm of compressive displacements.
