THE USE OF COMPOSITE MATERIALS TO REPAIR OF AIRCRAFT SEMI-MONOCOQUE AIRFRAMES

Keywords: repair, composites patch, semi-monocoque airframe, viscoelastic properties of composites

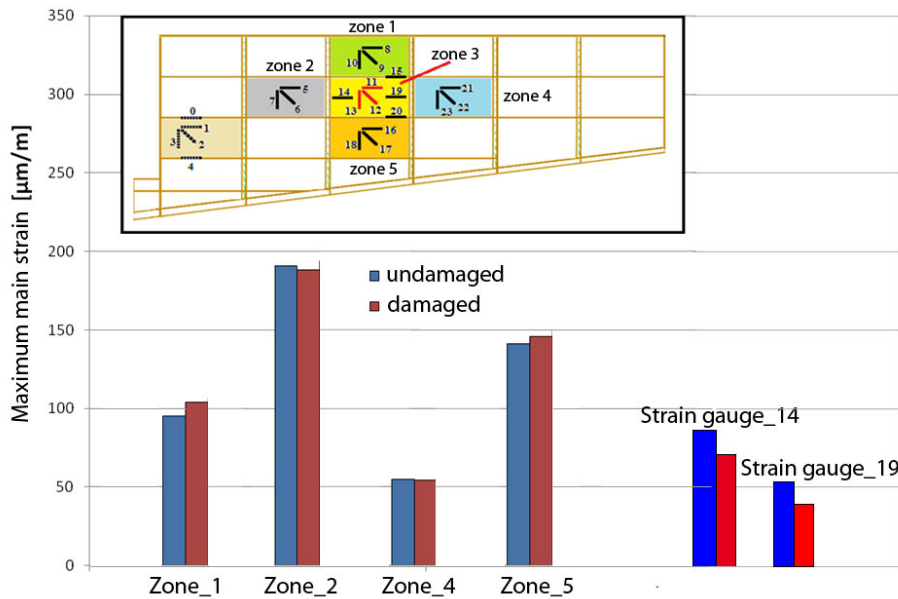
Fig. 7. Maximum main strain in the chosen zones of loaded construction

The results of performed tests showed that maximum main strain in the zones adjacent to damaged zone (outside the supporting elements) did not change significantly. A significant decrease in strain was registered in strain gauges no. 14 and 19 which were located in the damaged zone. The obtained results confirmed conclusions of the numerical calculations.

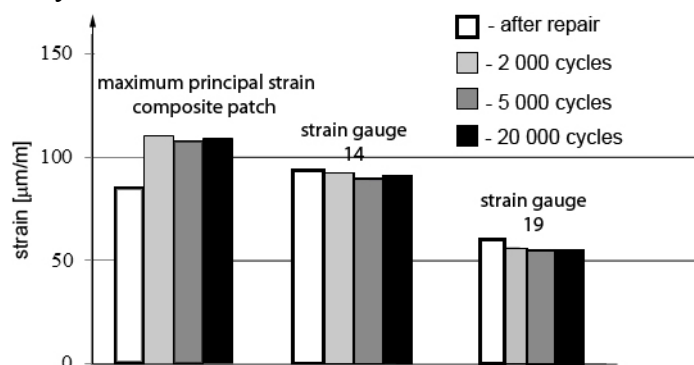
Fig. 9. Maximum main strain in the composite patch and in the adjacent area to repaired zone

was equal to 25 mm, as it was in static tests. 20 000 cycles were performed to analyze the strain changes in the repaired zone, particularly in the composite patch (strain gauges no. 11, 12 and 13) and in an adjacent area to repaired zone. The changes of main maximum strain during durability tests are presented in Fig. 9. There are presented strain changes after 2 000, 5 000 and 20 000 load cycles.

It can be assumed; based on the research included in the paper [5], that repaired zone damage of this type (including disbanding of metal insert) causes significant change of maximum main strain in a composite patch and in a repaired skin. Since this kind of phenomenon did not occur during the conducted tests, it can be assumed that the repaired zone was not damaged again during durability research.

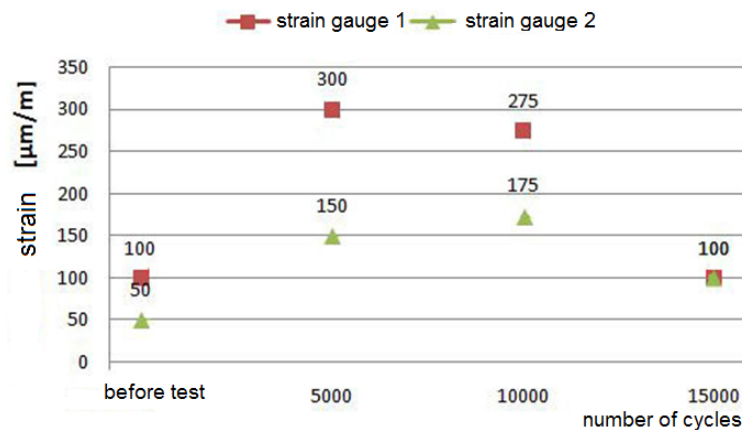
Fig. 13. The values of strain in repaired zone after 3x5 000 cycles of load (displacement 20 mm caused by force of 890 N)

The beam were subjected to cycling bending by shifting a hydraulic actuator down at the distance of 20 mm (it was achieved by load of 890 N). 15 000 cycles were performed during test in three stages of 5 000 cycles. The tested beam was off-load after each stage and strains in the composite patches were checked. The subsequent stages were executed at intervals. The first measurement of strain was performed directly after first stage (5 000 cycles) and the further measurements were conducted after 12 and 48 hours of interval. The results of test are presented in Fig. 13. The measured strains were returning to initial level with increasing interval between performance of measurement and completion of durability test. It seems to be connected with viscoelastic features of the applied composite patches.
