IMPACT DAMAGE AND SHEAR STRENGTH IN BONDED LAP JOINTS FOR REPAIR PURPOSES

Keywords: Bonded Joints, Composite Repair, Impact Damages

Abstract

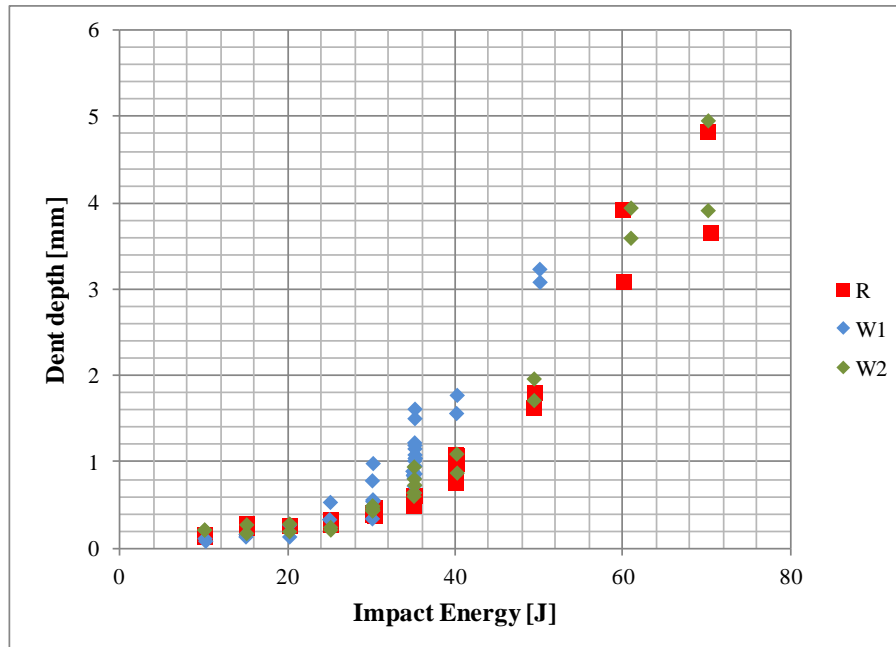
Figure 3. Calibration test results: Dent depth as a function of the impact energy.

Figure 3 shows the calibration test results for the repair prepreg R and the two wet lay-up materials W1 and W2, in terms of the dent depth as a function of the impact energy.

Figure 5 shows the average values of the dent depth for the three impact positions. For the four repair systems investigated, average dent depth values in positions X1 and X2 were comparable and also comparable to the ones in the calibration specimens with no bonded joint but the same total thickness (refer to Figure 3). However, the dent depth in position X3 was notably higher than the ones in positions X1 and X2.

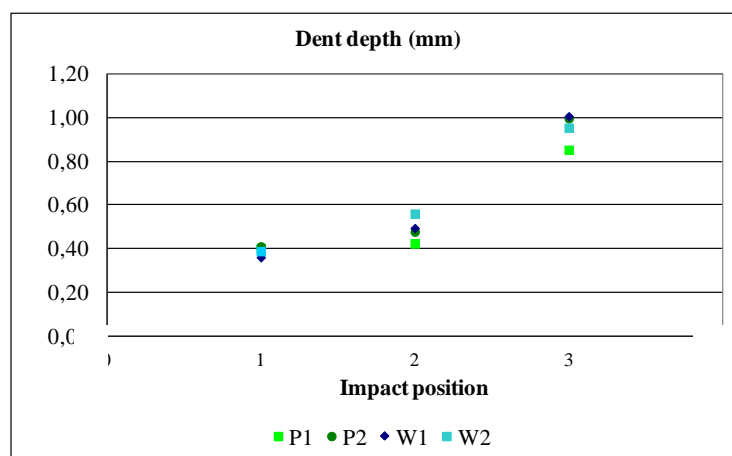
Figure 5. Dent depth as a function of the impact position in the single lap shear specimens.

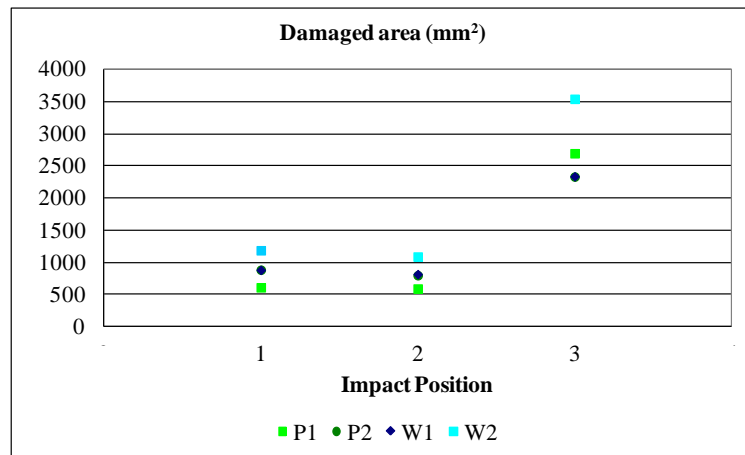
Figure 6. Damaged area as a function of the impact position in the single lap shear specimens.

The average values of the damaged area, obtained from the C-scan analysis of the impacted specimens, are shown in Figure 6 as a function of the impact position for the four repair systems. For the impacts in position X1, only the damaged area on the central overlap region was measured. Again, the damaged areas in the bonded specimens produced by the impacts in positions X1 and X2 were similar and comparable to the ones in the calibration specimens. In position X3, the damaged area was much bigger for the four types of bonded specimens, because this included not only the area where the laminates are damaged by also the debonded area in the overlap (refer to Figure 4).

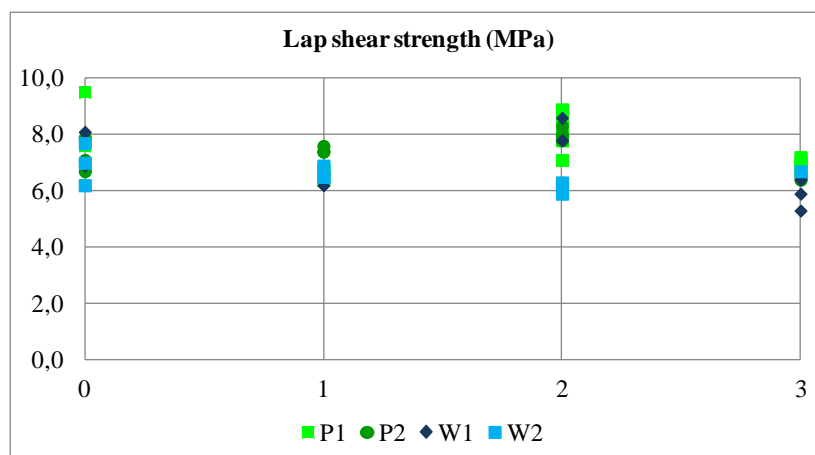
Figure 7. Lap shear strength as a function of the impact position. Reference samples with no impact are indicated as 0 in the graph.

Figure 7 shows the individual values of the ultimate shear strength for the four repair systems investigated and the three impact positions, together with the reference values from pristine specimens. Regardless of the impact position, the strength values in all specimens were similar and also similar to the ones of the reference specimens. A summary of the failure modes is presented in Table 1 together with representative photographs of failed specimens of type repair prepreg and adhesive film (either P1 or P2) and of type wet lay-up (either W1 or W2). Reference non-impacted specimens presented substrate failure by delamination between the plies combined in some cases with tensile ply failure. Specimens impacted on positions X1 and X3 presented net section tensile failure at the impact position in the load-carrying plates (pre-cured semi-specimen for X1 and co-bonded semi-specimen for X3). Finally, specimens impacted on position X2 (the center of the overlap area) presented substrate failure by delamination between the plies combined in some cases with tensile ply failure.

No significant differences were found in the ultimate strength of the single lap shear specimens impacted at 35 J with regards to the one of pristine specimens. Neither the impact position nor the type of repair system involved in the co-bonded specimens had an significant effect on the ultimate strength.
