SURFACE INTEGRITY OF MACHINED CFRP STRUCTURES

Keywords: CFRP, drilling, milling, surface integrity.

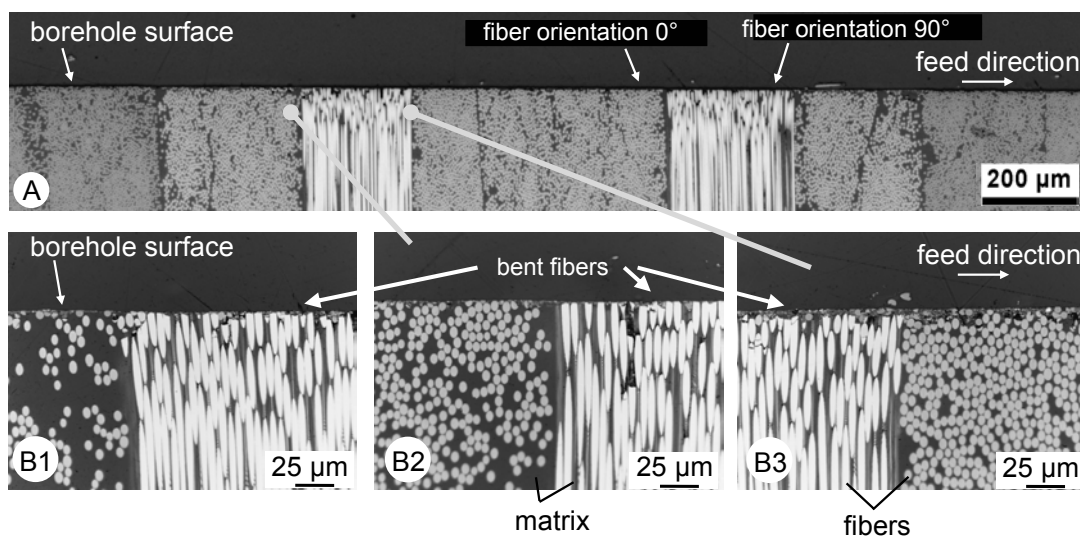
Figure 2a) shows a micrograph of the subsurface structure of a borehole in the CFRP material.

Figure 2. Micrographs of the subsurface structure of a borehole in multi-layered CFRP (cut at $v_c = 40$ m/min and $v_{fa} = 500$ mm/min)

The direction of the axial feed, i.e. the drilling direction, was from left to right and the cutting direction perpendicular to the view plane of the figure. Accordingly the multiple layers are aligned vertically. Layers with 0° fiber orientation show bright circular dots and layers with 90° fiber orientation bright vertical lines. Each layer has a thickness of about 250 microns and the diameter of the fibers is about 6 microns. The hole was drilled at a cutting speed v_c of 40 m/min and an axial feed v_{fa} of 500 mm/min which results in a feed per rotation of about 200 microns. For this condition the lowest temperature was measured ($T = 112.9^\circ\text{C}$) but the largest axial feed force ($F_a = 204.3\text{ N}$) (for further details see [7]). For the produced surface a sharp surface edge is characteristic. No noticeable damages can be detected, but near the surface the fibers with 0° orientation are bent in cutting direction (perpendicular to figure), which leads to the oval fiber cross-sections in this region.

In analogy to the observed fiber bending at the surface of the layers with 90° orientation (cf. figure 2), fiber bending was also observed in side milling of the slots. Figure 6 shows a micrograph of a cut specimen with 90° fiber orientation, which shows the bending of the fibers in cutting direction at the surface. These experiments were carried out at a cutting speed v_c of 200 m/min, a depth of cut a_e of 0.6 mm and a feed per tooth f_z of 100 microns/rev. In [8] and [9] a strain rate sensitivity of epoxy resin in tensile and shear loading is discussed which could provide the explanation for the observed fiber bending at larger feed rates.
