EVALUATION OF MACHINING DAMAGE AROUND DRILLED HOLES IN CFRPS USING MICRO-RAMAN SPECTROSCOPY

T. Miyake^{1*}, T. Tanaka¹, M. Ftamura²

¹Department of Mechanical and Systems Engineering, Gifu University, 1-1 Yanagido Gifu 501-1193, Japan

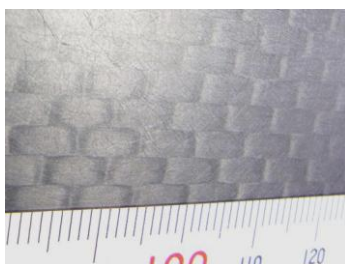
The composite materials used for the drilling tests were unidirectional carbon fiber/epoxy matrix ones fabricated using VaRTM molding, as shown in figure 1. The CFRP laminates were 1mm thick and have 60% cured fiber volume fraction. The fibers employed were high modulus PAN-based carbon fibers (M46JB-12K TORAY Ind. Inc.). After drilling under the condition as stated below, the composite panel was cut into strip specimens shown in figure 2 for micro-Raman measurement.

Figure 1. Unidirectional CFRP laminates.

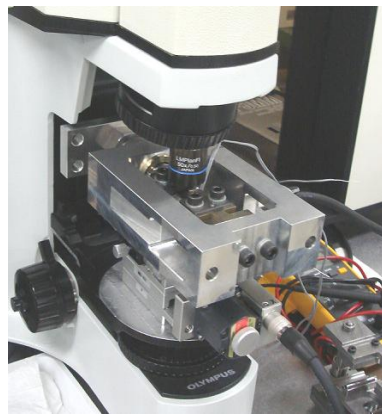
Stress measurement by micro-Raman spectroscopy was carried out for fibers around the drilled holes under tensile loading by mean of a rig which was mounted directly on the microscope stage in the Raman system, as shown in figure 5. Tensile stress was not induced in the fiber due to the presence of the drilled hole, and then the holes were filled again by epoxy resin to apply tensile stress for the Raman measurement.

Figure 5. Micro-Raman spectroscope with a custom-made loading rig.

Raman spectra were measured by a micro-Raman spectrometer system (LabRAM-300 Jobin Yvon), which was consisted of a 300mm polychromator. He-Ne laser light at a wavelength of 633nm was focused to a 1- μ m diameter spot on the fiber surface by an optical microscope lens at 100 \times magnification and the back-scattered light was collected by the same lens. The Raman spectroscopy measurement condition was listed at Table 2.

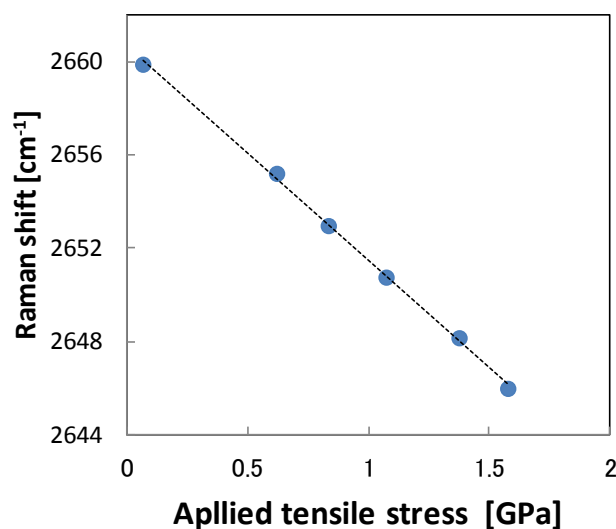
The Raman peak of wave number of 2700cm^{-1} , D'-band, was used to evaluate the fiber stress, because the other two peaks from the fiber, D-band (1350 cm^{-1}) and G-band(1580cm^{-1}), was found to be overlapped with the Raman peaks from the resin [5]. Figure 7 shows the dependence of peak wave number on applied stress, which was obtained from a stressed free-standing fiber. They are almost in a linear relation and fiber stress can be estimated from the peak wave number using the relation.

Figure 7. Dependence of D' band peak wave number on applied tensile stress.

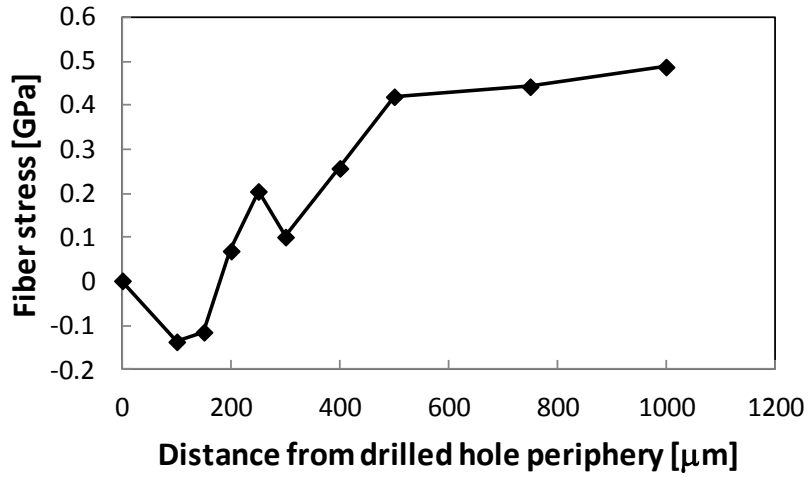
Figure 9. Stress distribution in the fiber located at 0° (up-cut direction) of drill-exit side.

Figure 9 showed the fiber stress distribution under tensile load at 0° of the drill-exit side. The shown result was one of the three measurements carried out. From the figure fiber stress was found to be zero at the edge and increase with the distance z from the edge up to almost the constant stress at $z > 500\mu\text{m}$. However, it was noticed that fiber stress was not almost caused at $0 < z < 150\mu\text{m}$.

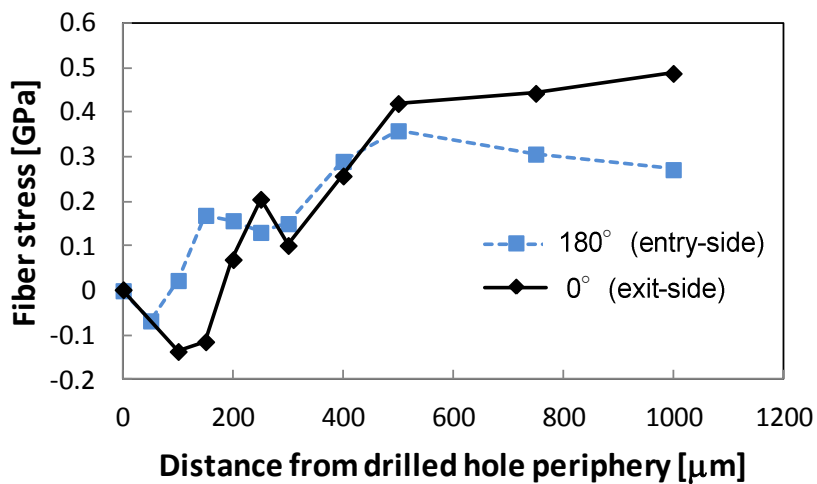
Figure 11. Comparison of Stress distribution in the fiber located at 0° (up-cut direction) of drill-exit side and at 180° (down-cut direction) of drill-entry side.

The former mentioned case (a) and (b) were performed using different specimens and the resultant settling stresses were different from each other. Compared with the both results in figure 11, almost the same stress build-up was seen in the region of $z > 250\text{-}300\mu\text{m}$. On the other hand, in the region of $50\mu\text{m} < z < 200\mu\text{m}$ the stress distributions considerably differed from each other. In the result of case (a), stress was not almost caused $z < 150\mu\text{m}$ and this resulted that the stress build-up in the case of (a) shifted about $100\mu\text{m}$ longer in the distance z compared to that of the case (b). From these results and the schematic model shown in figure 4, it was considered that perfect debonding about $100\mu\text{m}$ long was occurred at the fiber-matrix interface in the case (a). In case of (b) the debonding might occur in $z < 50\mu\text{m}$.

Because the case (a) and the case (b) were far different in location relative to the slope of drill bit flutes and the rotation of drill bit cutting-edges, fiber location was considered to be responsible for interfacial debonding.
