## DAMAGE BEHAVIOR OF CFRP LAMINATE WITH A FASTENER SUBJECTED TO SIMULATED LIGHTNING CURRENT

### Abstract

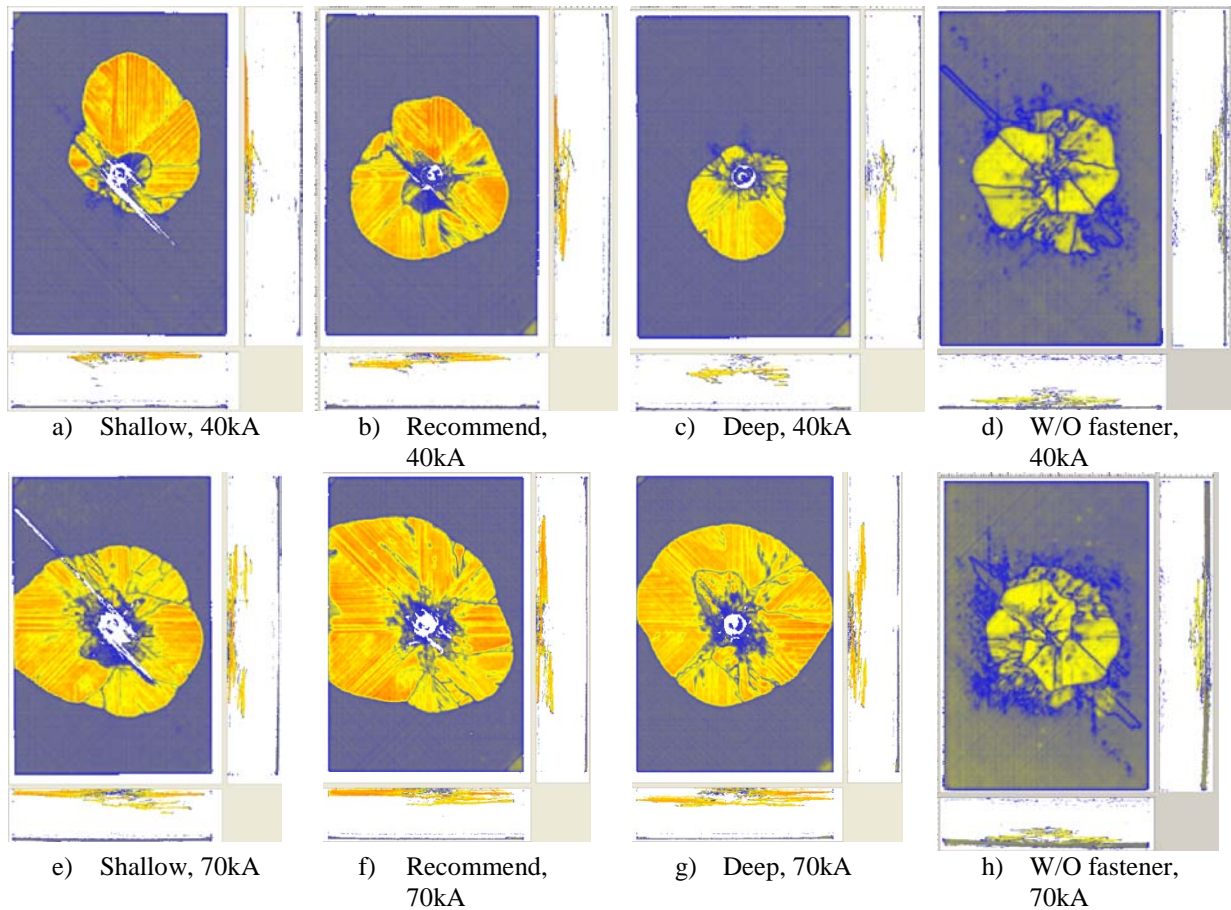
Figure 5. Typical C-scan images of post-lightning specimen

To analyze internal damage an ultrasonic flaw detector HIS3 produced by Krautkramer GmbH is used. Here, 3.5 MHz focusing ultrasonic transducers are used. The observed shapes of damage differ for different countersink types and the applied current intensity. Figure 5 shows an example of a c-scan obtained from post-lightning specimens. For comparison, ultrasonic testing result for the post-lightning specimen without fastener installation is shown in Figure 5 (d and (h).

In general it can be said though that the damage progresses outward from the fastener hole in radial direction. If there is large outer ply separation, the damage extending in that direction ( $+45^\circ$ ) is less than in the other directions. The delamination propagates in the shape of a pair of fans along the fiber direction starting from the fastener or the lightning attachment point in each interlayer. In some cases, the damage is neither equally large in all directions, nor symmetric with respect to the other side of the fastener. This trend can be observed only in fastener installed specimens.

Focusing on the B-scope result, it can be observed that the location of largest delamination is differ for different countersink types while internal damage area of the specimen without fastener installation is limited to the vicinity of the specimen surface of lightning attached side. Looking at the projected damage area as a function of the countersink depth (Figure. 7), shows that the recommended countersink depth is not the best from a damage area point of view; the deepest countersink has the smallest projected area for both 40kA and 70kA current intensity. Compared with the result of the specimen without fastener, it is understood that the result of all tested specimen with fastener install show large scatter in any countersink condition and current intensity.

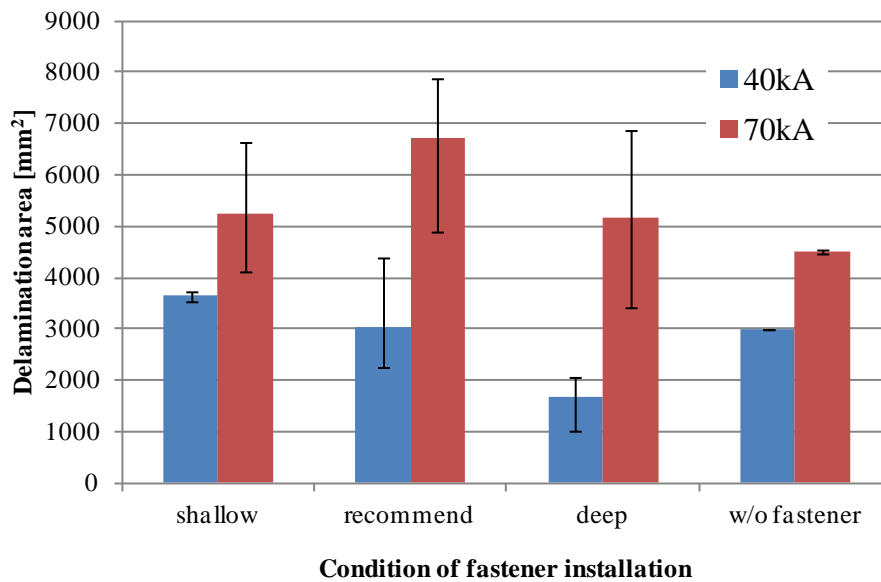
Figure 6. Projected damage area vs. countersink install condition.
