AN EXPERIMENTAL STUDY ON RAPID COMPOSITE REPAIR TECHNIQUES

Abstract

The scarf joint technique is one of the latest techniques used for repairing composite aircraft structures. But, this technique is mostly used at depot level repairing activities since it requires autoclave and other equipments. This paper focuses on scarf joint comprised of vacuum and autoclave precured and cocured composite patches bonded to autoclave and vacuum precured parent laminates. The tensile strength and ILSS decrease when the material has been exposed to moisture and tested at elevated temperature. But, no significant difference was reported for either tensile strength or ILSS. Therefore, repairs with vacuum precured or vacuum cocured patches requiring less equipment seems to be a serious potential alternative to the composite patch repair requiring autoclave conditions which might be only available at depot level maintenance centers.

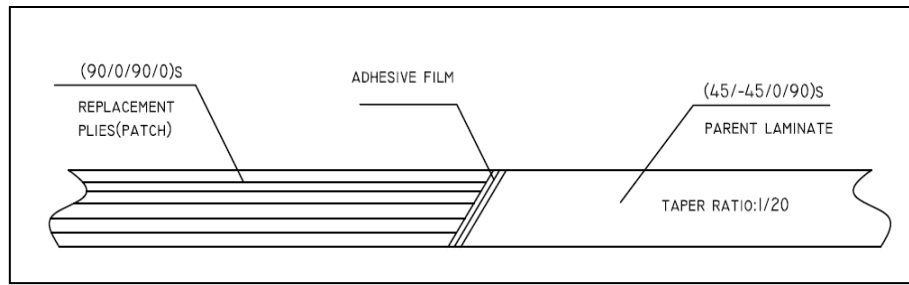
By contrast, a scarf repairing technique shown in Figure 1 seems to be more suitable for rapid repairing of composite structures since it does not require depot level capability instead it requires only a few simple hand tool, vacuum bag and heating blanket. As a general rule, the flush scarf repair has the following advantages over an external patch such as better strength, aerodynamic smoothness, weight, stiffness, appearances, durability [1-17].

Figure 1. Repair of a Flat Laminate with Single Scarf Technique

(FM 73) was used for both type of the patches, see Figure 1. The patches were easily fitted into the scarfed cut-out. The cocured patches always provided a flush and smooth repair surface after cure. Finally, the panels were machined into tensile specimens according to ASTM D3039, see Table 1.

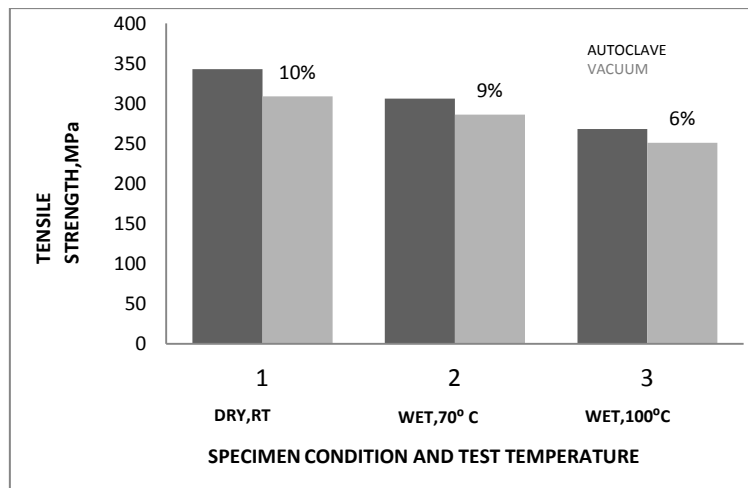
between the autoclave and vacuum cures of 9 % and 6 % at 70 °C and 100 °C respectively, see Figure 2. These differences were considered insignificant and they indicated that vacuum cured patches could be an alternative to autoclave cured patches for repair in the field level maintenance facility. It was also noted that moisture (wet) conditioned specimens showed a decrease in tensile strength of up to 8 % (from 343 MPa to 316 MPa) at a test temperature of 70 °C and up to 23 % (from 343 MPa to 268 MPa) at 100 °C for autoclave cured material. Similar results were also obtained for vacuum cured specimens. The maximum decrease in strength was about 23 %, which came from the effect of combining moisture, temperature and curing process, see Figure 3.

Figure 2. Effect of Curing Process on Tensile Strength

Considering the data obtained from the static tests of parent material performed at room temperature, 70 °C and 100 °C on dry and conditioned specimens for both autoclave and vacuum cure cycles, it can be seen that the average ultimate tensile strength (343 MPa) of dry specimens at R.T. for the autoclave cure is 10 % higher than the strength (309 MPa) of dry specimens at R.T. for the vacuum cure. The wet specimens had differences in tensile strength

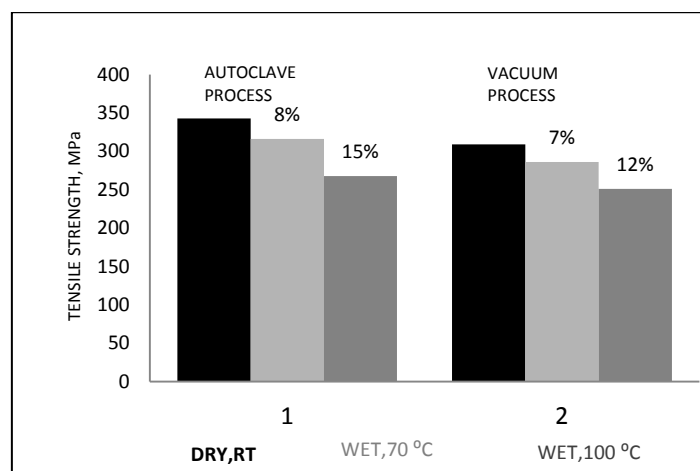
Figure 3. Effect of Moisture and Temperature on Tensile Strength
