BANANA AND ABACA REINFORCED POLYETHYLENE COMPOSITES MICROTENSILE VIDEO TESTS

This research focus on the characterization of banana and abaca reinforced composites obtained by rotomoulding. These composites were characterized by mechanical tests (tensile, flexural, impact and DMA), DSC and optical microscopy. This paper shows the results obtained when testing these composites with a microtensile tester, observing the failures method. Differences between both types of fiber have been observed, showing different compatibility of these fibers with the polymeric matrix; chemical treatments also influence the behavior observed at failure. Banana and treated abaca fibers break in the PE matrix, while pull-out effect was observed for abaca fiber.

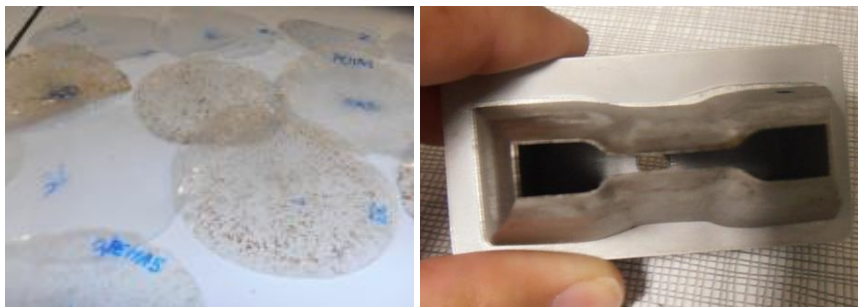
Figure 1. Films obtained from the rotomoulded parts (left); die used to obtain the test bars (right)

Films were prepared in a Gibitre instruments press, by placing the rotomoulded samples between two teflon papers and putting them at 140 °C for a few minutes; once the material was molten, the pressure cycle started: 200 bar for 2 seconds and 250 bar for 1,5 second. After cooling, films made with PE and fibers, as shown in figure 1 (left), were obtained; these films were cut by means of a die with the shape of a standardized test sample (as shown in figure 1, right).
