DAMAGE CONTROL WITHIN SKIN-STIFFENER DEBOND SPECIMENS UNDER FATIGUE CONDITIONS

R. Luterbacher*, R.S. Trask, I.P. Bond

Advanced Centre for Composite Innovation and Science (ACCIS), University of Bristol, Queen's Building, Bristol, BS8 1TR, United Kingdom

Abstract

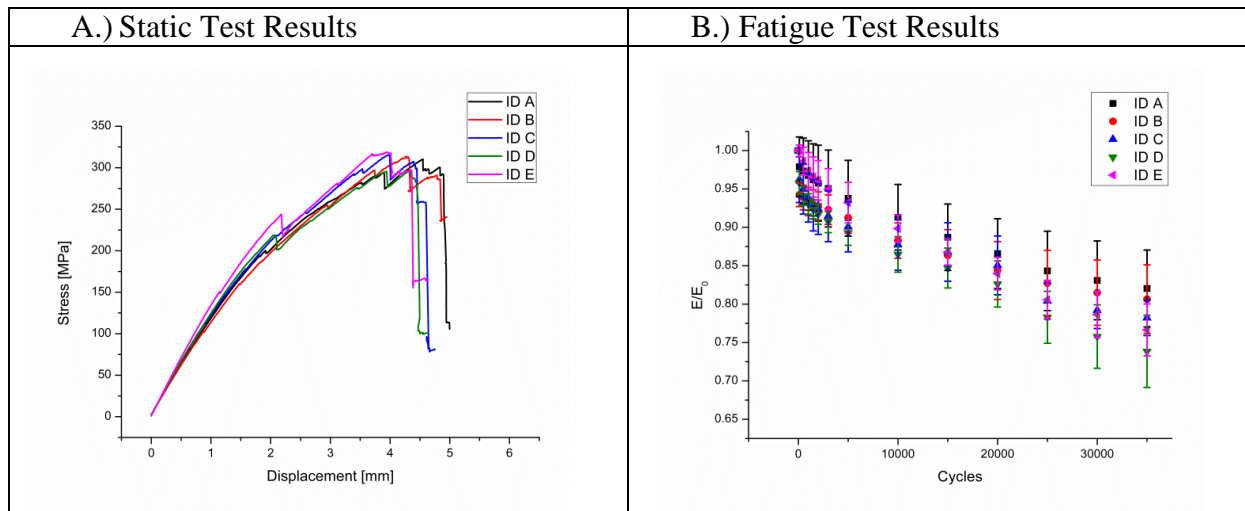
Figure 2 shows a typical tensile test curve and the stiffness as function of cycles for the different configurations.

Figure 2. Left: Typical static curve for each configuration. Stress referred to skin cross section. Right: Stiffness decay as function of cycles. Error bars correspond to one standard deviation.

after testing revealed that the delaminations were arrested at the vasculae. The introduction of the interleaves and the vasculae does not alter the overall mechanical performance (Figure 2 A). This is important for the design, since any modification to redirect and heal the damage, should not decrease the initial properties.

Fatigue tests were performed at approx. 40% of the ultimate tensile strength ($F_{\max}=10$ kN) for all specimens. Figure 2 B presents the mean values of the progressive stiffness loss as a function of cycles

Two different regimes can be distinguished in the stiffness decay: (1) a rapid decay during the first 1000 cycles is followed by (2) a nearly linear one.

The initial steep stiffness decay is due to the presence of resin pockets at the tip of the flange, where the damage is initiated. This damage propagates as delaminations which reduce the stiffness.

The stiffness decay in the different types of specimen is similar to that of the baseline, except for configuration D. In the case of configuration D, the specimens are nearly “unzipped” along the interfaces sIV (90/90) and sV(90/45) where the vasculae are present.

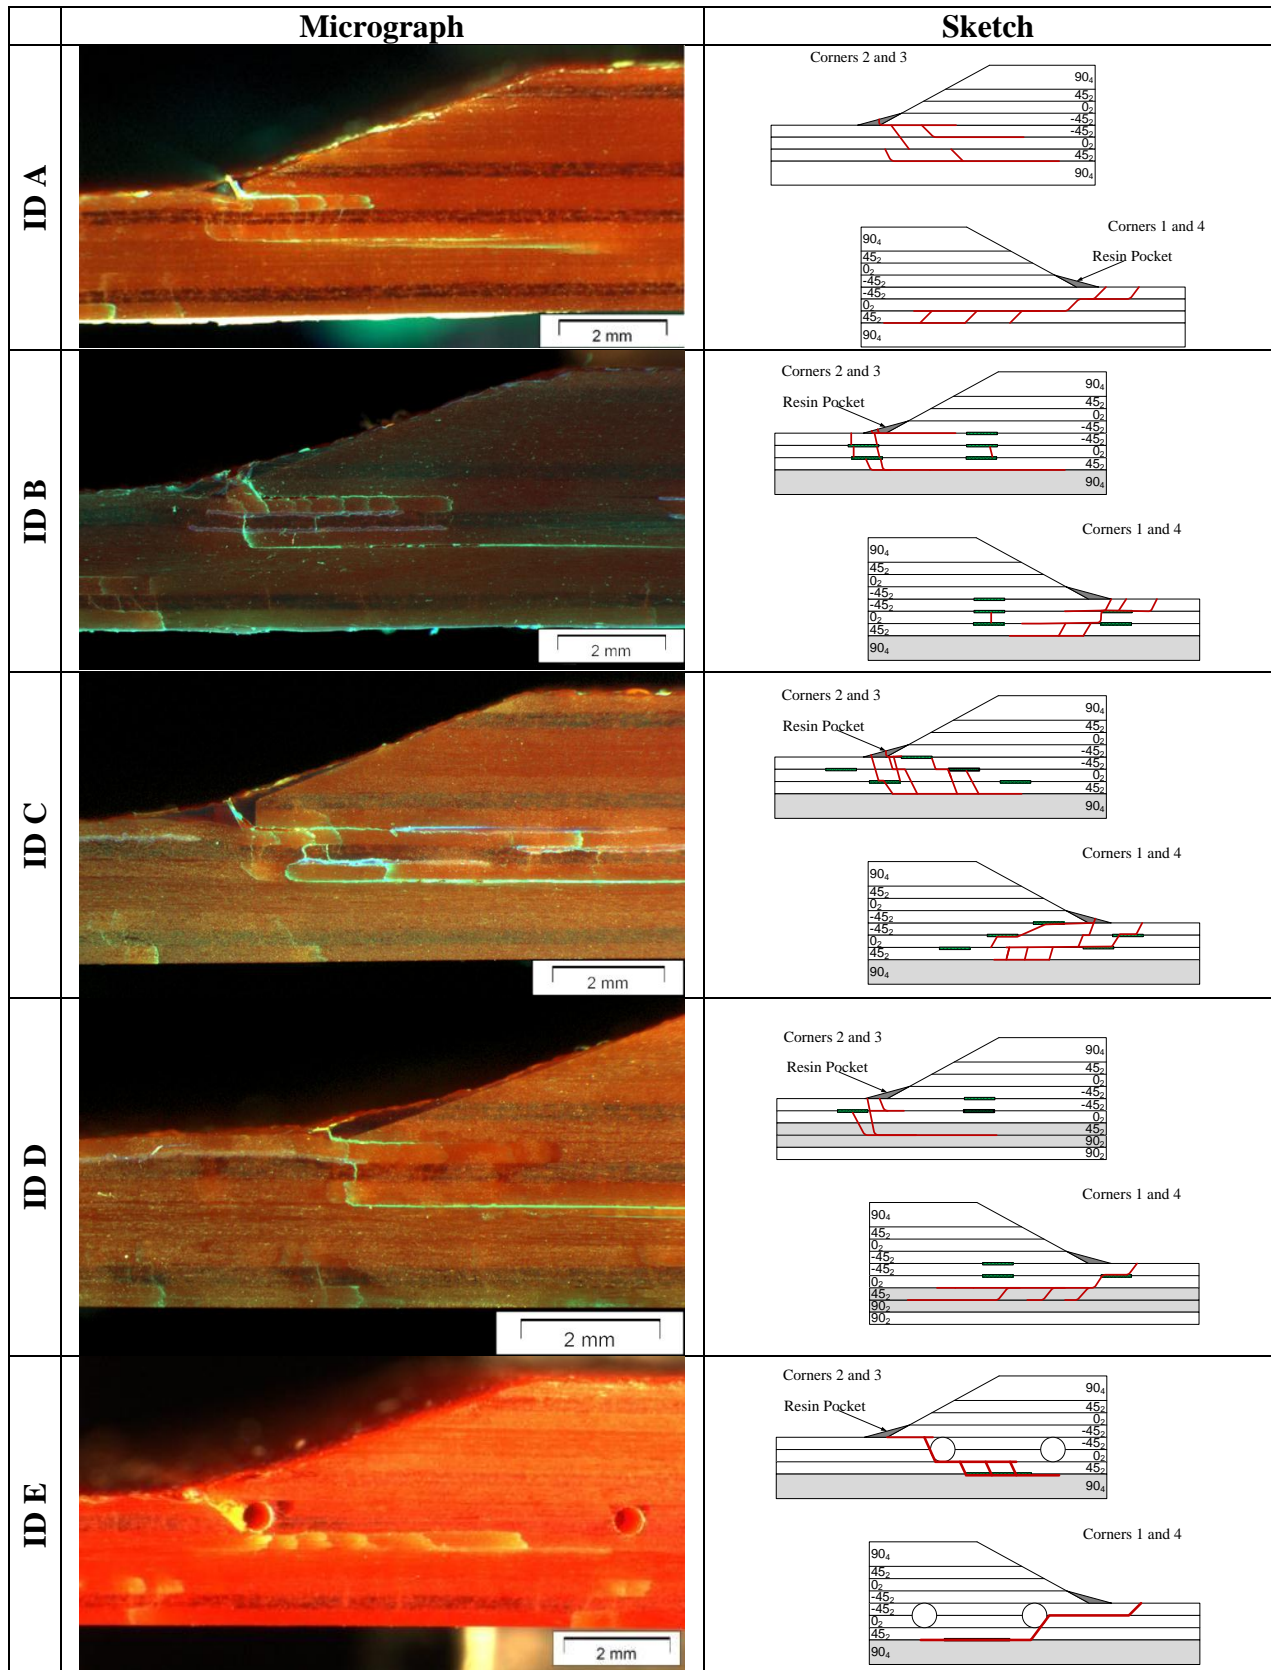
Figure 3. Damage pattern after fatigue damage. Left: micrographs. Right: sketches showing the different types of damage present

In all configurations, damage initiates at the resin pockets at the corners 1 and 4 (defined in Figure 1). In the case of corners 2 and 3, the damage starts due to ply splitting of the top -45₂ ply at 5 to 10 mm in front of the flange tip. These delaminations then migrate “downwards” along interfaces of different orientations. Figure 3 shows the damage pattern of the different configurations.

Through optical microscopy, it has been concluded that when encountering an interleave (ID B, C and D), the delaminations migrate to a lower interface. This may suggest, that the local increment of the fracture toughness [11] enhances the “inherent” tendency of delaminations to migrate into lower plies.

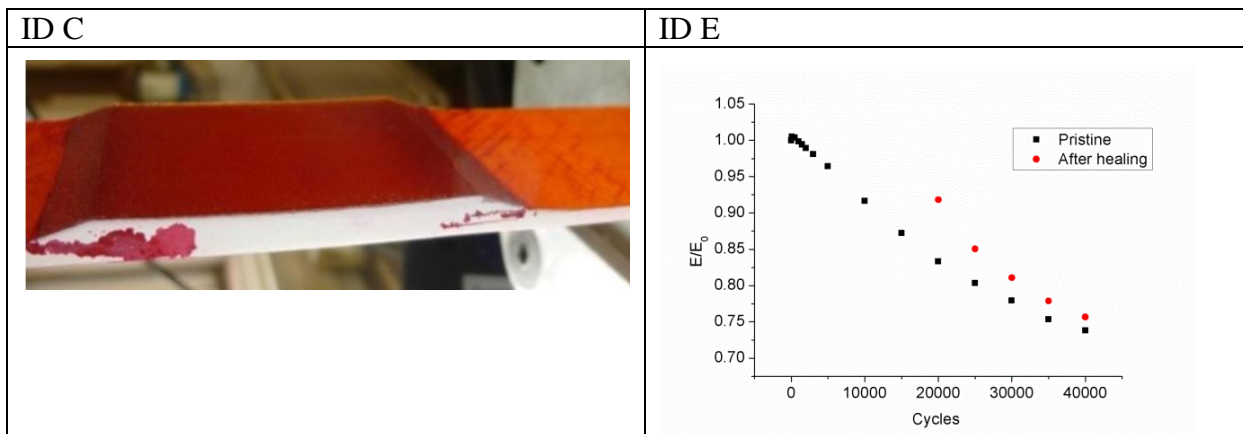
Preliminary healing tests have been performed on the specimens (Figure 4).

Figure 4. Left: “bleeding” composite showing connectivity between longitudinal vasculs and damage site. Right: Stiffness recovery after injection. Specimen cycled to 20000 cycles, then healing agent injected through vasculs and cured. Mean value of two specimens per configuration.

In order to show the connectivity between the vasculs and the damage sites, a red dye penetrant was injected into the vasculs of the specimens redirecting the damage through the interleaves (ID B,C and D). During fatigue testing, it was observed that the specimens started to “bleed” thereby demonstrating the connectivity between the damage sites and the vasculs.
