PASSIVE INFRARED THERMOGRAPHY FOR DAMAGE MONITORING DURING STRUCTURAL TESTING OF CFRP PARTS

This work aims to use passive IRT for the detection of damage evolution in CFRP parts while performing mechanical tests, combined with image processing strategies. The heat release related to fiber/matrix failure or due to stress concentrators is recorded during tensile testing.

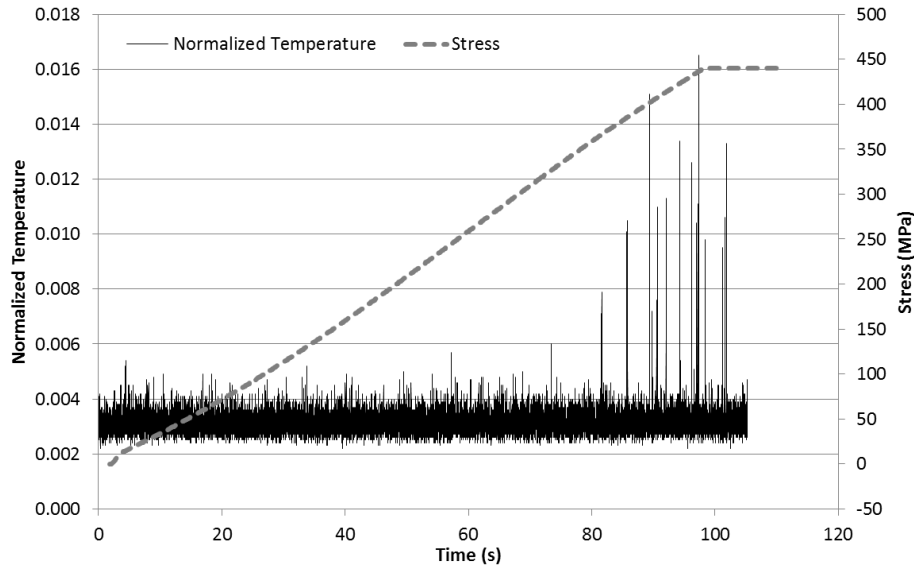
Figure 3. “Timing graph” of the maximum normalized subtracted temperature of the ROI during loading.

(ii) The second method consists on the subtraction of the previous frame for the whole normalized sequence. After this step, the background normalized temperature (of the ROI) is homogenized in each pixel image, and therefore any minor variation of local temperature can be detected. This can be seen in Figure 3, where more peaks and large contrast (of the previous recorded by the first method) are observable.
