## DAMAGE CHARACTERIZATION OF AEROSPACE CFRP PANELS AFTER IMPACT TESTING

**Keywords:** Impact damage, CFRP, Tomography, Ultrasonics.

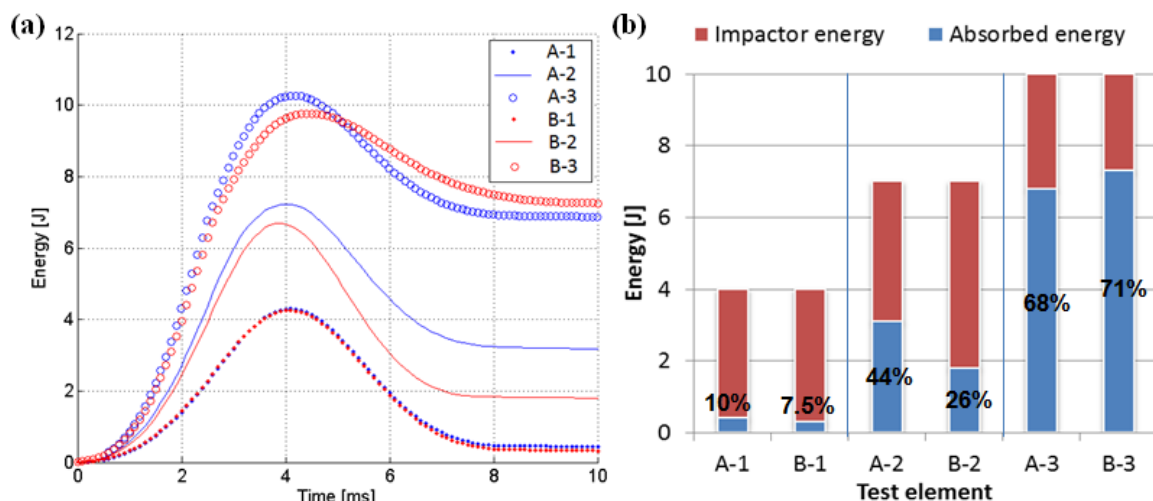
**Figure 1.** (a) Energy vs. time graph; and (b) absorbed vs. impact energy ratio (b).

Impacts were performed from low to high energies. Damage depth was recorder with a calibrated caliper after impact. Energy vs. time charts were obtained during impact testing, allowing the quantification of energy absorption. After that, US inspections were developed with same configuration parameters over the impacted face. In this way, area of damage was calculated through the obtained C-scans in amplitude and position. Once all information collected, Image J was used to estimate affected area.
