INFRARED THERMOGRAPHY TO EVALUATE IMPACT DAMAGING OF COMPOSITES

C. Meola^{*}, S. Boccardi, N.D. Boffa, F. Ricci, G.M. Carlomagno

Department of Industrial Engineering - Aerospace Division, University of Naples Federico II, Via Claudio, 21, 80125 Napoli, Italy

Keywords: Composites, impact tests, nondestructive evaluation, infrared thermography.

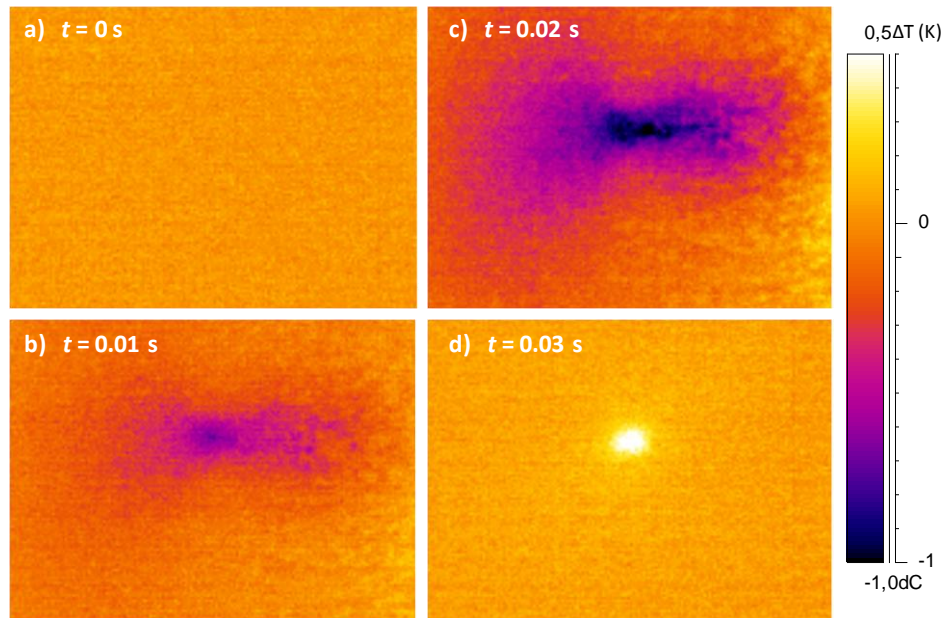
Figure 1. ΔT images of the CFRP_{ts}-1 for $E = 5$ J.

Fig.1 shows ΔT images of the CFRP_{ts}-1 specimen impacted with $E = 5$ J. The first image (Fig.1a) refers to the instant before the impact, which is assumed as $t = 0$ s; the specimen is at ambient temperature resulting in an almost uniform $\Delta T = 0$ K. The successive images, taken

lately at $t = 0.01$ s (Fig.1b) and at $t = 0.02$ s (Fig.1c), display a central darker zone (negative ΔT values) accounting for thermo-elastic effects [11]. More lately, at $t = 0.03$ s (Fig.1d), a lighter hot zone appears accounting for dissipation of energy there. Indeed, the over-temperature variation is limited to a maximum value of about 0.5 K meaning that practically no important damage occurred. As the impact energy is increased to 10 J, the material undergoes more important damage as the thermal signature in Fig.2a proves. In fact, in this case, a hot oblong structure (about 11 mm long and 3 mm wide) appears sudden at the impact ($t = 0.01$ s) surrounded by a colder (dark) zone. This means that fibers break along their horizontal (longer side) direction while the remaining surface is in tension under the pushing impact force. On the other hand, there is an abrupt temperature rise (Fig.2a, $\Delta T = 20$ K) accounting for fibers breakage. However, such a ΔT value is displayed only on a couple of images (i.e, fractions of a second) since there is a sudden cooling down towards the ambient temperature. More specifically, there is first a fast decrease followed by a slower one as the heat transfer rate is driven by the ΔT value. In particular, the ΔT decrease is accompanied by a better discrimination of the total extension of the warm zone; in fact, the maximum extension of equivalent diameter about 13 mm is visible for $t = 1.79$ s (Fig.2b). Such a warm zone may be assumed to coincide with the overall delaminated area [11, 13].

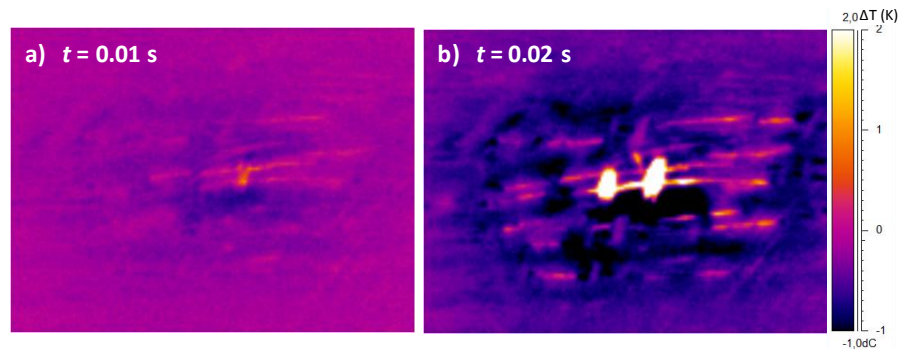
Figure 3. ΔT images of the GFRP_{ts}-1 for $E = 5$ J.

Figs.3 and 4 show ΔT images taken during impact respectively at $E = 5$ and 10 J of the GFRP_{ts} specimens. As can be seen, a hot spot appears sudden at the impact with $E = 5$ J (Fig.3a) which at 0.02 s, strengthens up to $\Delta T = 31.6$ K when a second lighter hot spot appears (Fig.3b) nearby on the left. Conversely, at the higher impact energy of $E = 10$ J, only one hot spot ($\Delta T = 24.2$ K) appears for $t = 0.02$ s (Fig.4b and c). The location of such a hot spot can be recognized, from a comparison of Fig.4a with Fig.4b, in the junction of the vertical central fiber with the horizontal dark line (Fig.4a). The overall warm zone (delaminated area) is attained for $t = 4.57$ s when the maximum ΔT value jumps to 1.5 K (Fig.4d). From the latter image it is possible to distinguish, inside the whole warm zone (about 11×6 mm²), a hotter

circular zone ($\Delta T = 1.5$ K) of diameter 3 mm, which practically coincides with the hot spot of Fig.4b and c. Of course, this small area bears witness for the most important damage (fiber breakage), while outside, as $\Delta T \rightarrow 0$, delamination becomes much milder. From a comparison of Fig.4 with Fig.3, it is possible to see that the stronger hot spot in Fig.3a is located at the apex of a bifurcation within two fiber pockets and corresponds to the hammer head axis. It is just such a misalignment of fibers coupled with a non uniform distribution of resin that has favored the breakage of fibers and matrix with a great dissipation of energy and abrupt increase of temperature ($\Delta T = 31.6$ K) for $E = 5$ J. In fact, it has already been demonstrated the detrimental effect of defects on the material performance under impact [13].
