THE EFFECT OF TECHNOLOGICAL DEFECTS ON PERFORMANCE OF FABRIC-REINFORCED COMPOSITES

Keywords: Fabric-reinforced composites, manufacturing and service defects, non-vacuum repair method, experimental characterisation

The effect of manufacturing and service defects on glass-fibre composite components was studied. A methodology of repair of defects in such components dismantling parts from the structure is introduced using a novel vacuumless repair technology. Experimental characterisation of strength properties of standard samples, samples with defects and repaired samples under tension and compression was conducted.

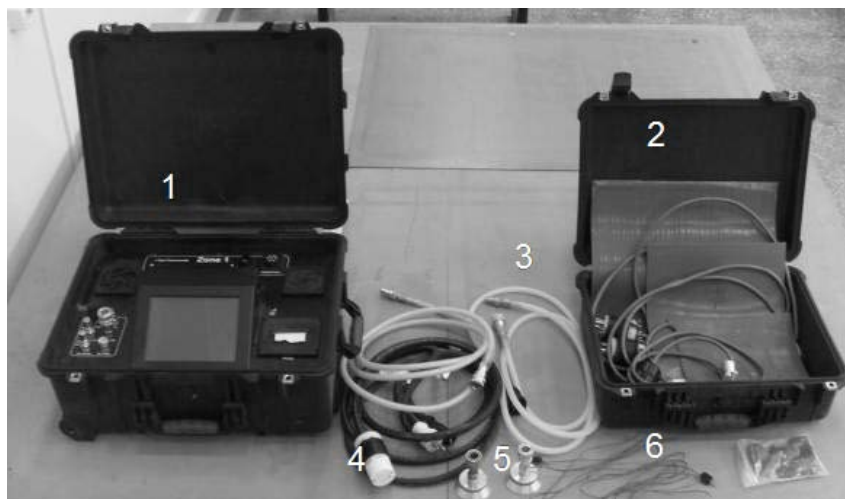
Figure 3. Hot Bonder kit

The specialized equipment ACR3 Hot Bonder (Fig. 3) was used for the repair procedure. The main technical features of the equipment include the ability to repair structural parts without removing them from the structure (aircraft parts, for instance), which can significantly reduce costs and shorten repairs cycle. It also allows controlling the repair process in real time. Its operation principle is based on heating the repair zone with a flexible silicone heater with temperature control according to a predetermined program, with a possibility of stepwise temperature increases with a given speed and duration, with the simultaneous creation of a vacuum by means of an ejector and an electric pump.

As the sample is perforated and repair zones are located on its both sides, the silicone heater was used without a vacuum. Moulding of the replacement layers was conducted by the contact method with a pressure of 0.1 kgf/cm². Hardening was performed at 60°C for 10 hours.
