DAMAGE MECHANISMS OF SHORT GLASS FIBER REINFORCED POLYAMIDE 6.6 UNDER FATIGUE LOADING

E. Belmonte^{a,b*}, M. De Monte^b, M. Quaresimin^a, C. Hoffmann^b

^b*Robert Bosch GmbH, Corporate Sector Research and Advance Engineering – Advance Production Technology 1 – Plastics Engineering, Waiblingen (Germany)*

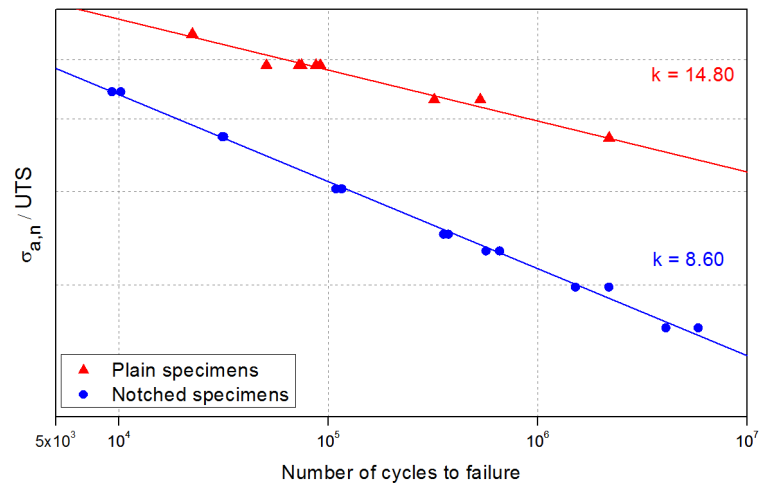
Figure 2: Normalized S-N lines for plain and notched specimens.

Uniaxial fatigue tests were carried out on a Schenck Hydropulsar servo-hydraulic testing machine, equipped with a load cell of 10 kN. The fatigue tests were carried out under load control, applying a sinusoidal load function with constant amplitude. Load ratio was kept constant and equal to 0 for all the performed tests. The fatigue tests were carried out at room temperature without any control on temperature and humidity. The frequencies were chosen so as to avoid the self-heating of the specimen. The adopted criterion for choosing the test frequency was to keep the increment of temperature on the surface of the specimen less than 5°C. Fatigue results were analyzed in terms of nominal stress amplitude to the net section normalized by the quasi-static strength (UTS) at room temperature of that specific specimen, versus the number of cycles to failure N (Figure 2). Test results are reported in double logarithmic scales. The parameter k is the inverse slope of the S-N curve. Some tests on notched specimens were interrupted before failure in order to investigate the damage mechanisms on the longitudinal section of the specimen. However, these results are not reported in Figure 2. For the damage investigation analysis, two specimens failed in high cycle fatigue regime were chosen.

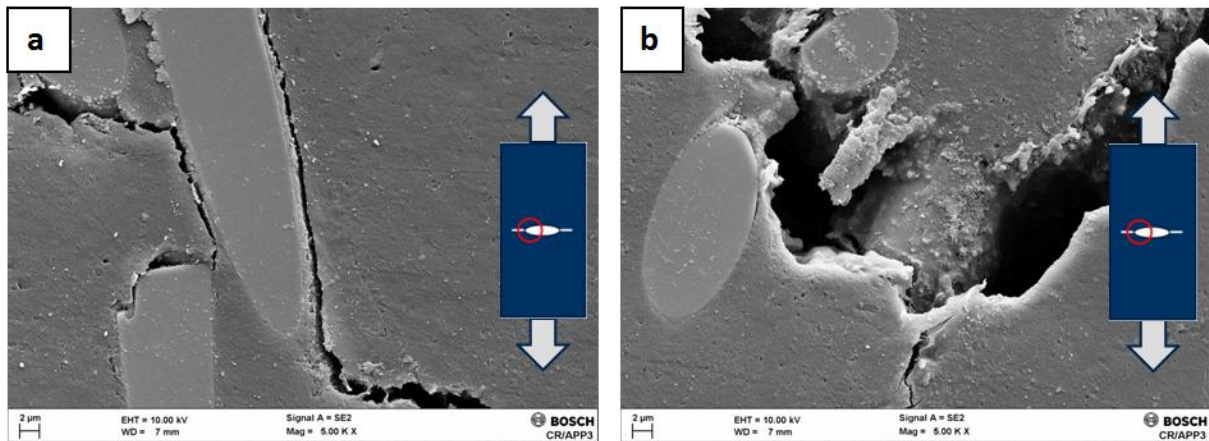
Figure 8 Analysis of the fiber-matrix adhesion on the longitudinal section of notched specimens subjected to interrupted fatigue tests (a) crack in the matrix along a fiber (b) Fiber pulled-out covered by a matrix layer.

The analysis of the longitudinal section of the specimens subjected to interrupted fatigue tests (Figure 8) confirms the results of the previous analysis. Figure 8a shows a fiber avoided by the crack but covered by a matrix layer. Figure 8b provides an example of the mechanism “fiber pull out” in which the fiber extracted from the fracture surface is completely covered by a matrix layer indicating that damage occurs in the matrix rather than at the fiber-matrix interface. These results are opposite respect to those shown by Lang et alii [[6]]. In fact, they observe clean fibers clearly debonded from the matrix, concluding that damage propagates directly at the fiber-matrix interface.
