INFLUENCE OF THERMAL CYCLING ON THE LOW VELOCITY IMPACT RESPONSE OF CFRP LAMINATES

D. Ghelli^{a*}, V. Cantarini^b, E. Troiani^b

Abstract

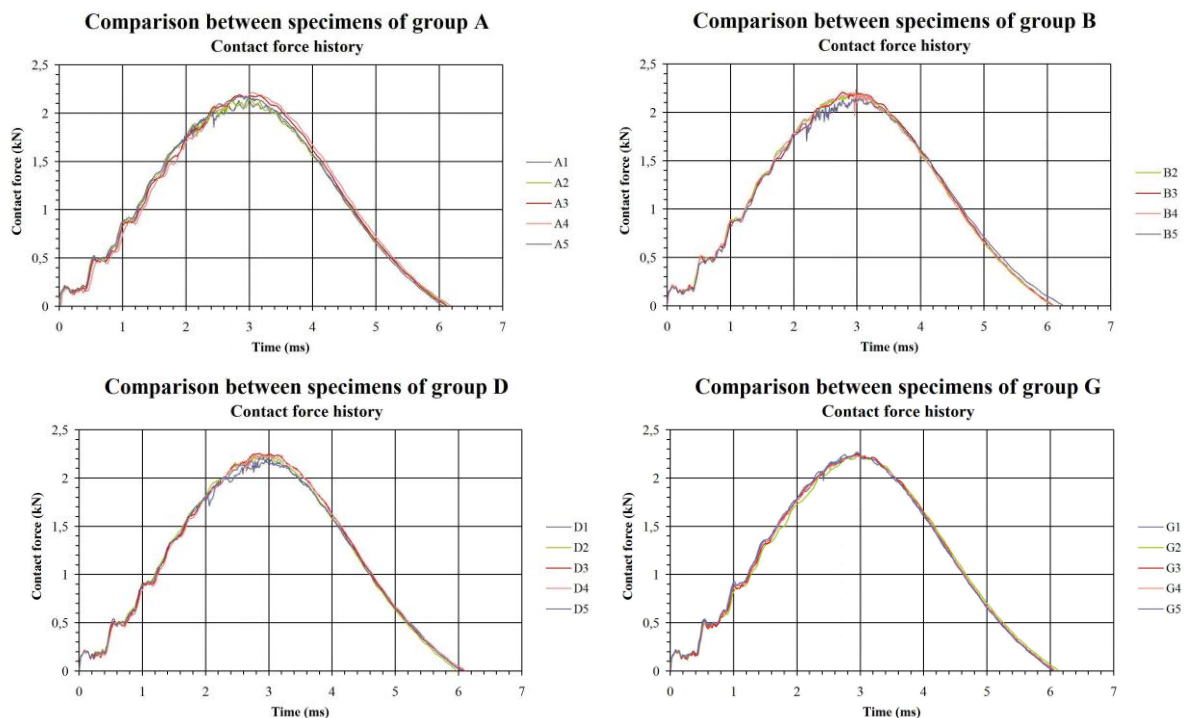
Figure 1. Representative contact force history recorded during impact tests of all specimens of groups A, B, D and G. The plot of the specimen B1 is missing because there has been a problem in data acquisition system.

Figure 1 presents the contact force history recorded during impact tests of some representative specimen groups. As it is shown in this figure, the laminate dynamic response to impact is dominated by the first vibration mode and the higher modes give a little contribution to the dynamic behavior. Indeed the contact force-time curve is similar to a half-sine wave with smaller waves with higher frequency superposed to it. In particular the effect of the higher modes can be seen in the initial part of graphic, where the first of this smaller waves appears in all plots [1]. In general graphics of all groups show that the 5 tests carried out of each group gave similar results. In particular this can be seen in the first part of the plots of contact force history where it is possible to see a similar behavior in spite of small thickness differences among specimens. In many cases several load drops are visible in the plots, that are usually attributed to the propagation of delamination. Some degree of variability can be seen within each group regarding the amplitude of such load drops. Nevertheless, the amplitude of drops clearly tends to decrease as the number of thermal cycles increases. Generally, the visual inspection of specimens has shown that the delamination is clearly visible in the form of a little swelling on the un-impacted face of the laminate and has a similar dimension in all specimens. On the other hand the laminate impacted side presents small dent, fiber micro-buckling close to the dent and matrix splitting.

The contact force-time curves (Figure 1) show that an increasing number of specimens do not present load drops with the increase of thermal cycles number. This suggests that the propagation of delamination occurred in a gradual, stable way, rather than suddenly. Because in literature it is possible to find that the thermal cycles produce microcracks in the material [3], then it can be supposed that the propagation was more gradual due to the presence of some microcracks, that acted as a trigger for the delamination onset. Microscope analysis of the polished laminate section away from the impact point (where one can expect that only damage generated by thermal aging can exist) did not display any matrix crack. On the other

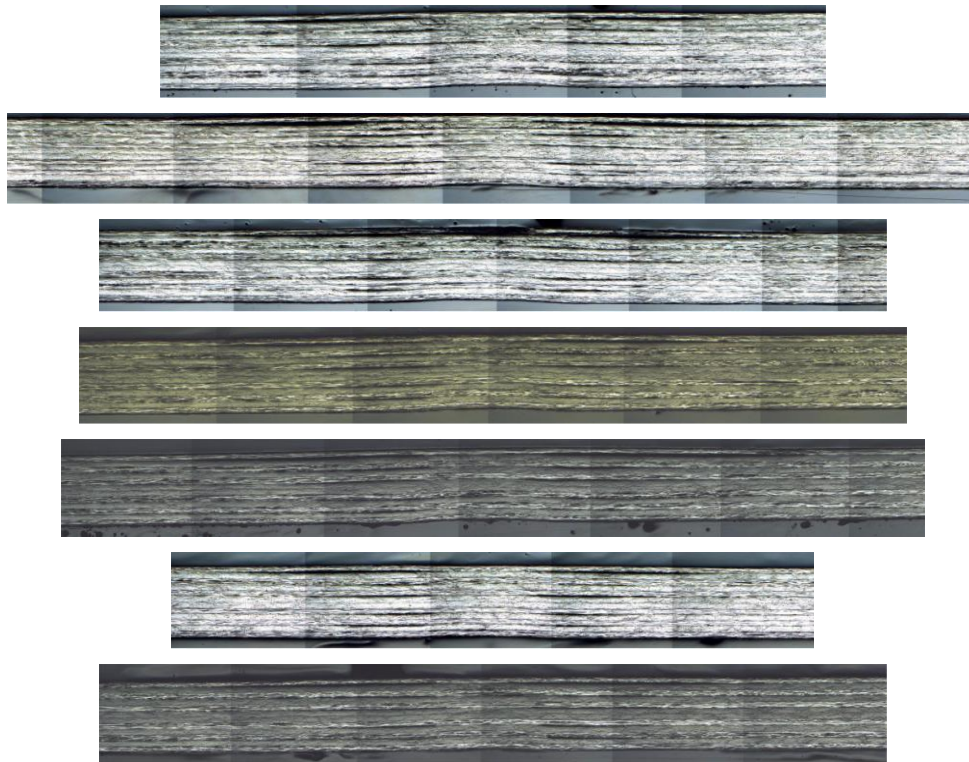
Figure 2. Optical microscope photographs of specimens A1, B5, C1, D1, E1, F3, G5 (from top to bottom) sectioned along the 0° direction through the impact point. The impacted face of laminates is on the low side of each picture.

The delamination size, as it can be appreciated by visual inspection, was consistently confirmed by microscope analysis of sectioned laminates. As shown by Figure 2, delaminations are present at each interface between a 0° ply and the adjacent 90° ply located above it. In every case the widest delamination is found at the lowest interface, above the 0° external ply on the un-impacted face of the laminate. The length of the swelling on the laminate back face corresponds to the length of this delamination as can be measured by microscope observation. As can be seen in Figures 3-5, no definite effect of the different thermal aging can be recognized neither in the extent of the largest delamination (Figure 3) nor in the sum of the lengths of all delaminations (Figure 4). The measure of each of the single delamination observed at all interfaces, reported in Figure 5, again indicates that the extent of this damage type appears not to be affected by the number of thermal cycles.

Generally on the other hand fiber fracture requires a very high level of energy to be generated. But in our tests the impact energy was limited, because the drop height was small (0.5 m). For this reason, as previously noted, only a few specimens present fiber fracture of little extent. Microscope photographs (Figure 2) also show that fiber rupture is not significant in the present tests. Then in our case we can suppose that the energy absorbed by fiber rupture was

hand, actual presence of cracks can not be excluded. Possible cracks may be left undetected at a certain distance from the impact point, where permanent deformation of the specimen after impact is negligible, thus cracks are not kept open by ply bending. Indeed, as can be seen in Figure 2, matrix cracking is visible in the vicinity of the dent induced by the impactor head, where local strain is much larger.

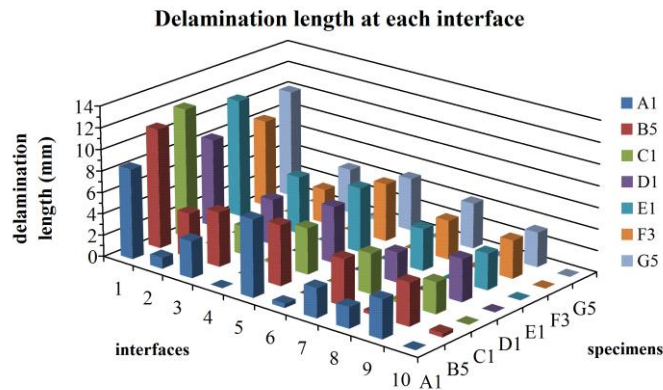
Figure 5. Single delamination lengths measured at all interfaces in sectioned specimens. Interfaces between plies with different fiber orientation are numbered starting from the lowest one (just above the 0° layer on the un-impacted face).
