AN INNOVATIVE USE OF X-RAY COMPUTED TOMOGRAPHY IN COMPOSITE IMPACT DAMAGE CHARACTERISATION

F. Léonard^{*1}, J. Stein^{1,2}, P.J. Withers¹, A. Wilkinson²

¹Henry Moseley X-ray Imaging Facility, School of Materials, The University of Manchester, Grosvenor Street, Materials Science Centre, Manchester M13 9PL, UK

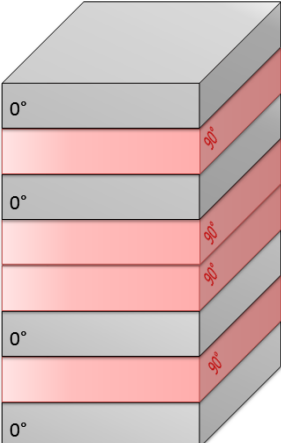
Composite laminates were manufactured by resin film infusion (RFI), the infusion set-up and the cure cycle have been detailed in [7]. Each panel consisted of 8 plies (7 ply interfaces) with 0° and 90° ply angles being used, giving a complete stacking sequence of $[(0^\circ/90^\circ)_2]_s$. The panel lay-up lay-out and the interface number (as referred to in section 3) are shown in Figure 1.

Ply No.	Orientation (°)	Interface No.
1	0	1
2	90	2
3	0	3
4	90	4
5	90	5
6	0	6
7	90	7
8	0

Figure 1. $[(0^\circ/90^\circ)_2]_s$ stacking sequence of the composite panels.

Figure 4. Damage profiles for all 4 energies. The peak numbers correspond to the interface number (1, 3, 6 are $0^\circ/90^\circ$ interface type; 2, 5, 7 are $90^\circ/0^\circ$ interface type, as shown in Figure 1).

The results in Figure 4 demonstrate that for all energies, the damage profiles are composed of six main peaks corresponding to six of the ply interfaces ($0^\circ/90^\circ$ and $90^\circ/0^\circ$ alternatively). No damage peak is observed for ply interface number 4 (Figure 1), which is the $90^\circ/90^\circ$ ply interface. The increase in damage resulting from the increase in impact energy is not distributed isotropically throughout the laminate structure (due to the three-dimensional stress field), highlighting the complexity of the impact damage process on polymer composites. As the impact energy increases, the peak intensity increases and the peaks broaden but the evolution is different for each peak. Larger length splits and hence induced delaminations develop in the lower part of the laminate since it is loaded in tension. The damage profiles extracted from the damage distance transform are an easy and convenient way to describe, qualitatively and quantitatively, the distribution of the impact damage through the thickness of the impacted laminate.

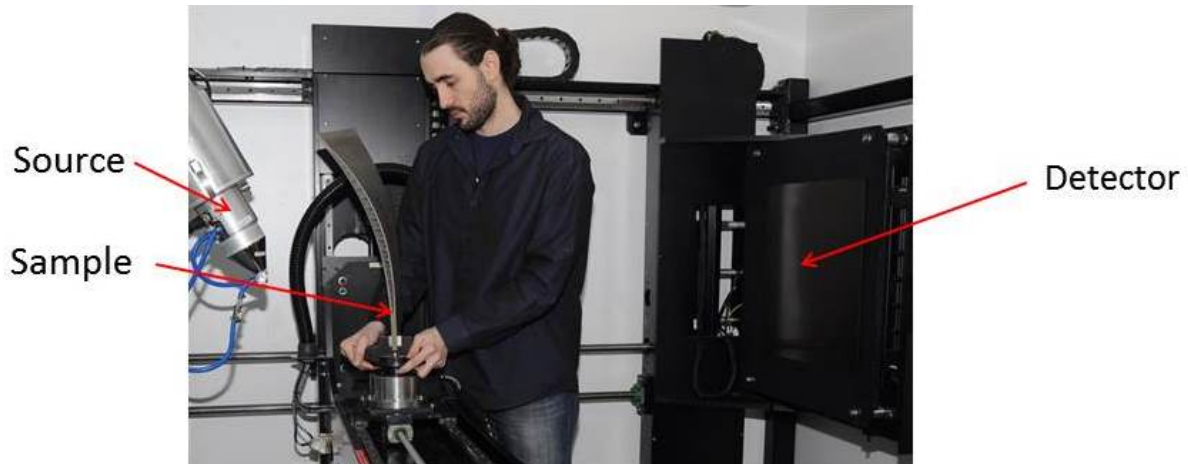
The impact specimens were scanned at the Henry Moseley X-ray Imaging Facility on the Nikon Metrology 225/320 kV Custom Bay system [9] equipped with a 225 kV static multi-metal anode source (minimum focal spot size of 3 μm [10]) and a PerkinElmer 2000 x 2000 pixels 16-bit amorphous silicon flat panel detector. The system is shown in Figure 2.

Figure 2. Nikon Metrology Custom Bay system.

The scanning was performed with the copper target using a voltage of 60 kV and a current of 175 μ A. The data acquisition was carried out with an exposure time of 1415 ms, and no filtration. The number of projections was set to 3142 and the number of frames per projection was 1. The entire volume was reconstructed at full resolution with a voxel size of 35.7 μ m along the x , y , and z directions.

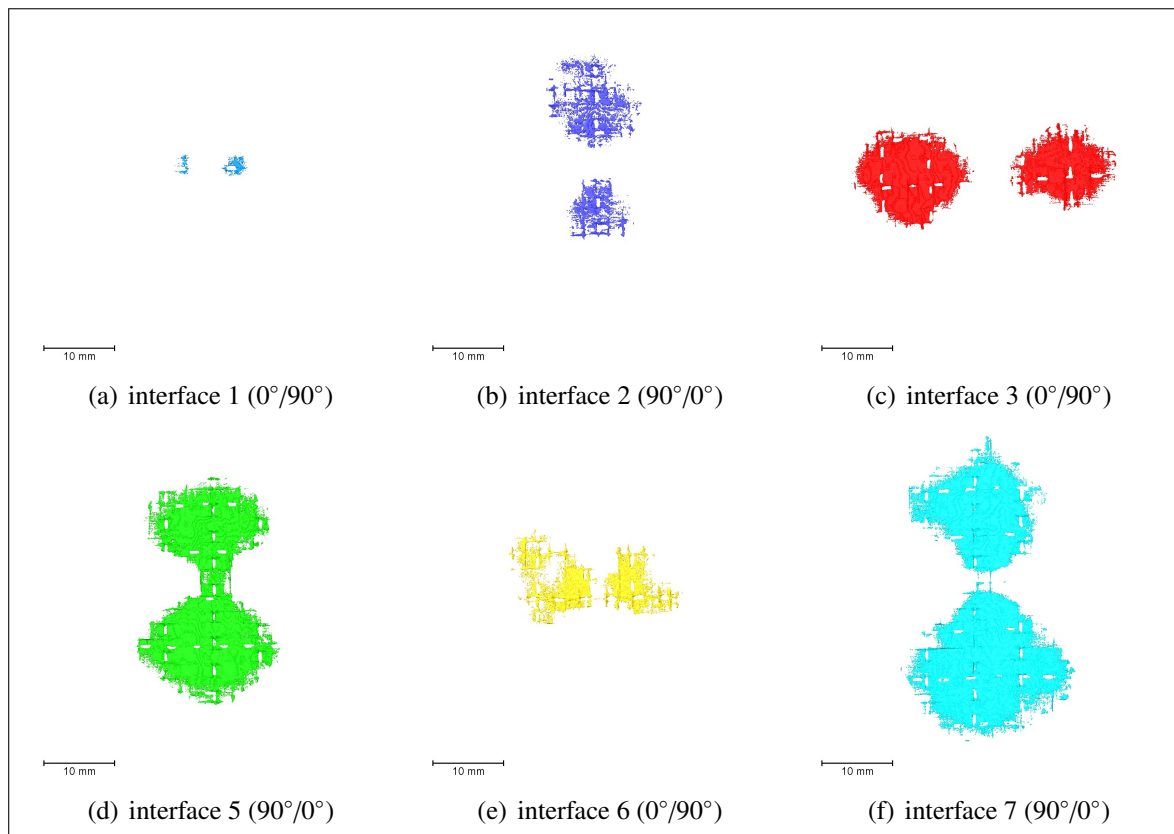
Figure 6. Ply-by-ply damage separation according to individual peaks from damage profile for 5 J impact energy.

An overview of the 3D rendering of the specimen tested at 20 J is given in Figure 5. The results of the semi-automated separation are detailed in Figure 6 and 7 for the specimens tested at 5 J and 20 J, respectively.

Figure 6 and 7 demonstrate that the ply-by-ply separation of the impact damage can be performed over the range of impact energy investigated. At 5 J, the delamination volumes are peanut-shaped, as reported in the literature [12, 13], with their main axis being coincident with the fibre orientation of the layer below the interface. The alternation of the main axes appears to be consistent with the lay-up of the laminate. At 20 J, the delamination volumes are more oblong-shaped due to extensive damage yet, they follow the same alternation of their main axes as the panel structure remains identical.

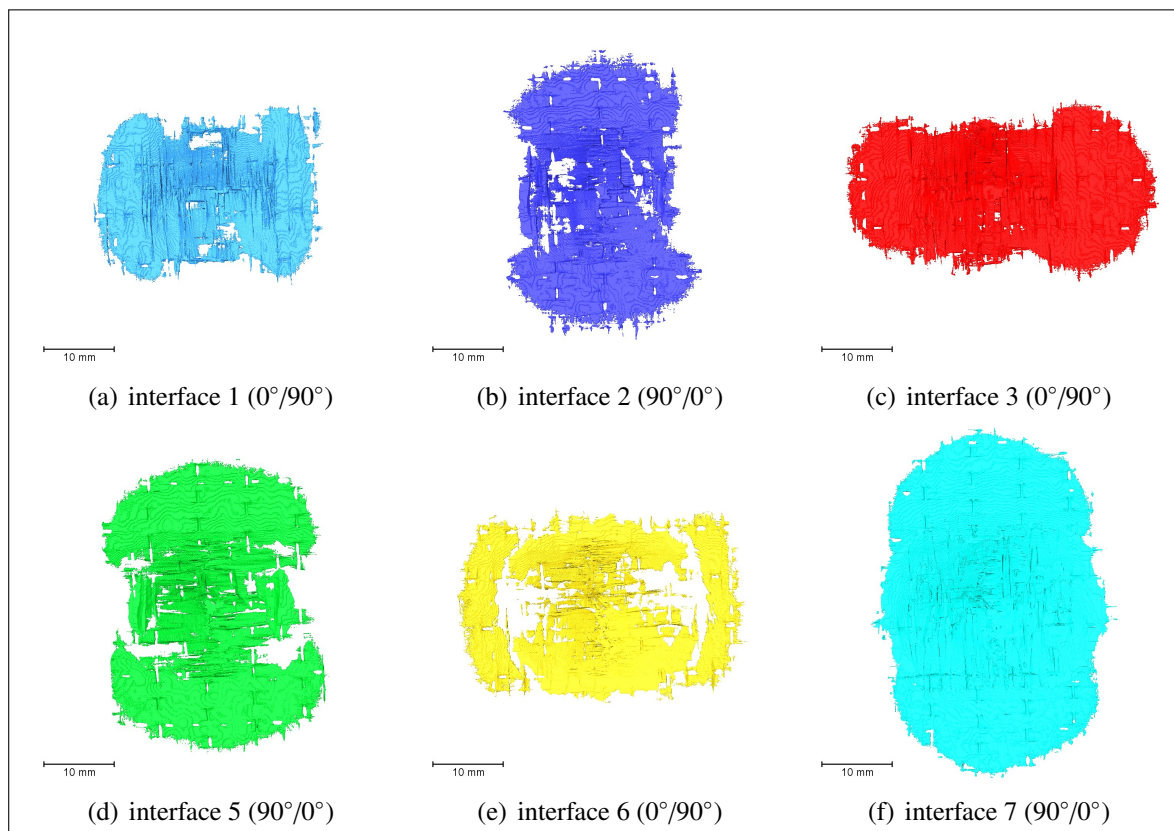
Figure 7. Ply-by-ply damage separation according to individual peaks from damage profile for 20 J impact energy.
