VISUALIZATION AND NDT EVALUATION OF LIGHTNING DAMAGE BEHAVIOR OF CFRP LAMINATE

Keywords: CFRP, lightning damage, visualization, NDT

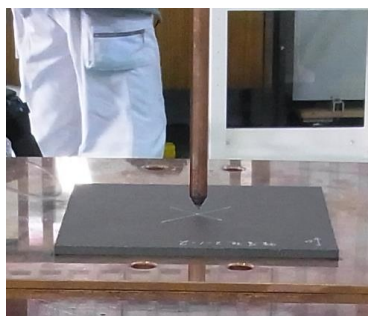
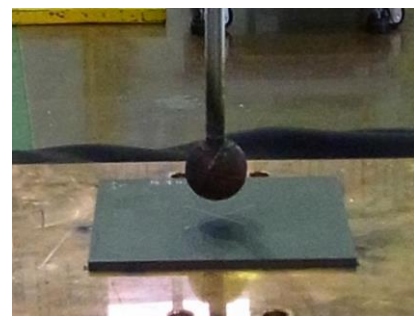
a) Discharge probe with conical tip

b) Discharge probe with insulating sphere

Figure 2. Specimen setup and discharge probes

An impulse high-current generator (ICG) produced by Haefely Test AG (Figure 1) was applied here to simulate natural lightning current. The specimens are simply placed on a grounded copper plate, so the top surface of the specimen is not covered with any material. The discharge probe is connected to the ICG. In this study, two different types of electrode were applied to examine the effect of acoustic shock waves on damage behavior: a metal electrode with conical tip (Figure 2 (a)), and a jet diverting electrode with insulating sphere (Figure 2 (b)) which can avoid confining acoustic shock waves between the electrode and specimen surface. The gap spacing between electrode and specimen surface is 2-3mm and 10mm for the conical tip electrode and the jet diverting electrode, respectively. In case of jet diverting electrode, aluminum wire of 0.05mm in diameter is connected from rod of discharge probe to specimen surface as initiation wire to ensure an arc entry of impulse current.

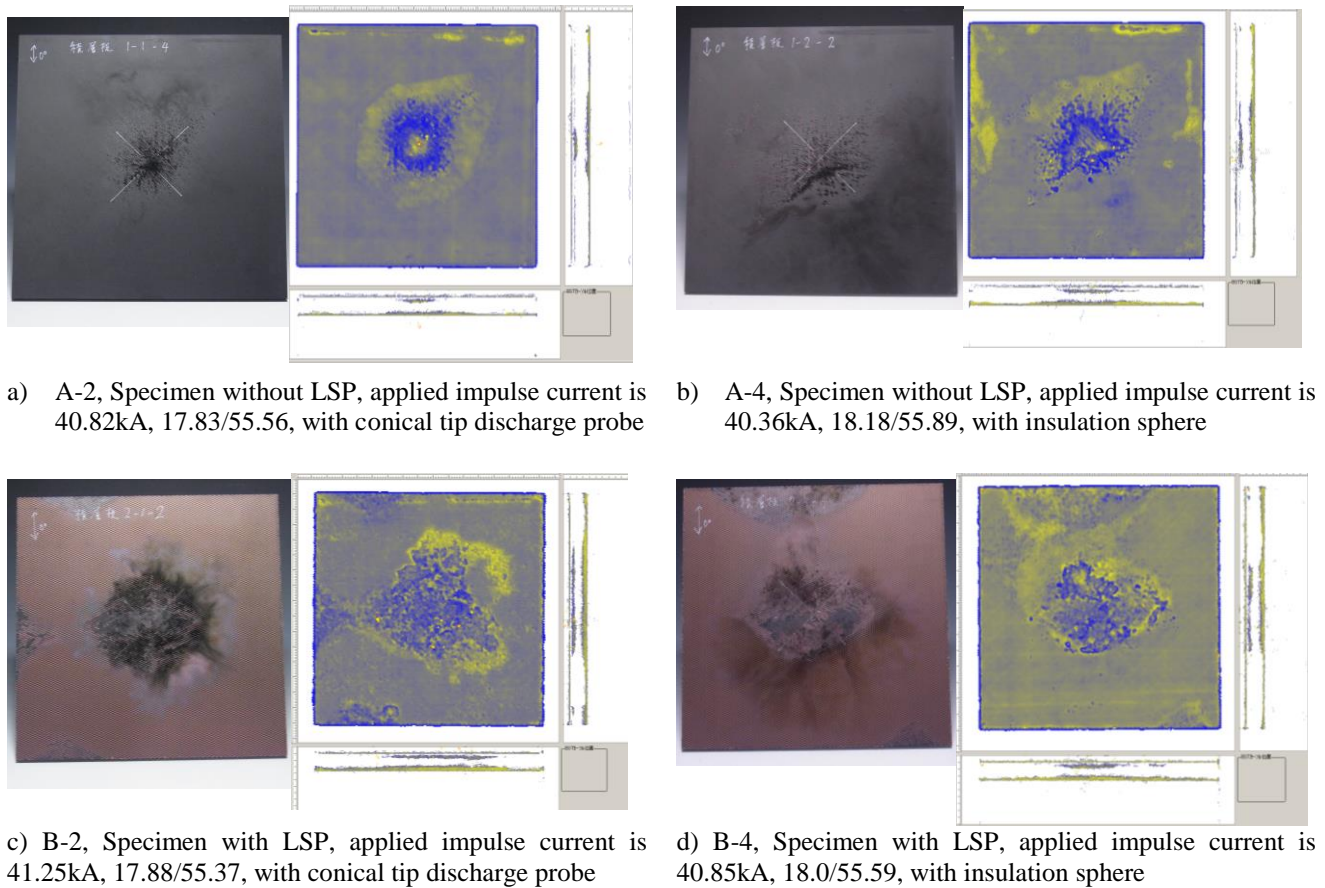
Figure 5. Typical experimental result of artificial lightning test; overhead view of post-lightning specimen and ultrasonic C-scan result

Figure 5 represent the typical damaged CFRP laminate after lightning test. Top view and ultrasonic C-scan images are schematically shown. The ultrasonic testing machine applied in this study is a high frequency ultrasonic parser/receiver HIS-3 produced by Krautkramer Co. LTD. Ultrasonic testing was scanned from lightning current attached surface with 1.0MHz transducer.

Specimen without LSP mesh (A-2 and A-4) shows damage modes of fiber breakage, resin vaporized area, and resin deterioration area. Each damage modes are indicated in the UT testing result as the center yellow region, surrounding blue region, and outer most yellow region, respectively. From the B-scope result, it can be observed that the damage is limited in vicinity of specimen surface. In both case, small delamination can be observed just under the fiber breakage area in few layers from specimen surface. Compared with the case with insulation sphere (A-4), smaller fiber damage area and resin vaporized area, and larger resin deterioration area can be observed in case of conical tip discharge probe (A-2).

On the other, specimen with LSP mesh (B-2 and B-4) shows damage modes of LSP mesh vaporized area and surface resin deterioration area. In case of conical tip discharge probe, LSP mesh vaporized area propagate in concentrically, though that of the case with insulation sphere propagate irregularly. From the UT B-scope results, it is considered that damage is limited in the surface LSP mesh and first layer of CFRP laminate in both cases. There is no fiber breakage and delamination can be observed. It is showed that applying the LSP mesh to CFRP laminate is effective to reduce the lightning damage.

When applied current is decay to the half of maximum current (t_2), arc flash and high temperature area of hot gas can be observed separately. The outer most shadow line represents the acoustic shock wave. Though the shape of hot gas region is difference between the specimen with LPS and without LPS as same as the t_1 stage, outer shape of acoustic shock is hemisphere in both specimens. This indicate that acoustic shock wave is generated by the arc discharged at gap between the tip of discharge probe and specimen surface and propagation of the shock wave is hardly affected by the emitted hot gas. At stage of $t = 120\mu s$, since discharge of impulse current is almost finished (See Figure 2), the schliren photography shows the propagated acoustic shock wave and high temperature region of hot gas. Though the hemisphere of acoustic shock wave is developed from the t_2 stage, the region of hot gas seems mostly unchanged. This is because epoxy gas is no longer generated after finishing the applying impulse current. Comparing the diameter of acoustic shock wave hemisphere between $t=120\mu s$ and $t=55\mu s$ (t_2), propagation speed of shock wave can be calculated as 475.36 m/s on average. In case of specimen with LPS (B-1), only the outermost strong acoustic shock wave can be observed. However, in case of without LPS (A-1), several strong shock waves subsequent to the first outermost shock wave can be observed. It is considered that the cause of these several subsequent acoustic shock waves is the fiber breakage and internal damage associated with the impulse current (See Figure 5 (a)).

As shown in the result of schliren photography, propagation of acoustic shock wave associate with the insulation break down of atmosphere and the development of hot gas region is heavily affected by the difference of discharge probe and with or without LSP on the specimen surface. However, the observation result of post lightning specimen and the NDT results (Figure 5) indicate that the difference of acoustic shock wave propagation and development of hot gas region have an insignificant effect on CFRP damage behavior. Especially, they have little influence on damage behavior in thickness direction and fiber breakage which have large effect on residual strength of damaged CFRP. Damage behavior of CFRP laminate suggest that applying insulation sphere and initiation wire makes difficult to control the location of lightning current attached. Because the leader channel easily shifts with using initiation wire, lightning attached point is also moved and result in expanding of fiber breakage region (Figure 5 (b)).
