## FATIGUE DAMAGE INVESTIGATION OF PA66/GF30 BY X-RAY MICROTOMOGRAPHY

**Keywords:** Micro-computed tomography, damage mechanisms, fatigue, injection molding.

### Abstract

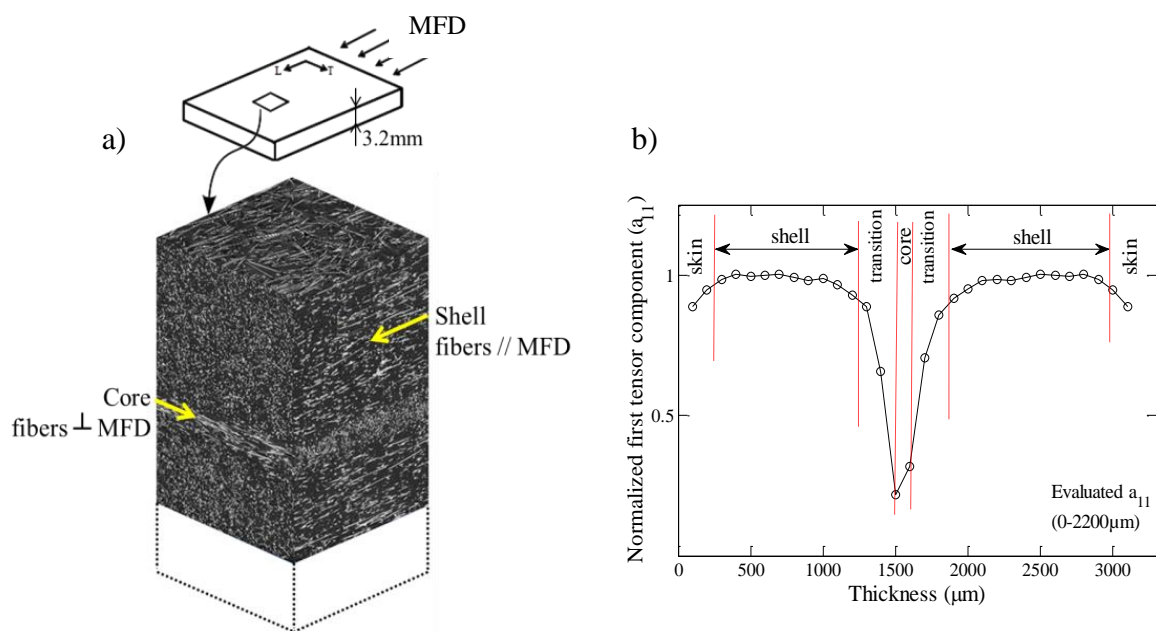
**Figure 1.** Microstructure formation of PA66/GF30; a) fiber orientation description by  $\mu$ CT, and b) normalized fiber orientation tensor. (MFD = mold flow direction)

Due to the injection process, PA66/GF30 has a skin-shell-transition-core microstructure as shown in Fig. 1. It can be seen that the shell layers, with preferential fiber orientation parallel to the mold flow direction (MFD), are the most dominant ones. Thin core layer is developed and mostly fibers in this layer are oriented transversely to the MFD. Additionally, thin skin layers at the upper and lower specimen surfaces, and the shell-core transition layers are also developed. For further description of PA66/GF30 microstructure, readers can refer to [4,5].

Specimens for fatigue damage characterization were machined in longitudinal direction with respect to the MFD from the rectangular plate produced by injection molding. This extraction condition results in the average fiber orientation in the shell (and *core*) layer that is parallel (and *perpendicular*) to the applied fatigue loading direction.

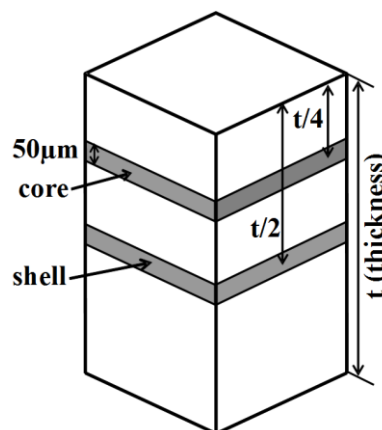
**Figure 2.** Description of the analyzed  $\mu$ CT volumes in the shell and core layer of the composite.

In this work, the void features; the aspect ratio, volume and Euler orientation angle are analyzed. To reduce the number of analyzed voids and to establish a consistent comparison between the void features in the shell and core layer, the evaluation of void characteristics has been performed in a 50  $\mu$ m volume slice of the shell and core layer of the  $\mu$ CT volume, as described in Fig. 2.

The evolution of the void volume and void aspect ratio with respect to the void orientation angle and number of cycles in the representative  $\mu$ CT volume of the shell and core layer, as described in Fig. 2, are then analyzed. Examining together the void volume and void aspect ratio is important to comprehend both the size and the anisotropic behavior of the voids in relation to their orientation angle and number of cycles. It should be noted that our segmentation technique may lead to a connection of adjacent voids to be detected as a single object. This could result in an improper analysis of the void orientation angle. To avoid this, a separation algorithm was implemented so that the connected voids can be separated into many individual objects. However, while this technique leads to a reliable analysis of void orientation angle, the separation algorithm also generates small voids to be detected as independent objects, notably the ones with small void volumes and void aspect ratio.

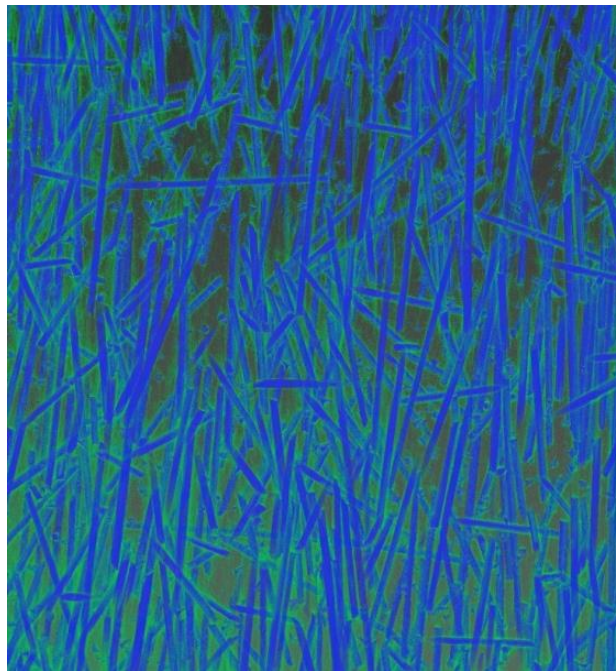
**Figure 3.** Rendered  $\mu$ CT image of fatigue loaded specimen which shows damage in the form of fiber/matrix interfacial debonding. The blue (and *green*) color represents the fiber (and *damage*).

To build a more consistent analysis on damage mechanisms of PA66/GF30, segmentation process which involves separation of the composites' phases (fiber, matrix and damage) has been carried out. Fig. 3 shows the rendered  $\mu$ CT image representing the damage and fibers. One can see that the fiber/matrix interfacial debonding is frequently observed in the fatigue loaded composites. Therefore, this interfacial debonding can be considered as the main fatigue damage mechanisms in dry PA66/GF30.

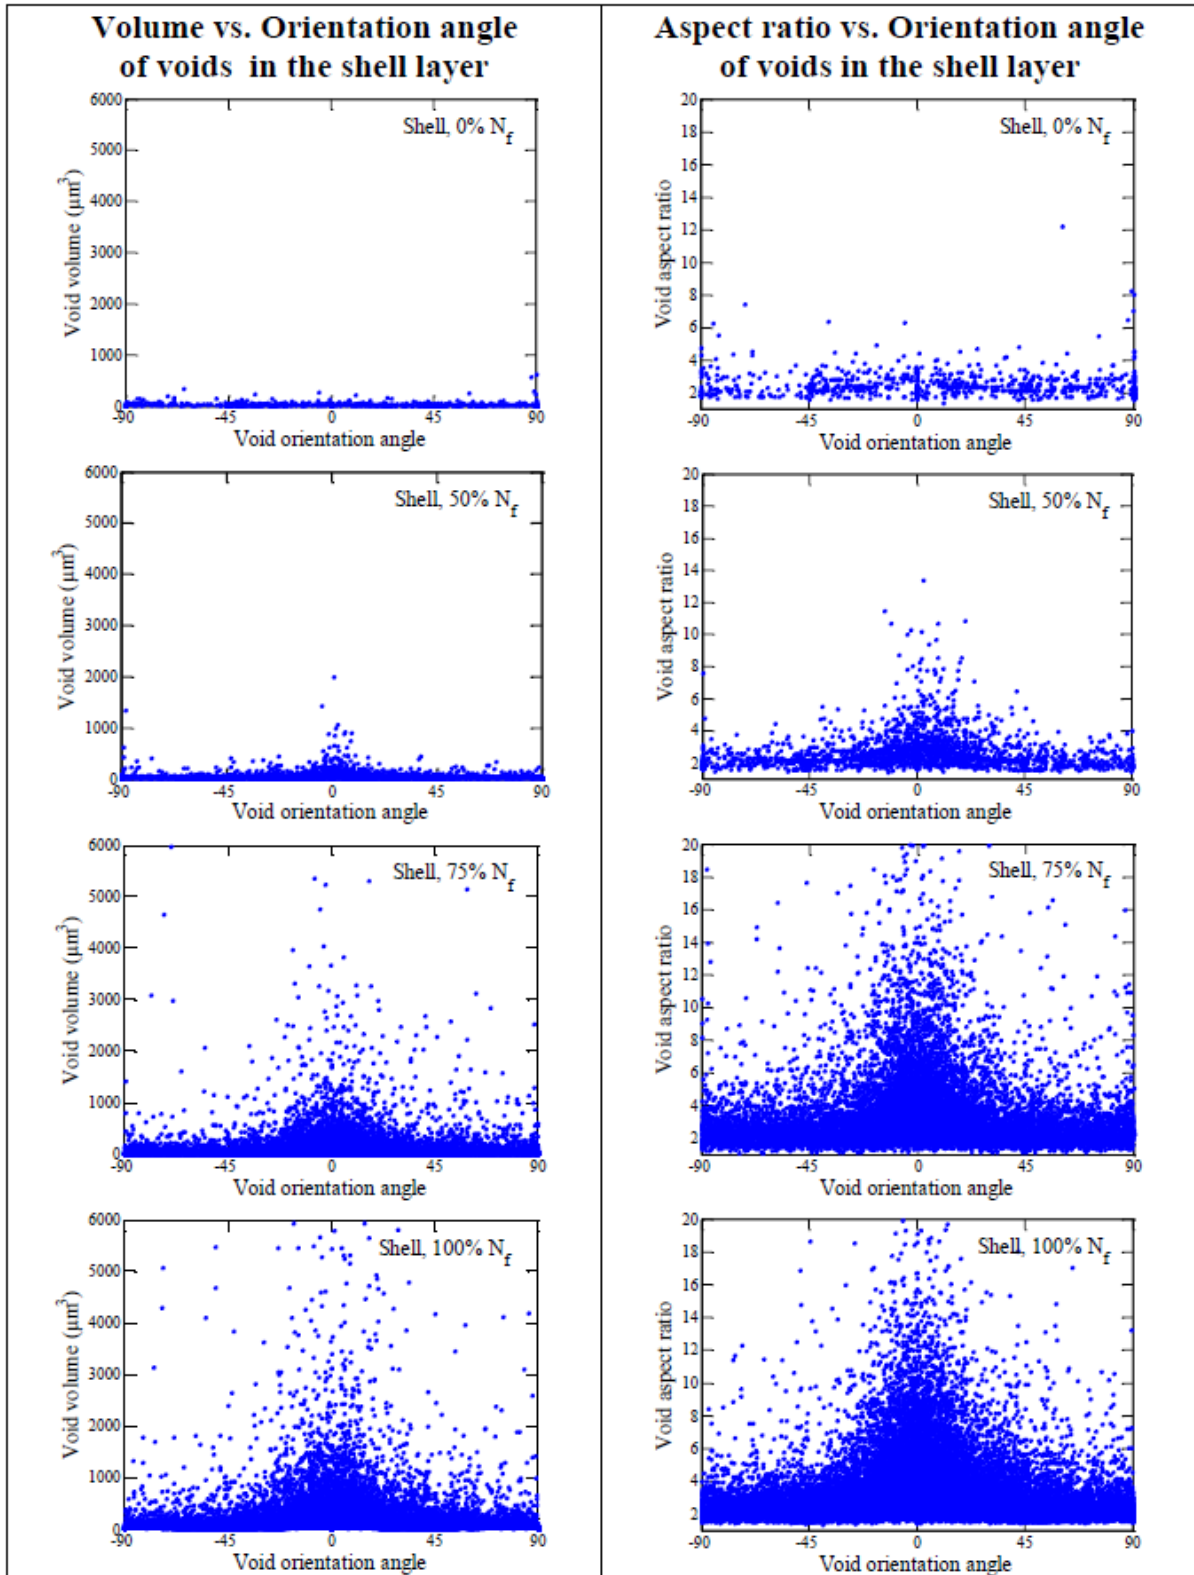
**Figure 4.** Graphs of void volume vs. void orientation angle (*left*) and void aspect ratio vs. void orientation angle (*right*) of the representative  $\mu\text{CT}$  volume of **the shell layer** of the specimens fatigue loaded up to different percentage of fatigue life ( $N_f$ ). The  $0^\circ$  void orientation angle represents the orientation parallel to the MFD and the applied fatigue loading.

Fig. 4 illustrates the evolution of void volume and void aspect ratio with respect to the void orientation angle and number of cycles at the shell layer of specimens fatigue loaded up to different percentages of fatigue life. The figure clearly demonstrates that the void volume increases as the percentage of fatigue life increases. It is worth noticing that voids with low volumes are also observed in the virgin sample, which could be due to the real initial damage

or due to the image artifact. As the percentage of fatigue life increases, the voids with high volume are oriented mainly at around  $0^\circ$ , longitudinal to the fiber orientation as well as to the applied fatigue load direction. The largest void volume evolution is situated at this orientation angle. By visual verification in the rendered  $\mu$ CT volume, as shown in Fig. 3, it was shown that these high void volumes are all situated along the fiber matrix interface. It can be concluded that the damage is mainly in the form of fiber/matrix interfacial debonding.

Moreover, one can see that the voids with low volumes at orientation angle around  $\pm 45^\circ - 90^\circ$  are also slightly increases as the percentage of fatigue life increases. In fact, these voids are also mainly situated along fiber matrix interface. However, these small voids do not follow the fiber orientation angle due to the separation algorithm applied during image processing, as discussed above. Many small void volumes are also situated at fiber ends and in the matrix, which could be due to the image artifacts, or due to the real damage in the form of fiber/matrix interfacial debonding at fiber ends and matrix microcracks.

The evolution of void aspect ratio at the shell layer has also been analyzed (Fig. 4). The void aspect ratio can be used to study the anisotropy degree of the voids, as well as to strengthen the analysis on void volume evolution. One can see from Fig. 4 that the void aspect ratio of voids oriented at around  $0^\circ$  increases as the percentage of fatigue life increases. This evolution is the same as the trend of the void volume which means that the voids enlarges and elongates mainly along fiber interface as the percentage of fatigue life increases.

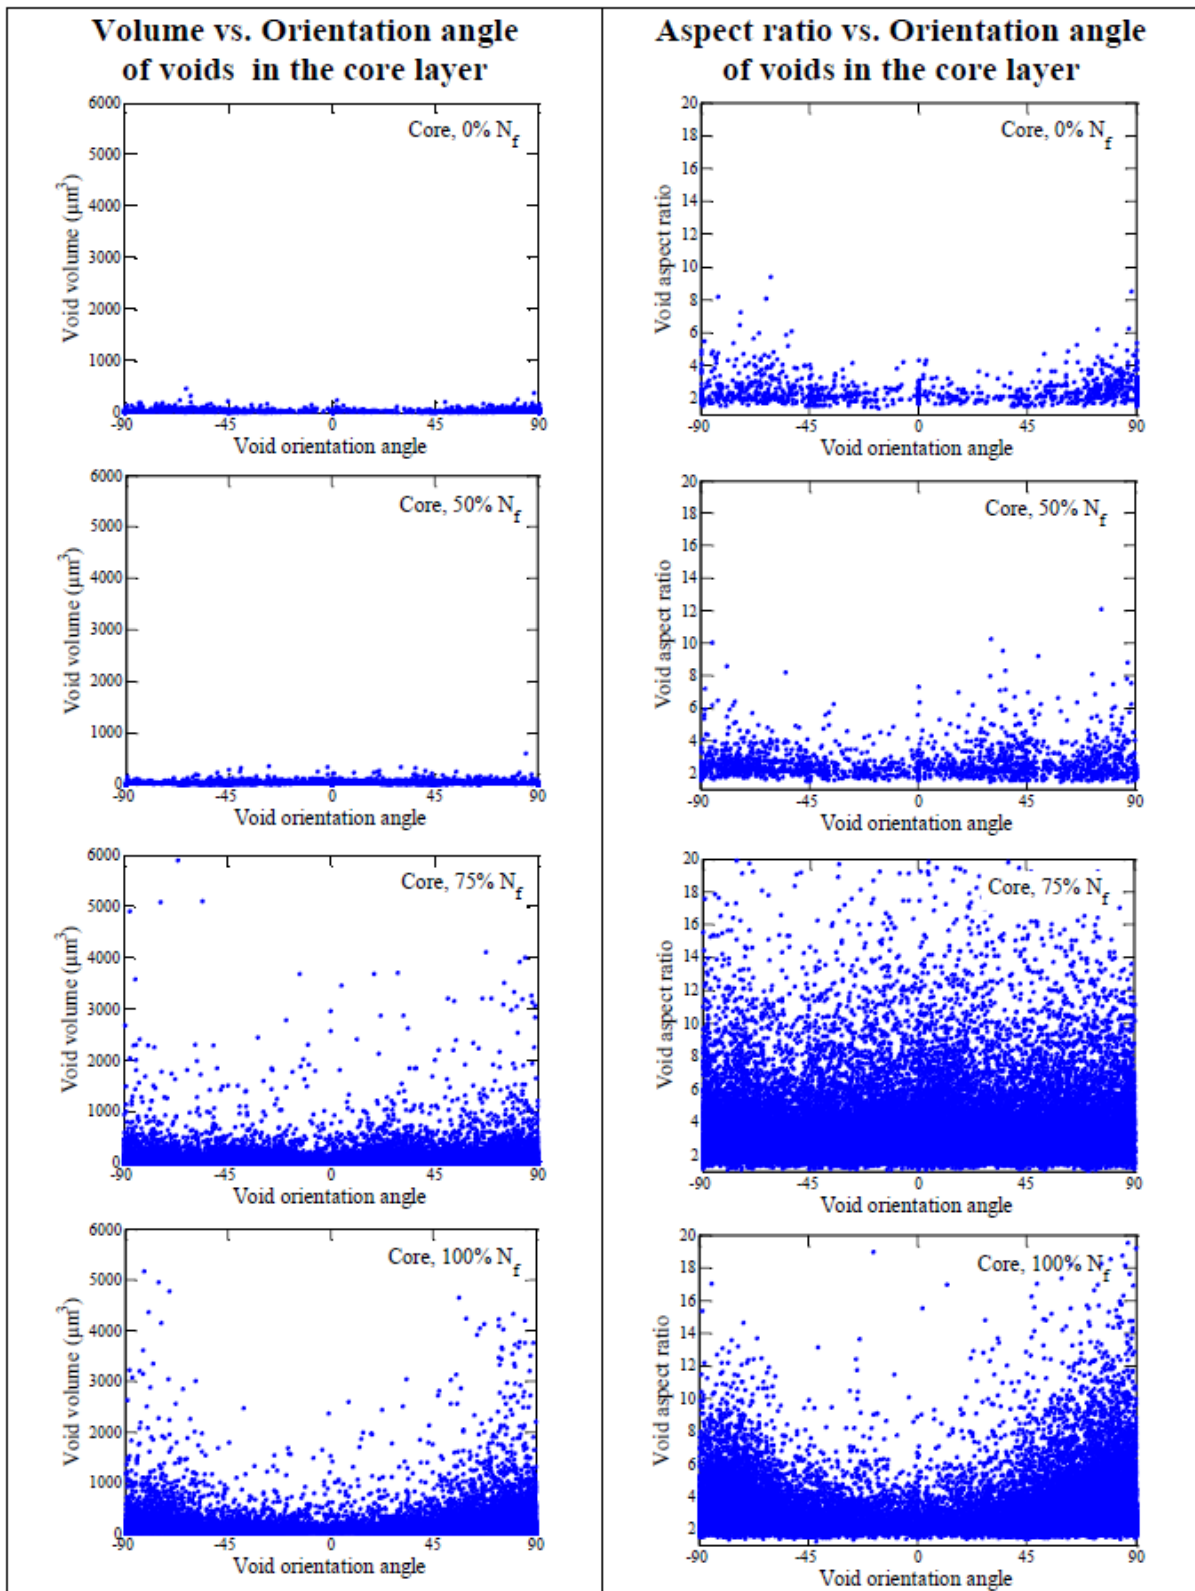
**Figure 5.** Graphs of void volume vs. void orientation angle (*left*) and void aspect ratio vs. void orientation angle (*right*) of the representative  $\mu\text{CT}$  volume of **the core layer** of the specimens fatigue loaded up to different percentage of fatigue life ( $N_f$ ). The  $0^\circ$  void orientation angle represents the orientation parallel to the MFD and the applied fatigue loading.

The evolution of void volume and void aspect ratio with respect to the void orientation angle and number of cycles at the core layer is then analyzed. As seen in Fig. 5, obvious increase of void volume is only remarked at 75% and 100% of fatigue life. It should be noted that the thin core layer for the specimens used in the current study doesn't impart an active role on the load transfer due to its perpendicular configuration with respect to the applied fatigue loading direction. Due to this reason, the voids are only significant at 75% and 100% of fatigue life. At 75% of fatigue life, voids are mainly situated along the fiber interface. However, these voids have no tendency to be oriented into a certain orientation angle. This is affirmed by the trend of void aspect ratio which shows a highly varying aspect ratio without any preferential void orientation. As the number of cycles increases, the void volume increases and elongates along the fiber interface. Therefore, at 100% of fatigue life, voids with high volume and aspect ratio are oriented at around  $90^\circ$ , parallel to the principal fiber orientation of the core layer but perpendicular to the applied fatigue loading direction.
