DAMAGE MECHANISMS INTO SHORT GLASS FIBRE REINFORCED THERMOPLASTIC DURING IN SITU MICROTOMOGRAPHIC TENSILE TESTS

Keywords: In situ microtomography, Reinforced thermoplastics, Damage mechanisms, Injection molded composite

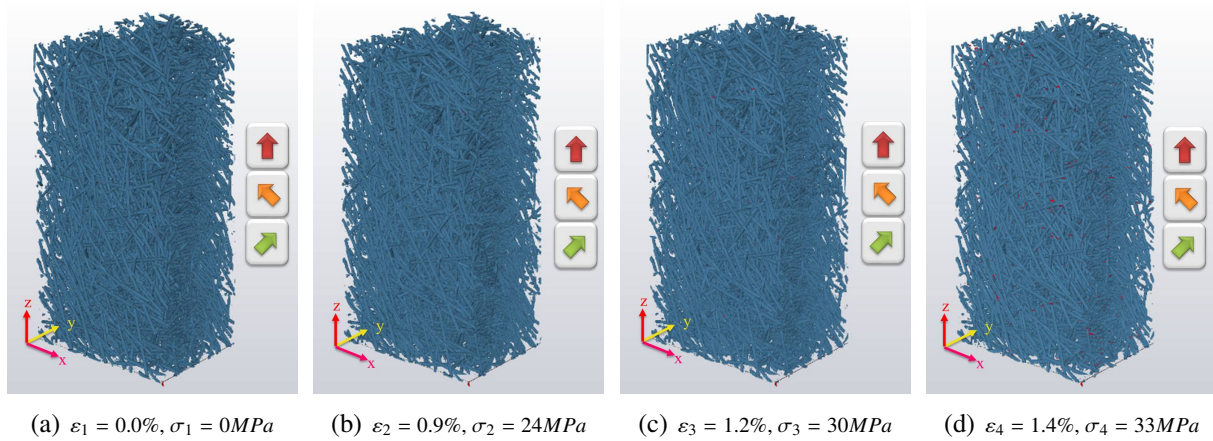
Figure 4. 3D pictures of the sample at different deformation stages of the test.

Figure 4 presents 3D pictures of the sample, with increasing level of strain from left to right. To obtain these pictures, appropriate thresholds have been identified for fibres and for voids. Then, only these elements have been kept. In blue, we can observe fibres, with a core-shell structure. In red, identified voids used as indicators of damage into the material.

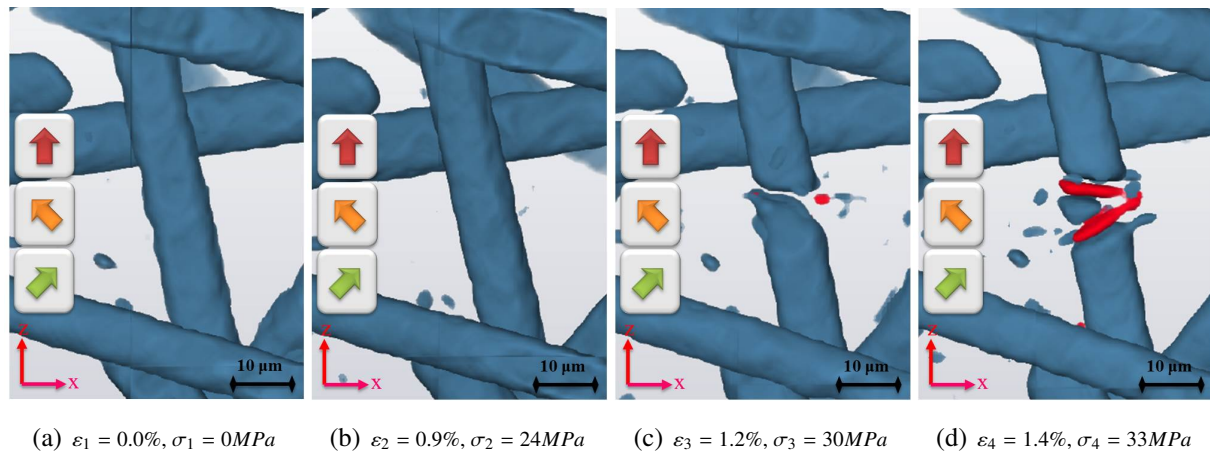
Figure 8. Rupture of a fibre oriented in the same direction as tensile strength

mechanisms for this material, has been observed and seems to contribute to failure mechanism. As a matter of fact, significant fibre breakage is largely detected, transverse to macroscopic stress direction. This mechanism is present, whether the fibre and the main stress direction are collinear (figure 8) or perpendicular (figure 9). The fact that this mechanism has not been considered yet can be explained by two points. First, the previous descriptions were limited to surface observations, where fibre failure can hardly be evidenced. Secondly, sizing or other
