DAMAGE – PROPERTY CORRELATION AFTER LASER CUTTING OF CFRP

Wolfgang von Bestenbostel^{a*}, Max Kolb^a, Andreas Fürst^b, Andreas Wetzig^b

^aAirbus Group Innovations, TX2, Willy-Messerschmitt-Straße, 81663 München

^bFraunhofer Institut für Strahltechnik IWS, Winterbergstraße 28, 01277 Dresden

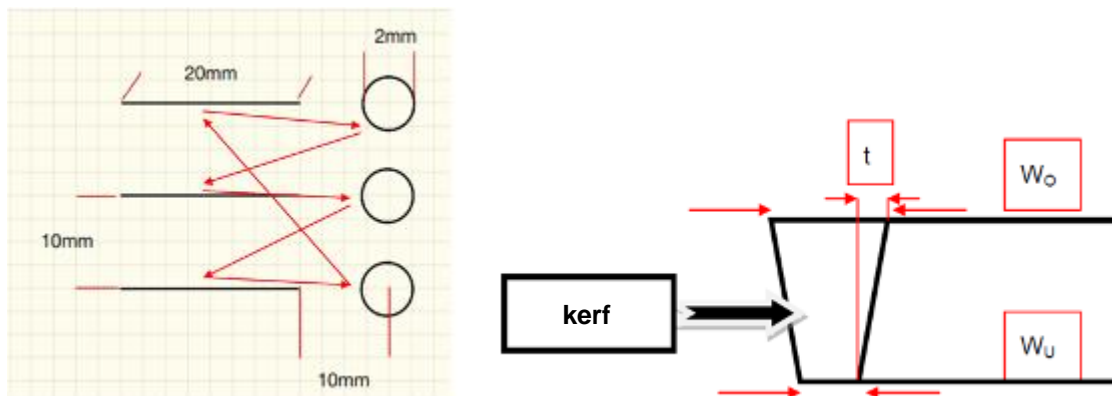
Figure 1. Schematic view of the cutting strategy (left) and the definition of the extend of funnel shape

The influence of cutting strategy, cutting rate, line overlap and focus location were investigated during multiple test series (Fig. 1).

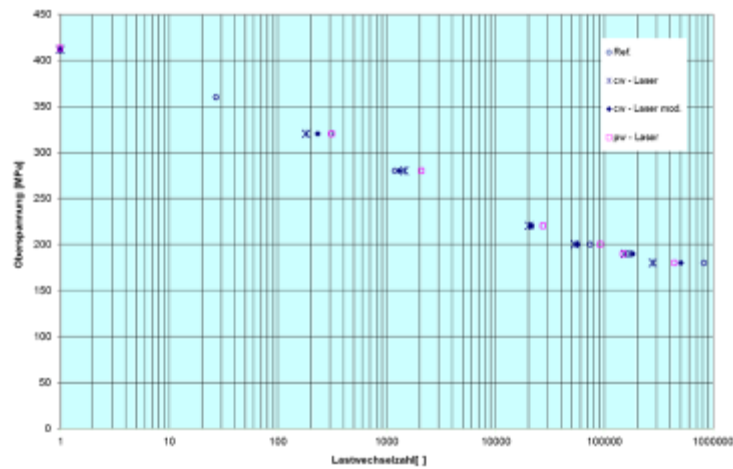
Figure 8. OHT Wöhler – lines of the different laser types

The results of the OHT – test in static and fatigue is shown in Fig. 8 in form of Wöhler lines. The lines of the different laser types cover each other very accurately.
